ENGINEER HEADQUARTERS, FIFTH ARMY :
A. P. O. #464, U. S. ARMY

1 November 1944

ENGINEER TECHNICAL BULLETIN NO. 25

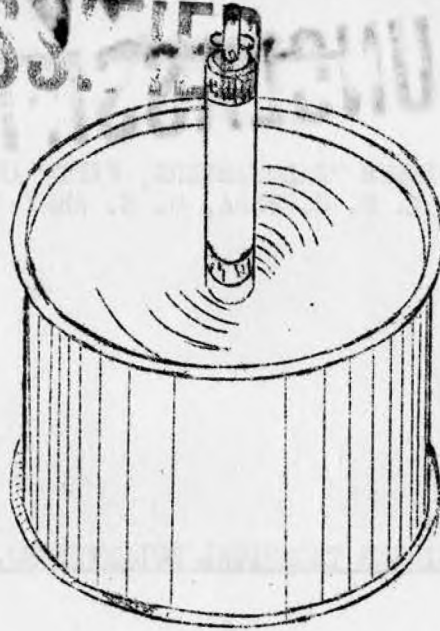
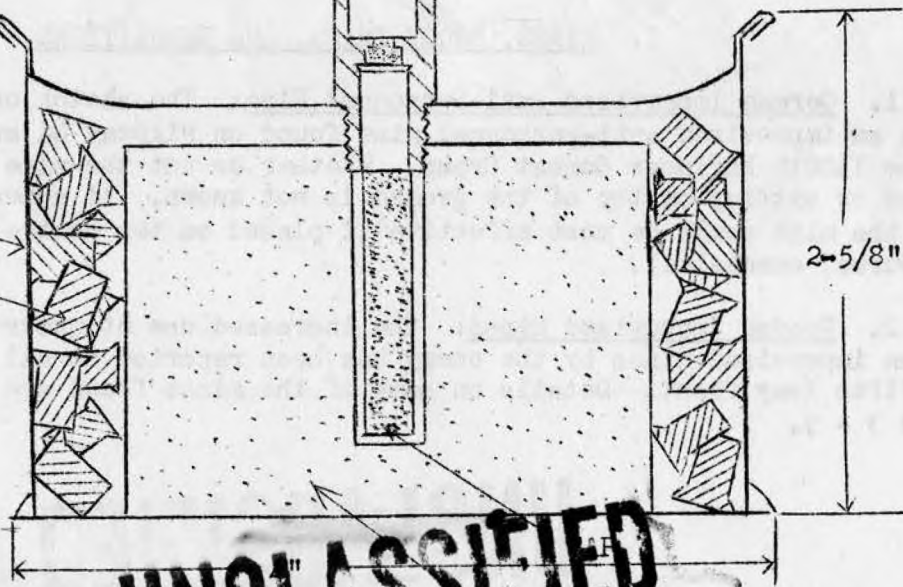
GERMAN IMPROVED A.P. MINE

1. German Improvised Anti-Personnel Mine: The sketch on page 2 shows an improvised anti-personnel mine found on Highway 64 and reported by the 1108th Engineer Combat Group. Whether or not the mine was found buried or sitting on top of the ground is not known. It appears, however, that the mine would be most effective if placed on top of the ground (and, of course, concealed).

Z.Z. 42
IGNITER

TIN CAN
425 RIVETS

CHARGE 200 gm BLOCK TNT

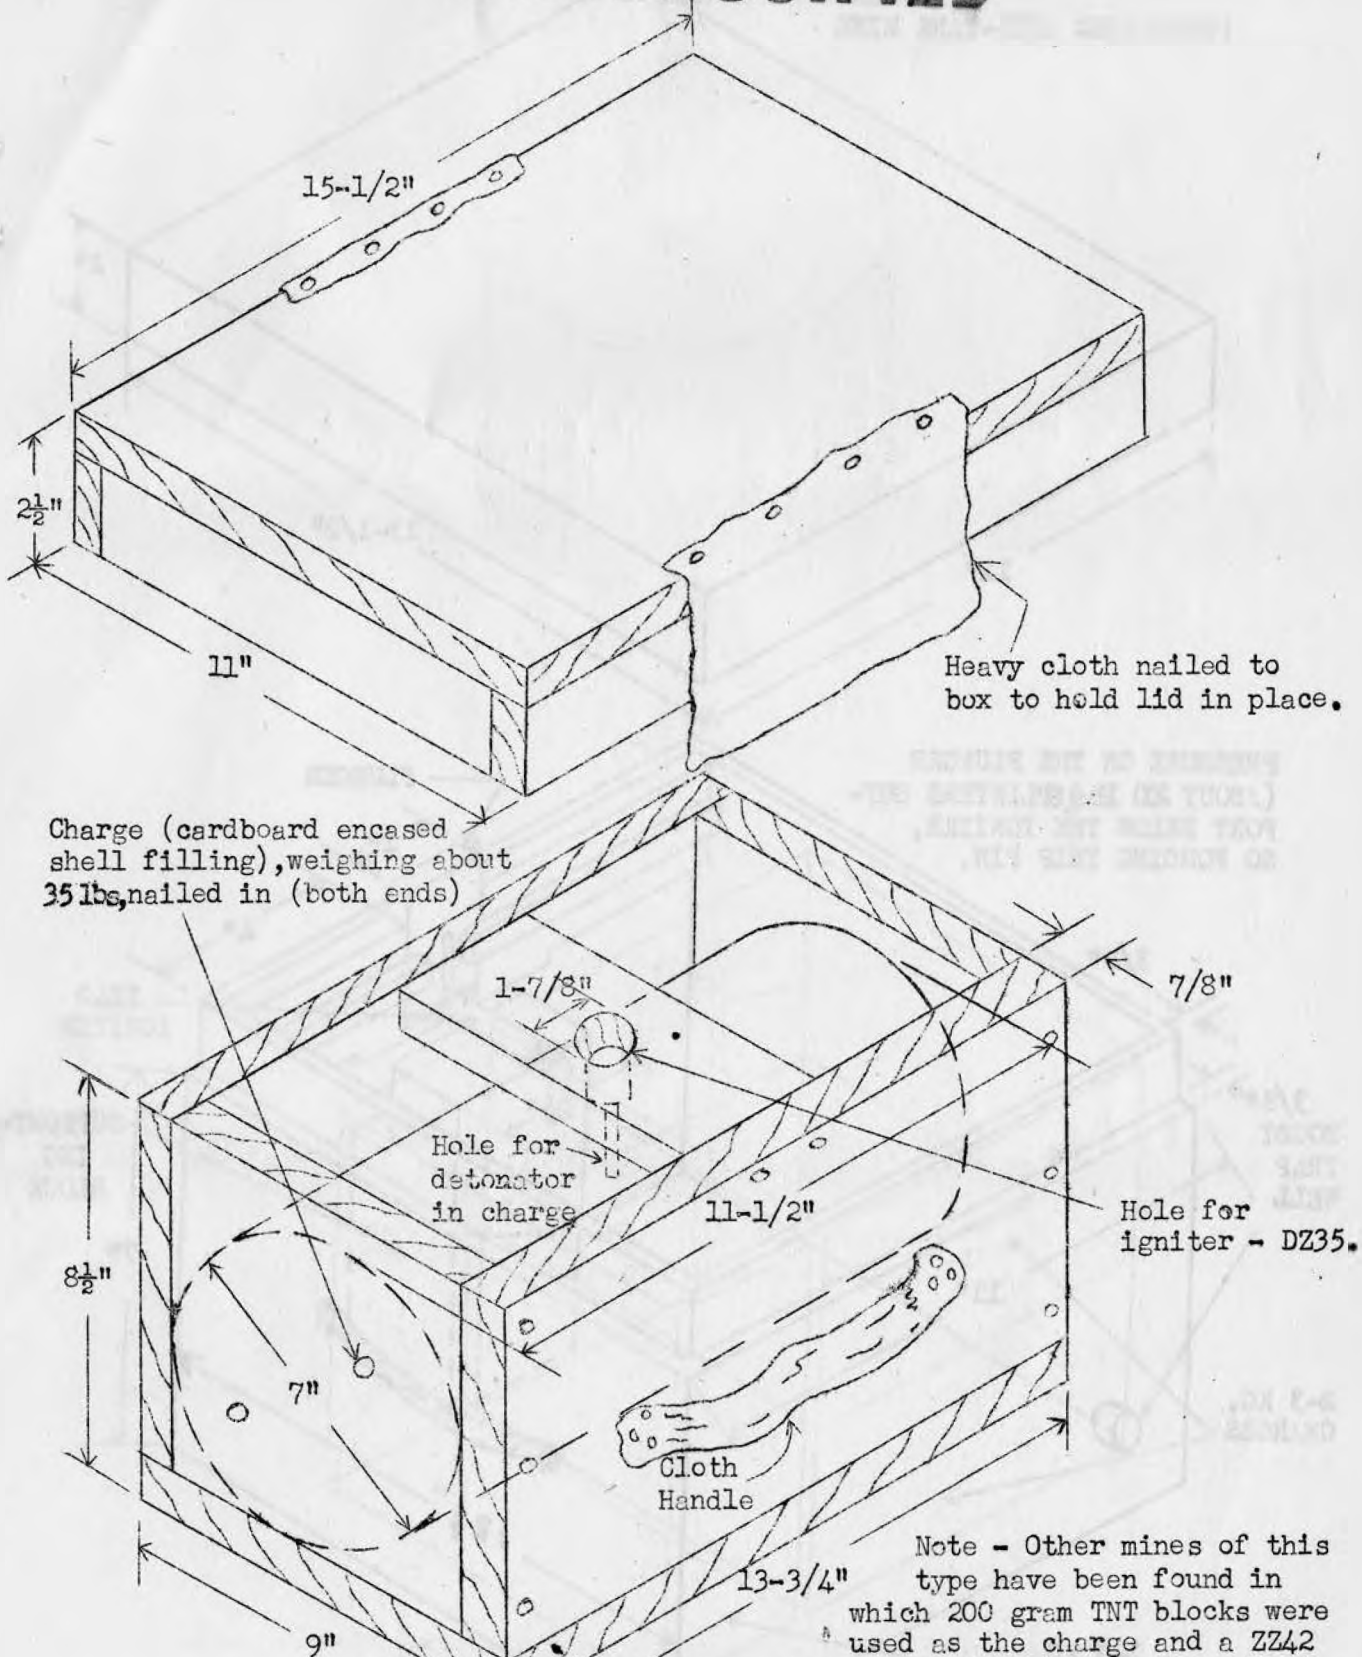
IMPROVED WOODEN ANTI-TANK MINE
UNCLASSIFIED

2. Wooden Improvised Mines: The increased use of numerous types of wooden improvised mines by the enemy has been reported on all sectors of the Fifth Army front. Details on some of the mines found are shown on pages 3 - 5.

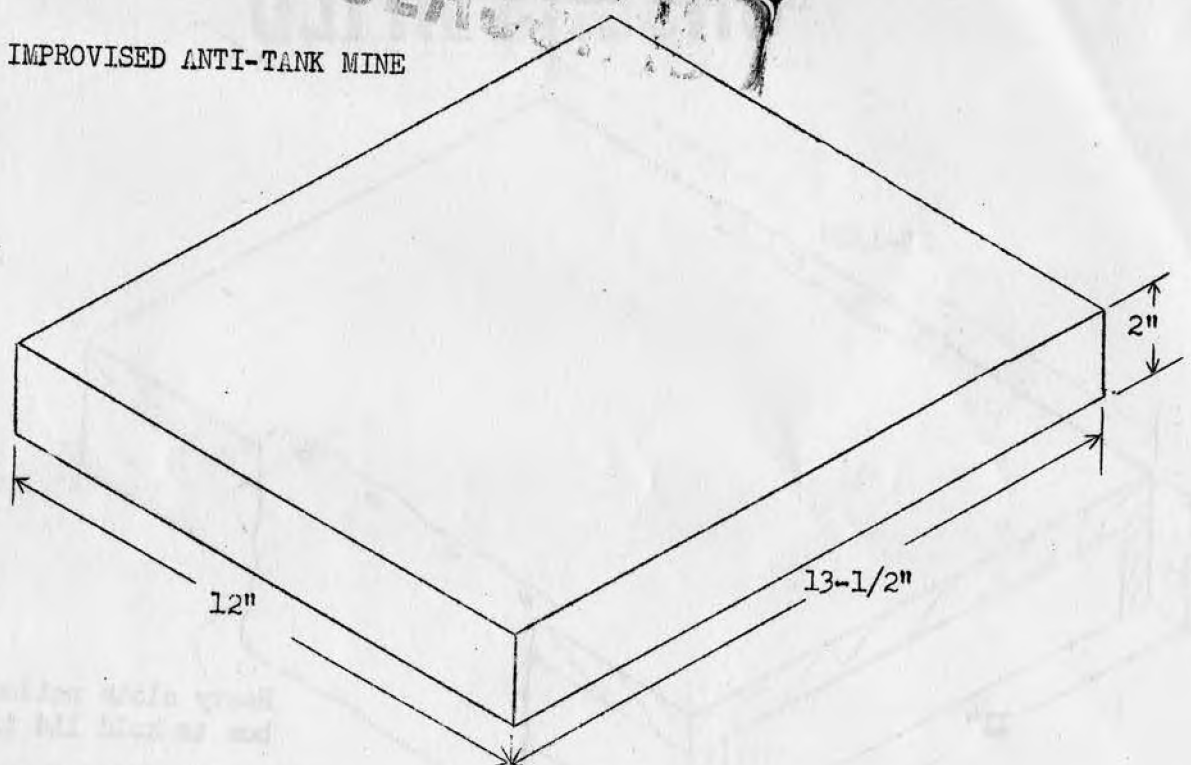
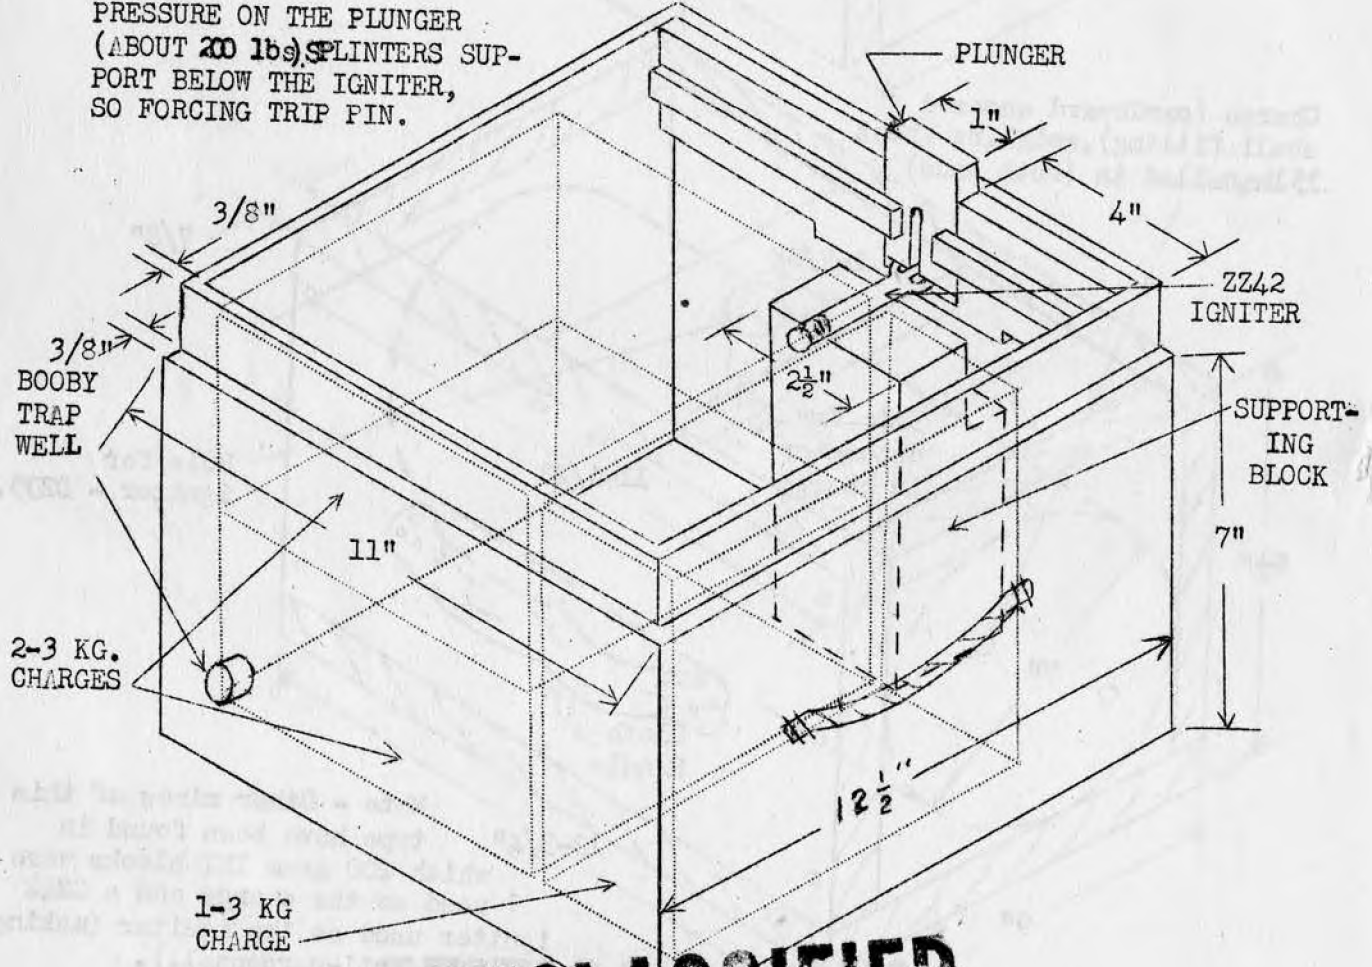
IMPROVED ANTI-TANK MINE

PRESSURE ON THE PLUNGER
 (ABOUT 200 lbs) SPLINTERS SUP-
 PORT BELOW THE IGNITER,
 SO FORCING TRIP PIN.

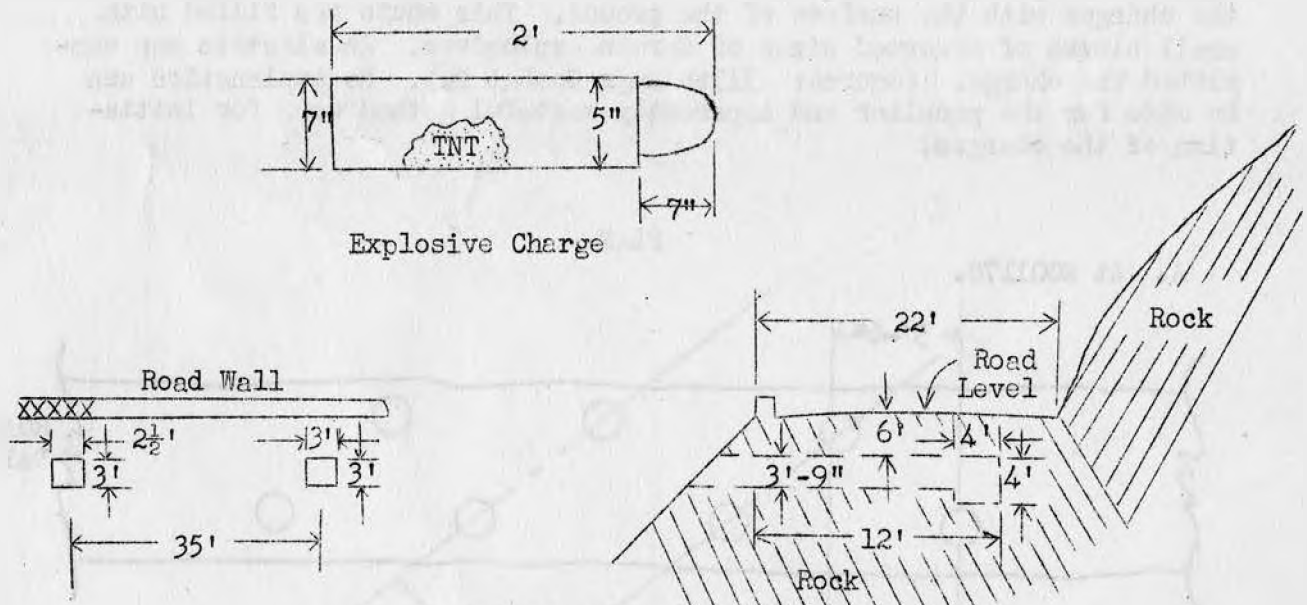
a. While widening Route 6524, where it had been blown, in the vicinity of Q9098, two demolition chambers were found close to the crater. The first was about fifty feet east of the crater, and the second was thirty-five feet east of the first. Eighteen prepared charges were removed from the first chamber and sixteen from the second. There were no wires or caps. A sketch of the chambers and one of the charges (which were cardboard encased shell fillings) is shown below. (Source: 19th Engr Combat Regt)

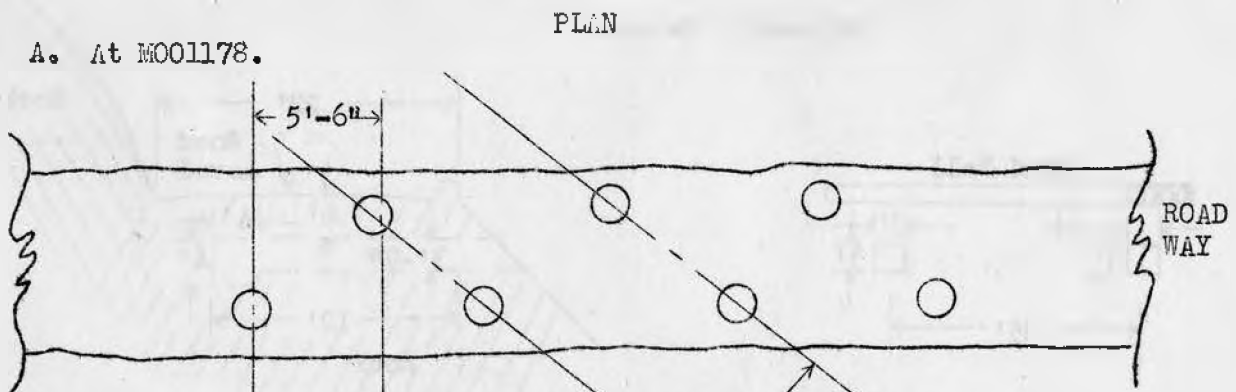
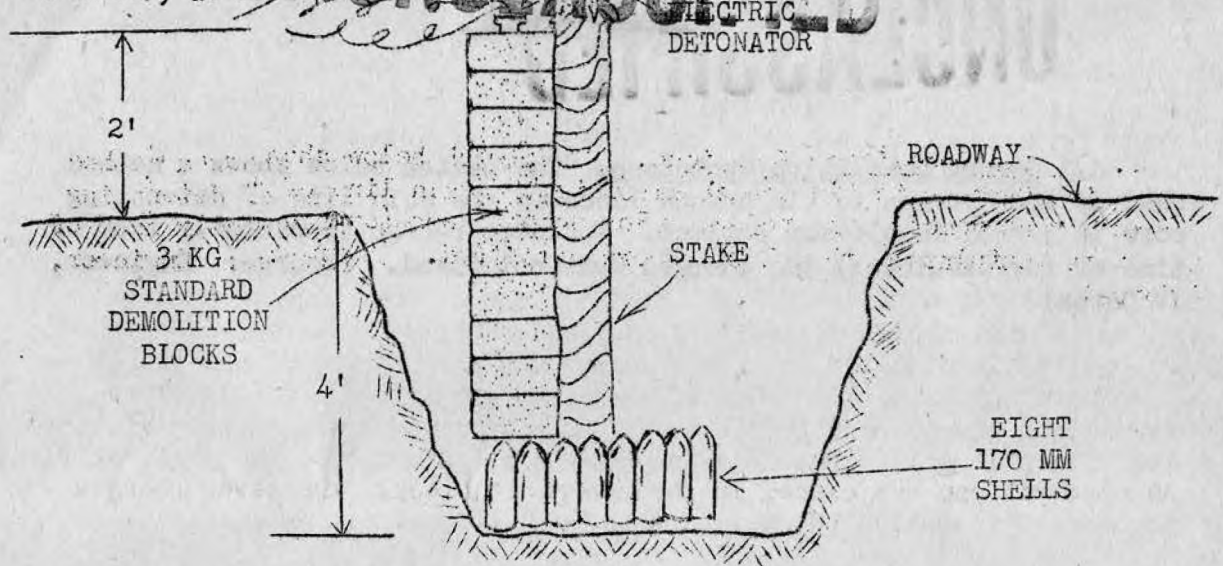
A cont., at M001178

(1) At MO01178, seven individual charges were spaced evenly along both sides of the roadway (see sketch). Each charge consisted of eight 170 mm. shells placed upright in a hole approximately 4 feet deep and 3 feet in diameter. A stake extended from the top of the shells and protruded approximately two feet above the ground. Standard German 3 kg demolition blocks were fastened with wire along one side of the stake for its entire length. These charges acted as a booster in the chain of fire. An electric cap was placed in the uppermost block. The seven charges were wired in series but the last three failed to detonate.

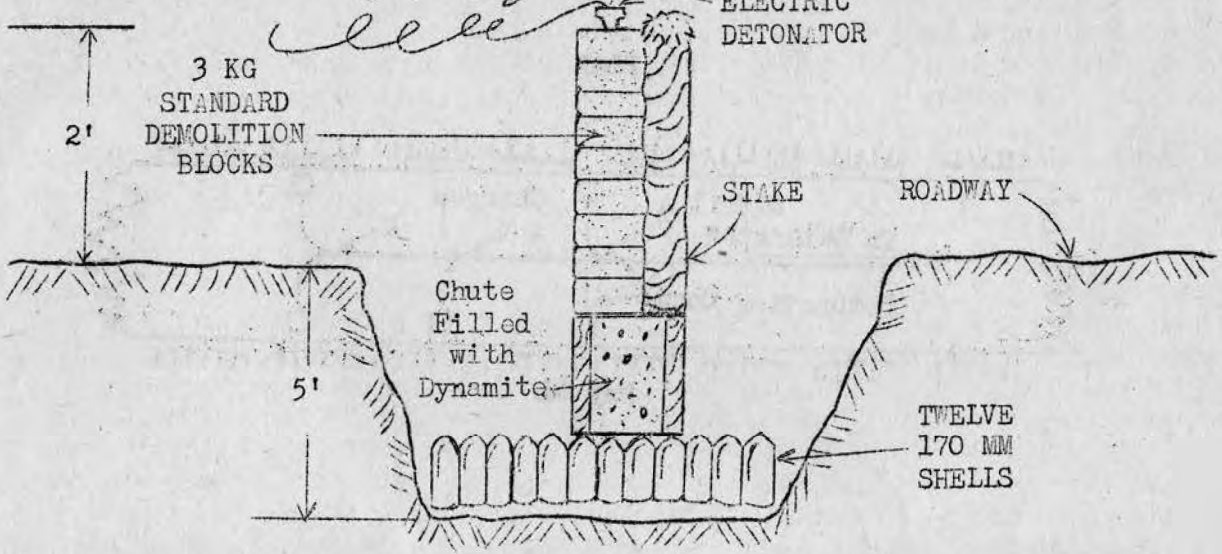
B. At L994199.

(2) At L994199, three individual charges, each consisting of twelve 170 mm. shells, were placed upright in a hole approximately 5 feet deep and 4 feet in diameter. In this case the stake with the 3 kg charges wired to it extended only about halfway down to the shells (see sketch). A wooden chute approximately 6" square was placed between the top of the shells and the bottom of the stake. The chute was filled with German dynamite. An electric cap was placed in the uppermost demolition block.

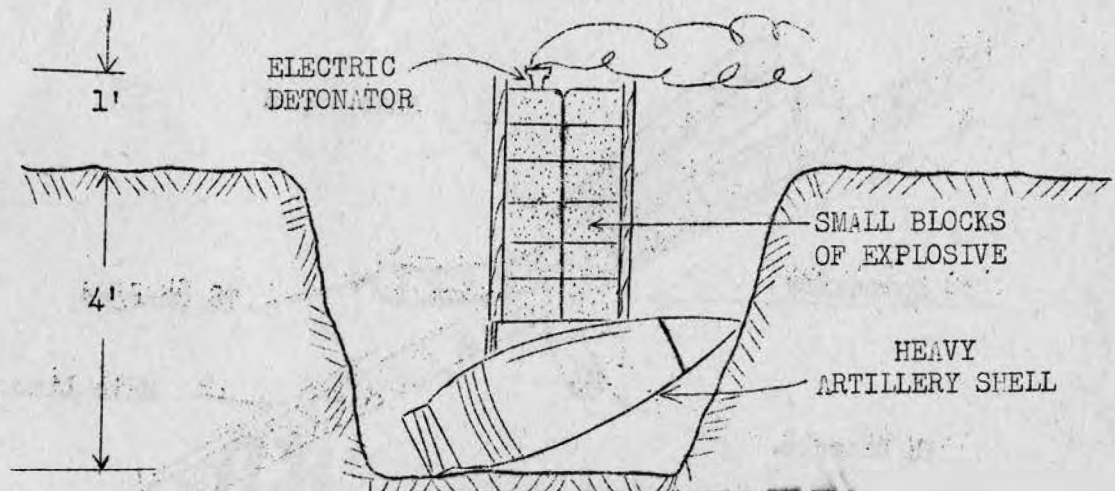
C. At L987197.

(3) At L987197, eleven cratering charges had been prepared--two failed to detonate. Of these two, one consisted of an Italian aerial bomb shaped similarly to the 100 lb. Italian aerial bomb but weighing approximately 250 lbs.; the other charge was a large artillery (?) shell (325 mm. diameter, 121 cm. long). Both of these charges were buried approximately 4 feet deep. A wooden chute 4" x 6" x 5' long connected the charges with the surface of the ground. This chute was filled with small blocks of assorted sizes of German explosives. An electric cap completed the charge. (Source: 313th Engr Combat Bn). No explanation can be made for the peculiar and apparently wasteful method used for initiation of the charges.

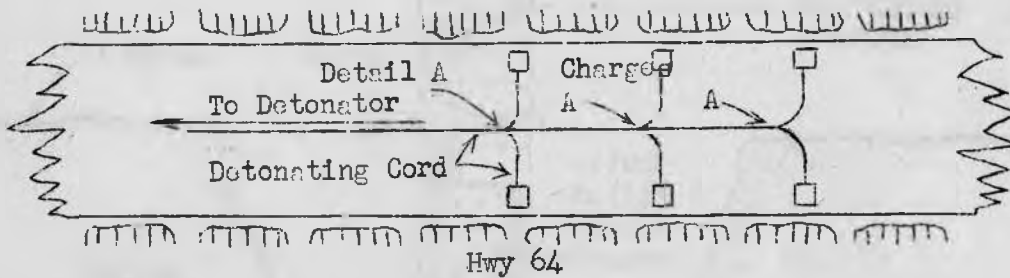
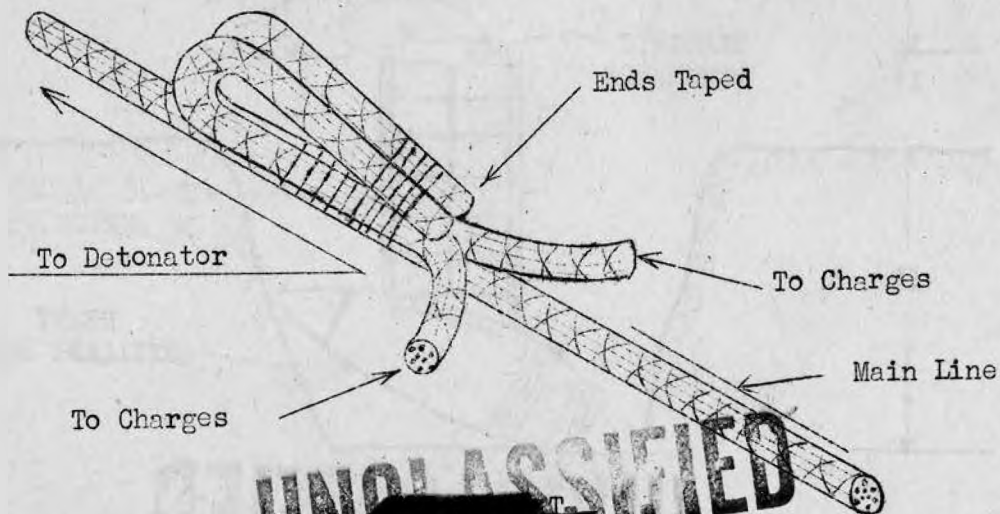
DETAIL "A"

4. German Demolition Technique. The sketch below shows a method used by the Germans to tie branch lines to the main line of detonating cord in a road demolition project. For some reason (apparently lack of time or forgetfulness) the charges were not fired. (Source: Engineer, IV Corps)

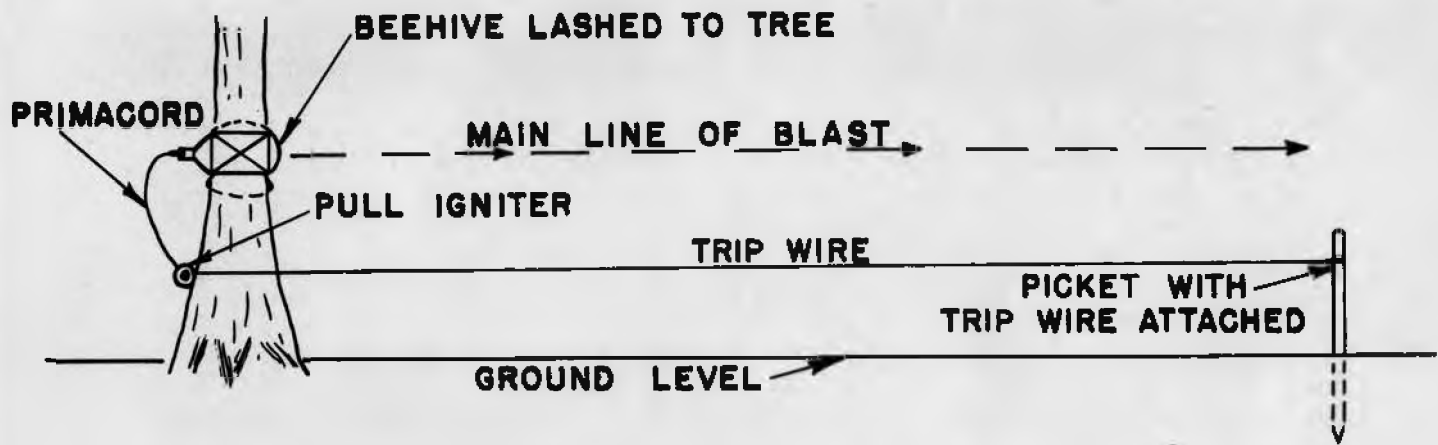
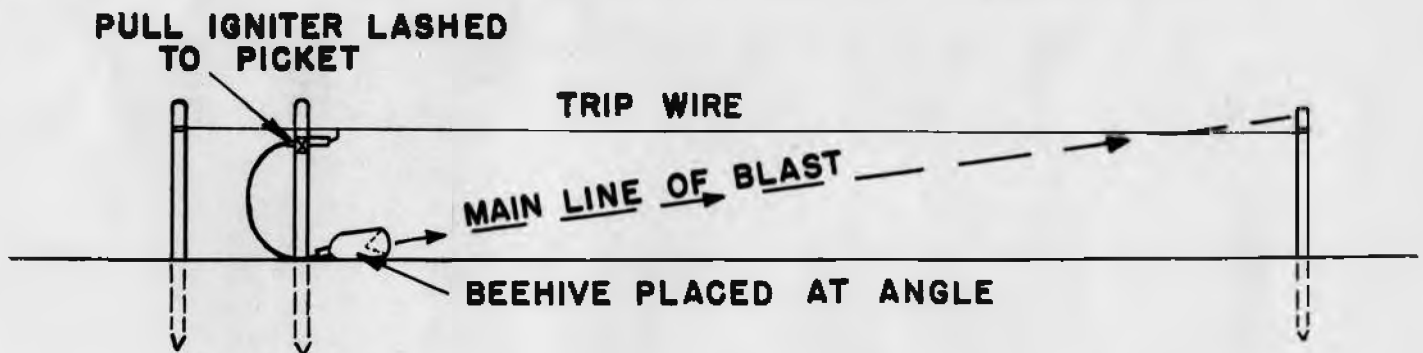
BEEHIVE BOOBY TRAPS

5. Beehives as Anti-Shrapnel Mines. The following paragraphs, submitted by the CRE, 78th Division (British), show the effectiveness of beehives as anti-personnel mines. They can be used singly to cover tracks etc., or in large numbers to cover a length of front.

a. Method of Laying. The beehives can either be tied to a stake or tree, or lain on the ground. In the latter case the all round lethal effect might be increased by surrounding them with stones (leaving the cone exposed). This would also improve concealment. It is considered that the beehives are best laid with the hollow cone pointing along the trip wire, or slightly towards the enemy side with the line of blast at about waist level, or, if laid on the ground, at a slight elevation. The igniter assembly consists of a pull igniter, two feet of primacord and a detonating cap. The trip wire can either be arranged to operate from both directions, or by a man approaching from the enemy side only (see sketch). Ten yards is considered a suitable length of trip wire in a continuous belt.

b. Effect. There is a considerable blast effect in all directions, and a very strong blast and some shrapnel effect in the line of the cone, where trees were splintered over 20 yards away during a trial. A belt 100 yards long, consisting of 10 beehives, was laid recently in operations, about 400 yards from our leading infantry positions. An attack was later made on our positions from a flank, and repulsed. While attempting to regain their own lines, the enemy ran into the booby trap belt. It is thought that another enemy force was forming up just on the enemy side of this belt at the same time. Four beehives were set off and although it has not been possible yet to approach the area in daylight, observers have reported 15 corpses in the immediate vicinity.

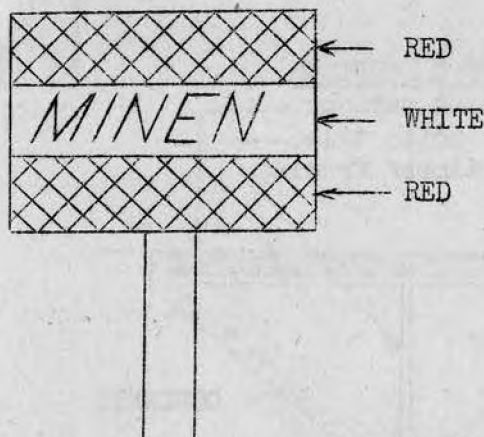
7. German Minefield Marking. A German Engineer Manual suggests that dummy minefields should be marked by signs with slanting letters, as shown below. (Source: Engineer Intelligence Memorandum No. 28, First U. S. Army).

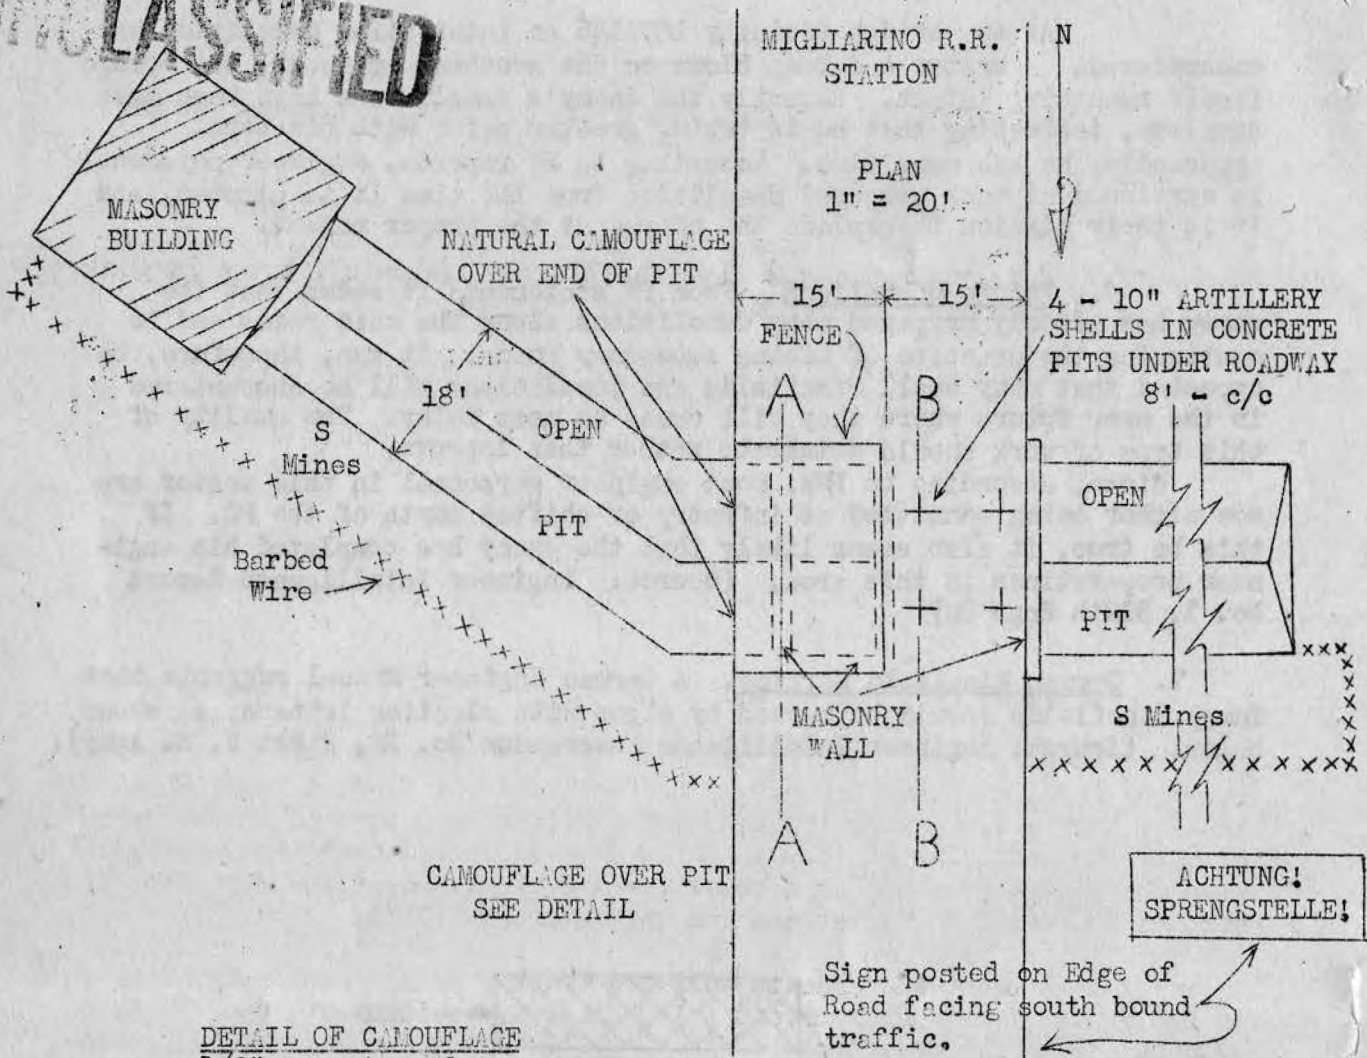
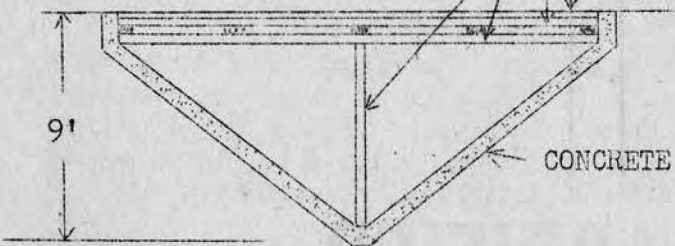
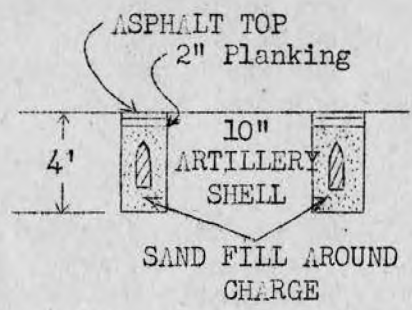
ENEMY TANK TRAP ON
ROUTE 1 - Q057706

1. German Tank Trap. The sketch below shows a German Tank Trap on Route 1 at Q057706, as reported by the 175th Engr. G.S. Regt.

DETAIL OF CAMOUFLAGE
1/2" cement surface
2" Terra cotta tile
2" x 2" timber framing

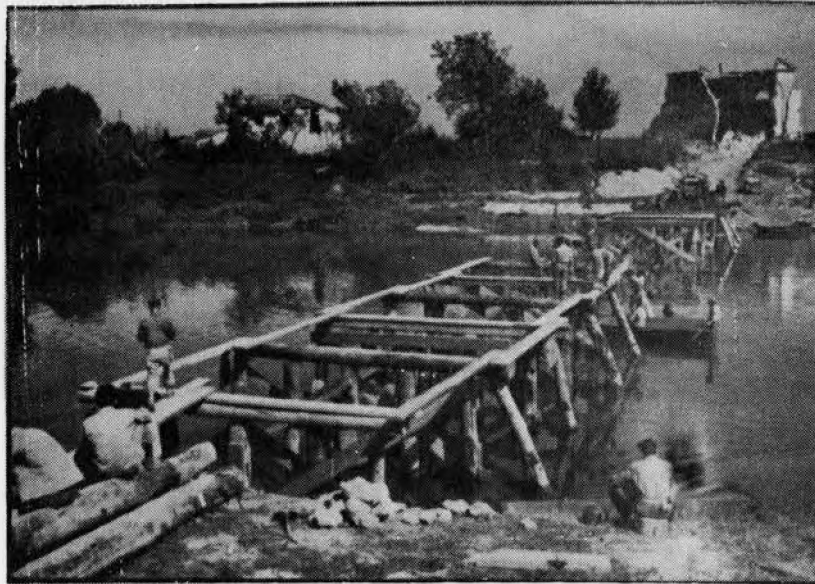
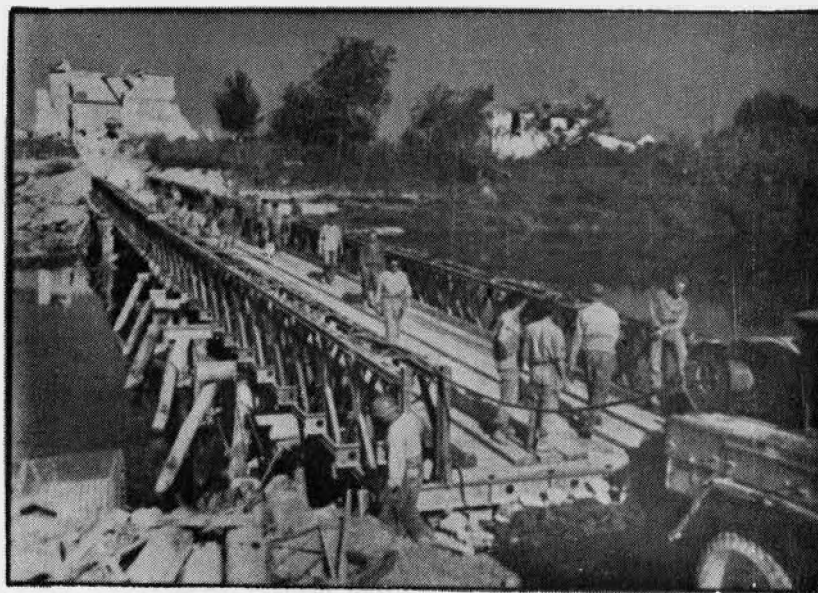
SERCHIO RIVER BRIDGE

2. Bailey Bridge across SERCHIO River. On 12 September 1944, it was decided that a Class 40, medium level bridge should be constructed over the SERCHIO River at Q059708 a few hundred yards upstream from the demolished bridge on Highway No. 1. At the site were the remains of a German wooden pile trestle bridge. It was proposed to use the remaining piles as supports for a continuous Bailey.

As first planned, the bridge was to rest on the caps of the pile bents and was to consist of an 90-foot double-single portion across the center gap and single-single trusses at either end. But since the bent spacing was such that some of the caps would not be under panel points, verticals, or diagonals, considerable discussion arose as to possible bending in the lower chords and crushing of the caps under the chords of the single-single portion. The two bents adjacent to the north end of the long center span would fit under panel points or verticals, but the one at the south end of the gap would miss a panel point by about six inches.

It was finally decided to cut down the two bents adjacent to the south end of the gap and place four heavy timber stringers on them so as to support continuously the lower chords in this short span. It was fur-

ther decided to make the entire bridge continuous double-single in order to increase the strength of lower chords and the bearing surface on caps. Since these decisions were made after all bents had been capped at the same level, construction was delayed several hours while two bents were cut down and the stringers placed.

(NOTE: The Army Engineer points out that this bridge would eventually have failed because of the excessive piling which would have collected too much drift. Only piles actually needed for support should have been left in place. The bridge, however, was removed a short time after construction.)

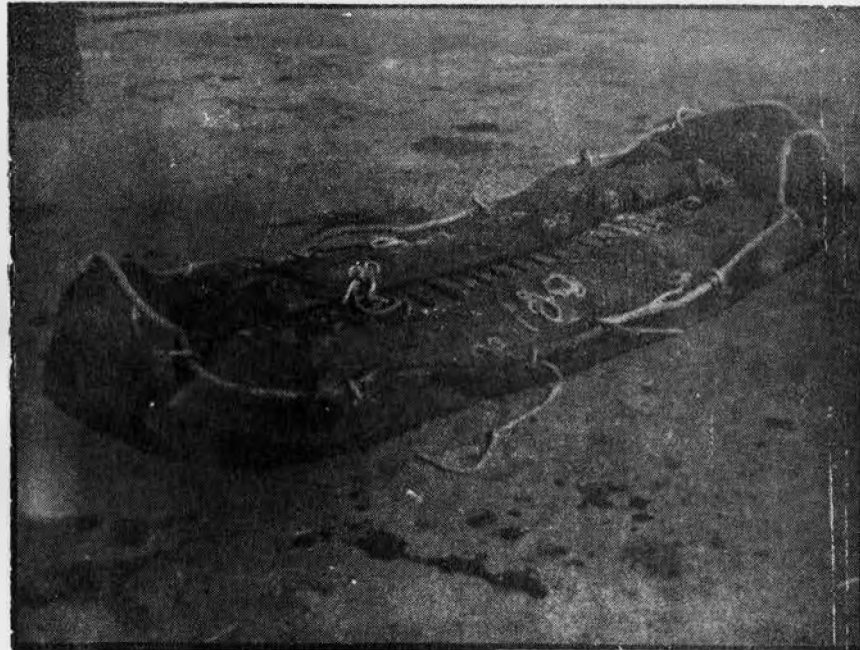
PONTON

a. Small Pneumatic Boat. Name of the boat is Kleiner Flossack, 34. Weight with floorboards is 120 pounds and when the boat is inflated it has a rated load capacity of 660 pounds. Three passengers are carried, including a crew of two. Six of these boats with a wooden superstructure will make a raft with a capacity of $1\frac{1}{2}$ tons. The boats are also used in the construction of improvised foot bridges.

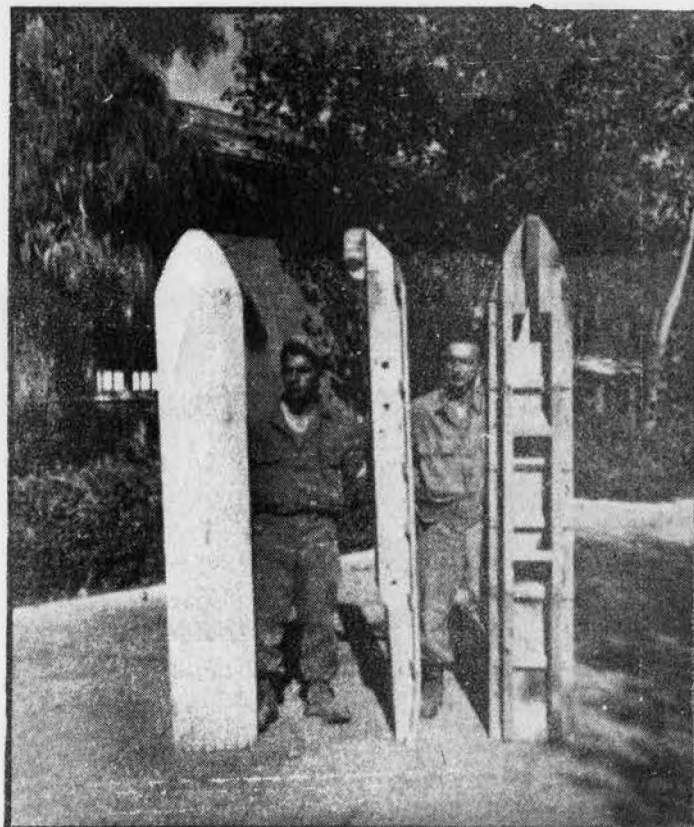
MUD SKIDS

b. Wooden Skids. The skids are made of soft wood with a 3-ply, plywood base. They are approximately 6 feet long and 1 foot wide and were apparently designed for moving towed guns and trailers in deep mud or snow.

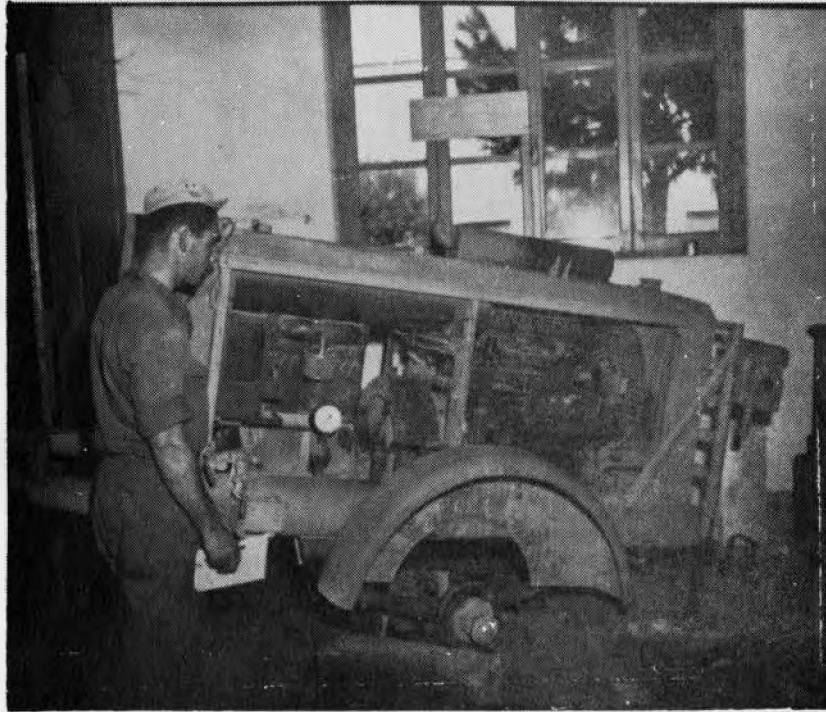
AIR COMPRESSOR

c. Air Compressor. The F.M.A. Air Compressor was built in FRANKFURT, Germany, in 1937. The 2-cylinder, single-stage compressor is driven by a 4-cylinder, 4-cycle gasoline engine rated at 27 horsepower. The air outlets can be easily adapted for the standard U.S. Army air hose connector with a little filing. Two interesting points should be noted:

(1) The construction of the air tank and its use as the chassis for the unit.

(2) The German inscription on the engine "Early Ignition", which means that low octane gasoline was used.

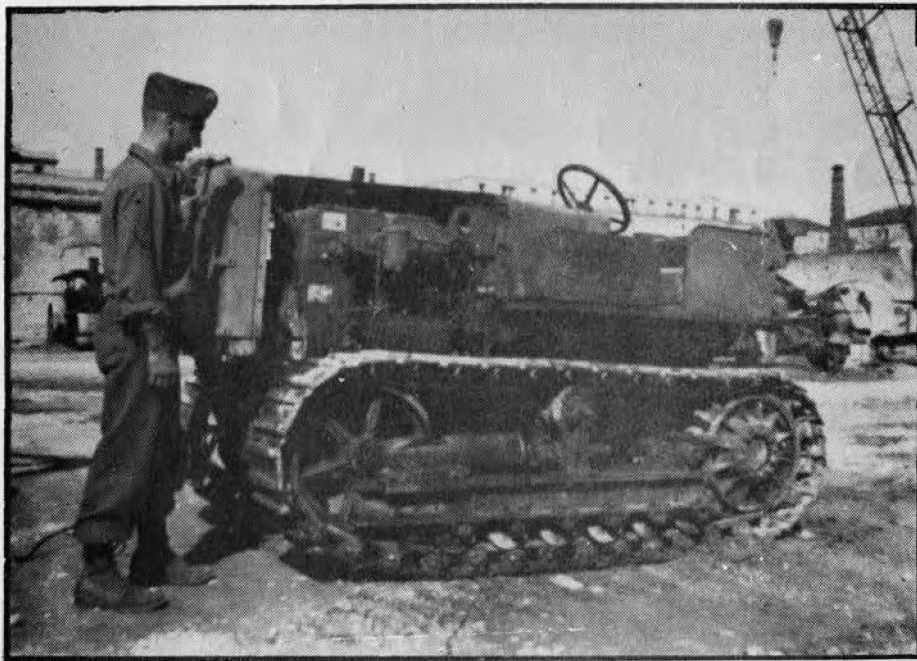
TRACTOR

d. Hanomag Tractor. The tractor was manufactured in HANOVER, Germany, in 1941. According to the available information, it was captured at ANZIO and used by the 815th Engineers. It is powered by a 4-cylinder, hot-plug diesel engine and is quite sturdy. It was probably used for towing light and medium loads.

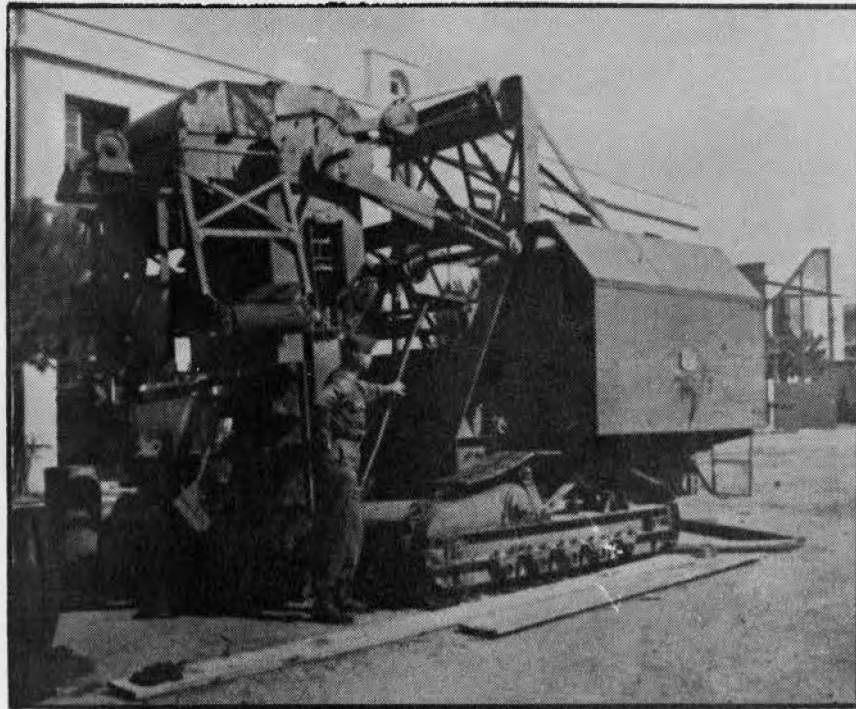
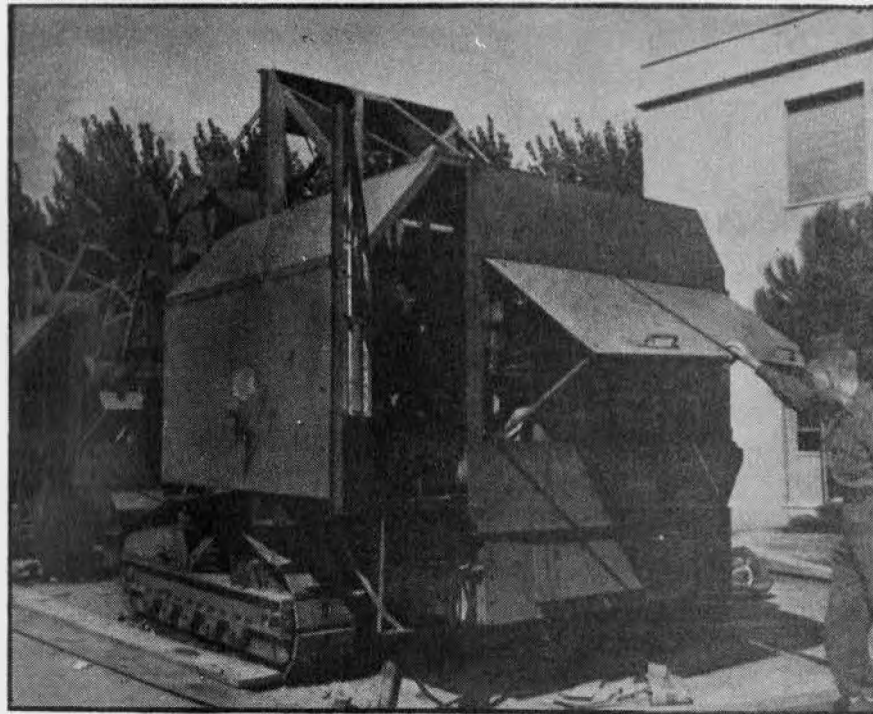
TRENCH DIGGER

e. Ditchdigger. The Dolberg Ditchdigger was made in BERLIN in 1939. It is powered by a 4-cylinder, 4-cycle Diesel engine, with gasoline starting and magneto ignition. Maximum depth of cut is approximately 6 feet and width is one yard. It is a very sturdy machine with an estimated weight of 10 tons. Although ideal for use by civilian contractors, its bulk and weight hamper movement for military use. This ditchdigger is much larger than those used in the U. S. Army.

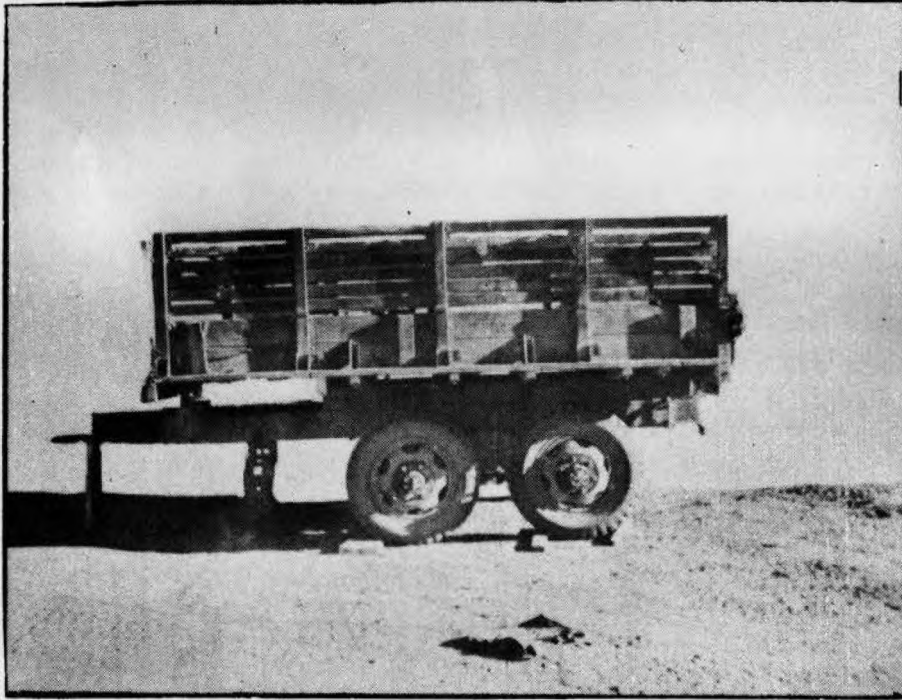
1. Map Trailers. The peculiar terrain in front of Fifth Army and the uncertainty of the future action of the enemy have required that the Army hold bulk stocks of maps of a very large area. In order to have the required maps readily available for issue to the front-line troops, it was necessary to develop a mobile map depot. This was done by building van type bodies on wrecked 2 $\frac{1}{2}$ -ton trucks made into trailers.

TRAILER AS RECEIVED FROM ORDNANCE

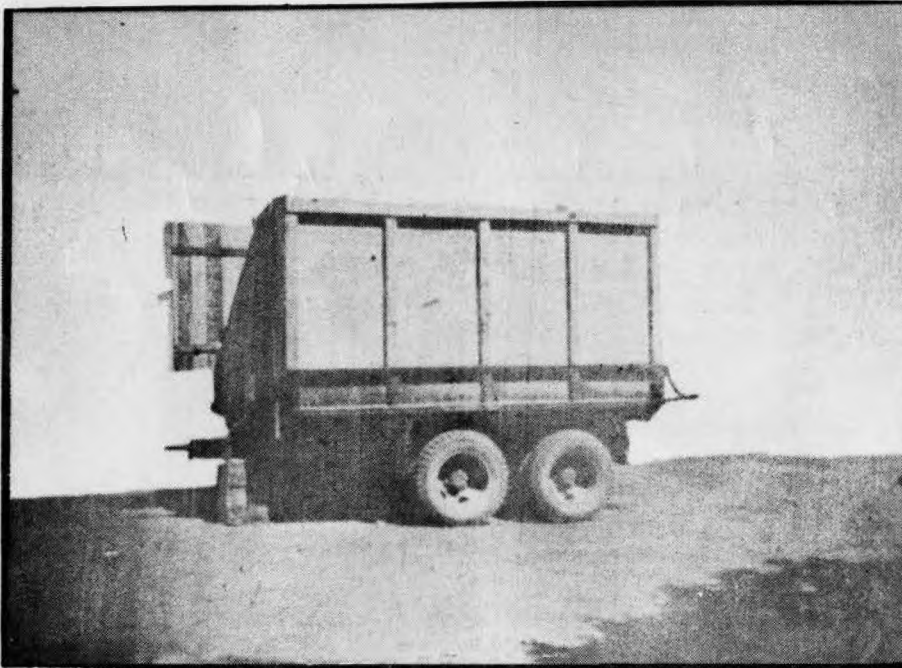
The van body was built directly upon the trailer body. They were built of any material available, 2" x 4" or angle iron frames covered with tar-paper or canvas with an interior of 1" x 12" or plywood. The bins are in general built of rough 1" x 4" lumber. Each trailer will hold approximately 160,000 maps. The Army Map Depot now has nine trailers in operation.

**TRAILER AFTER BODY HAS BEEN COMPLETED
(LESS CANVAS ON TOP)**

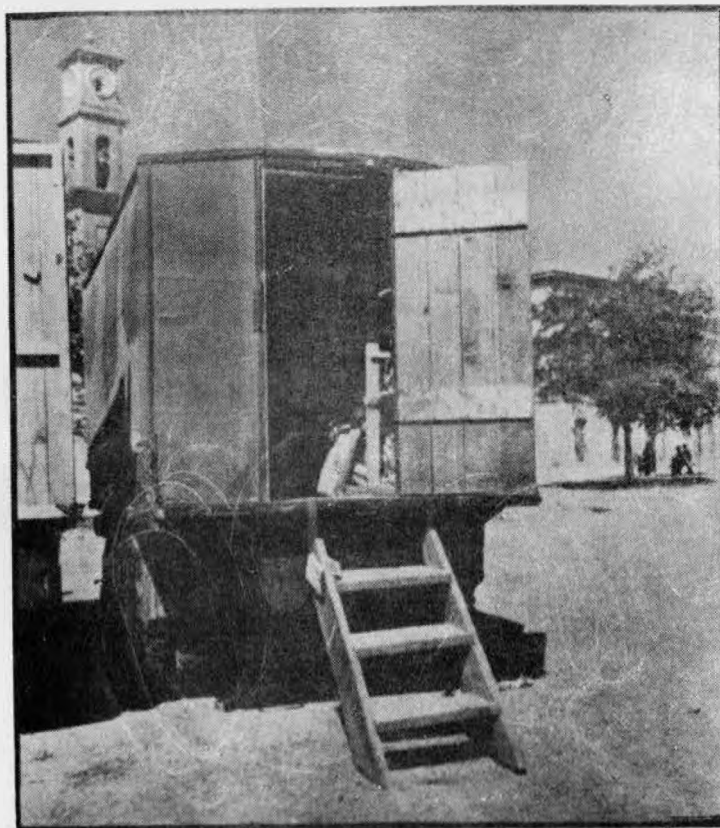
**REAR VIEW OF A TRAILER
STOCKED WITH MAPS**

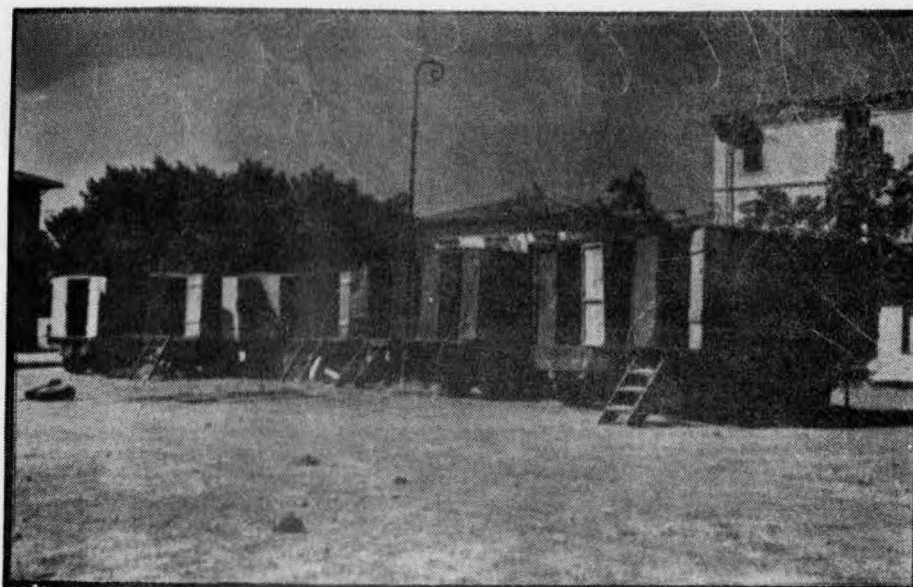
**MOBILE MAP DEPOT SET UP FOR ISSUE
BULK ISSUES ONLY ARE MADE FROM THESE TRAILERS**
