# Engineer Technical Bulletin No. 26

~~UNCLASSIFIED~~  
ENGINEER HEADQUARTERS, FIFTH ARMY  
A. P. O. #464, U. S. ARMY

3 December 1944

ENGINEER TECHNICAL BULLETIN NO. 26

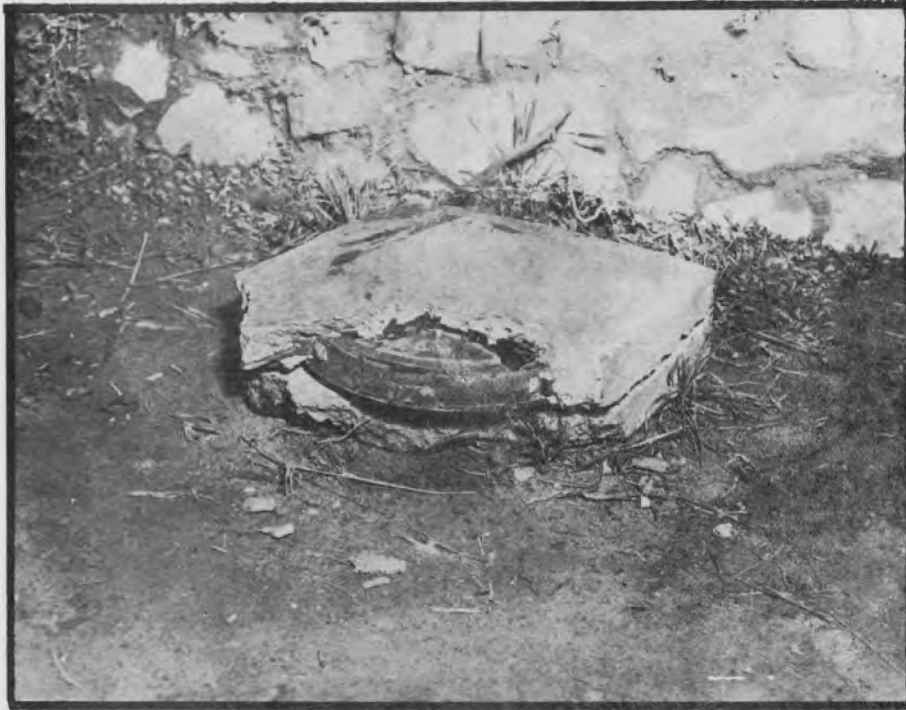
TELLERMINE EMBEDDED IN CONCRETE

PERSPECTIVE VIEW OF TELLERMINE IN NORMAL POSITION

5. Tellermines Embedded in Concrete: Several Tellermines No. 43 were found embedded in concrete vicinity Q197918 on Highway 1227. The block is about 15 inches square and 4 inches thick. Tar paper covers the pressure plate allowing an air space between the concrete and the top of the mine. The advantages of laying Tellermines in this manner are as follows:

a. It waterproofs the mine around the pressure plate where moisture is most likely to enter.

b. It blends the mine into the road, bridge, etc.

It increases the tamping factor. The detonation of one of these mines formed a crater about four feet wide and three feet deep in ordinary field soil.

d. It increases the shrapnel effect: pieces of steel casing as large as three inches and sizeable chunks of concrete are hurled as far as 250 yards.

It is recommended that the mine be blown in place. Although none was found to be boobytrapped, it would be very difficult to neutralize the mine with the added weight of the concrete cast.

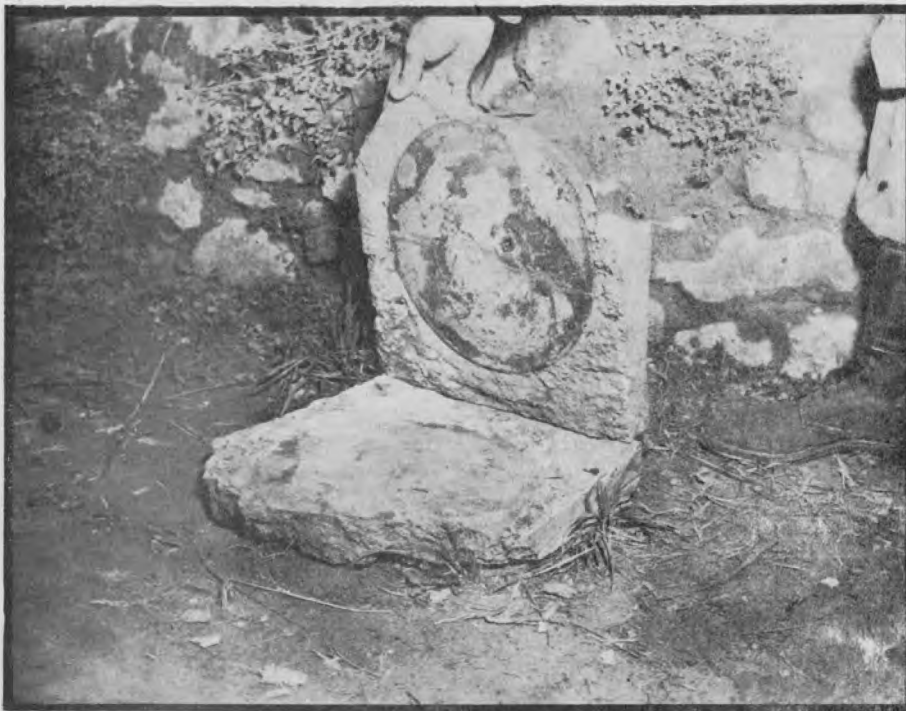
OPEN VIEW OF TELLERMINE EMBEDDED IN CONCRETE

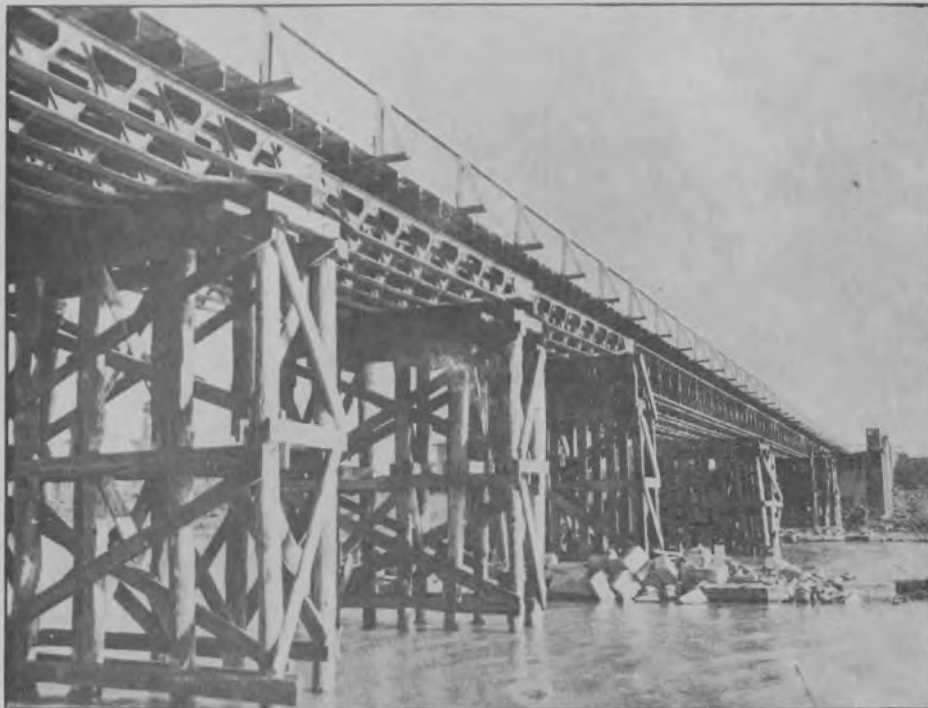
CLOSE UP OF COMPLETED BRIDGE

Decking. Two layers of 3" timber were spiked to the nailing strips, the top layer being placed diagonally to the center line of the bridge. Curb consisted of 6" x 6" bolted through the decking, and the handrail and braces were of 4" x 4" timber.

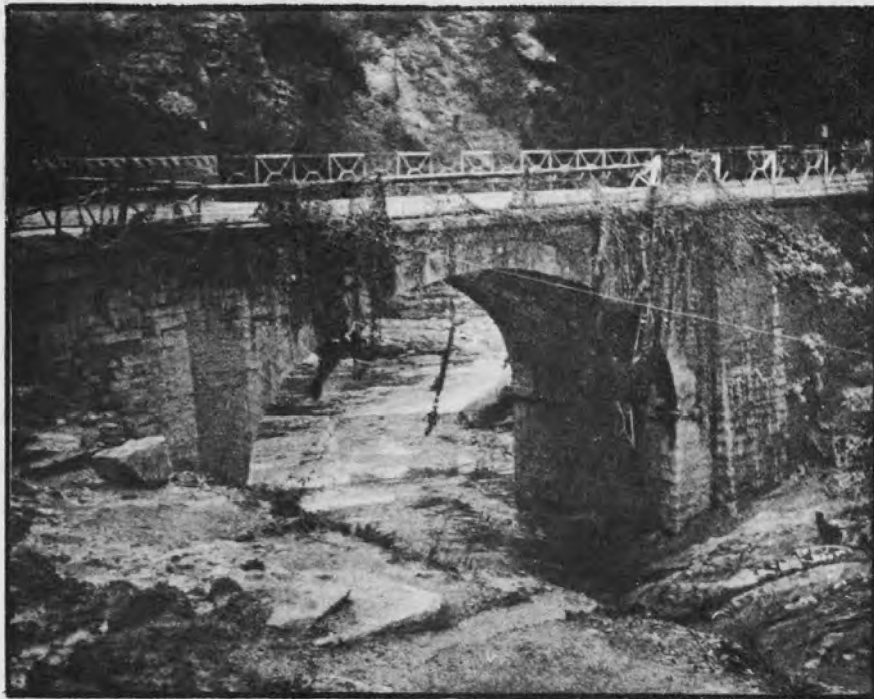
FIG. 1

1. German Camouflaged Bridges: The following photographs (Figs. 1, 2, 3 & 4) show the method used by the Germans to camouflage bridges along a 15-mile section of Route 67 just south of ROCCA. Three different camouflage materials were used, namely:

- a. Italian Army camouflage net with tufts of straw woven through the net.
- b. Branches and saplings.
- c. Mats of flax approximately 3' x 6' strung on number 14 wire.

The exact purpose of this camouflage is not known, but the dark shadows under the bridges appeared to have been effectively broken up by the disruptive pattern of the camouflage used.

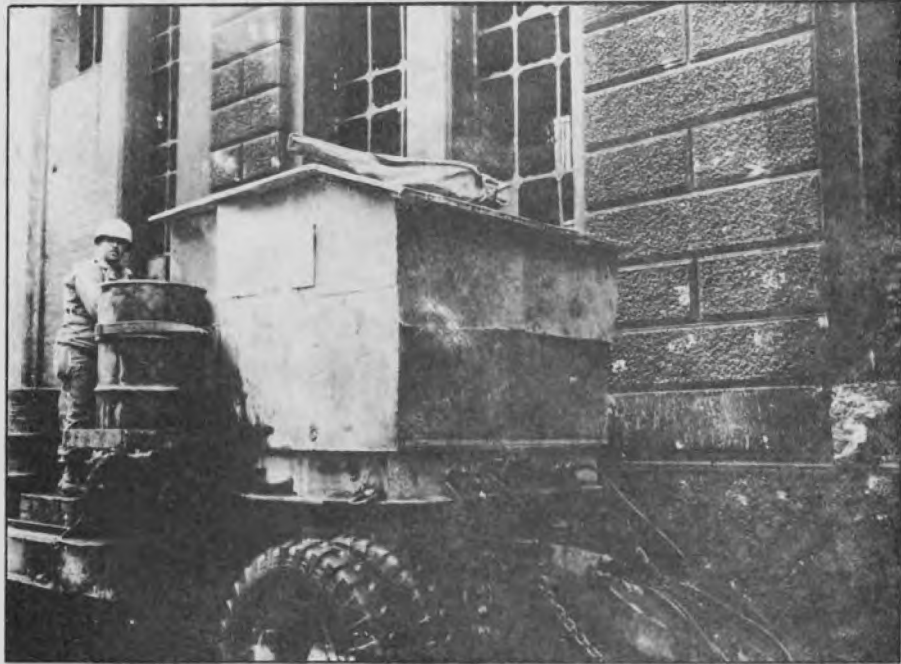
PERSONNEL CARRIER ON  
20-TON BULLDOZER TRAILER

SIDE VIEW

2. Personnel Carrier: The accompanying photographs show a removable personnel carrier for the 20 ton (Bulldozer) trailer constructed by the 16th Armored Engineer Battalion. It was built to carry a D-7 dozer team; additional personnel to:

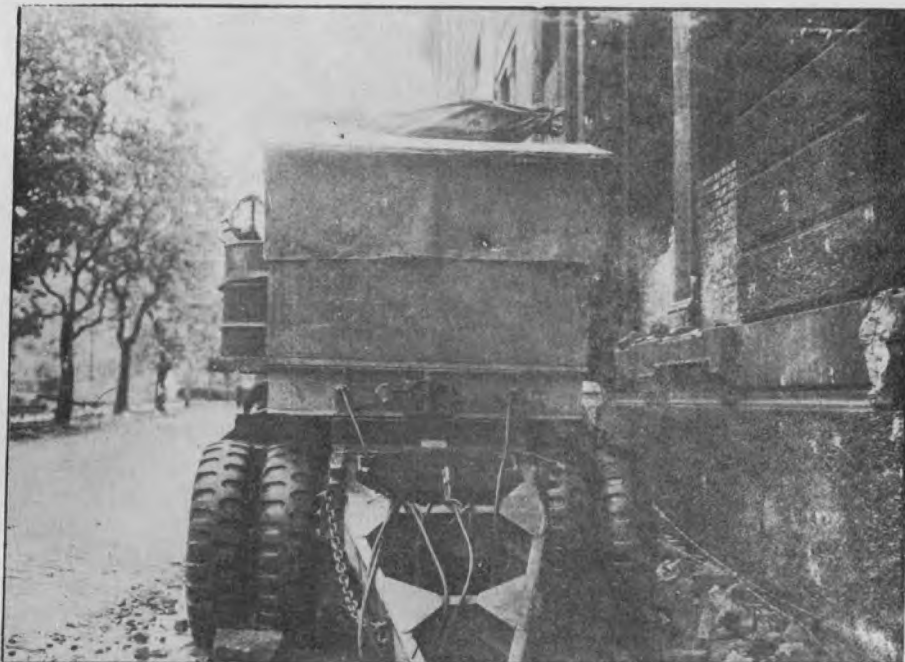
FRONT VIEW
