3 Jan 1945

Engineer Technical Bulletin # 27

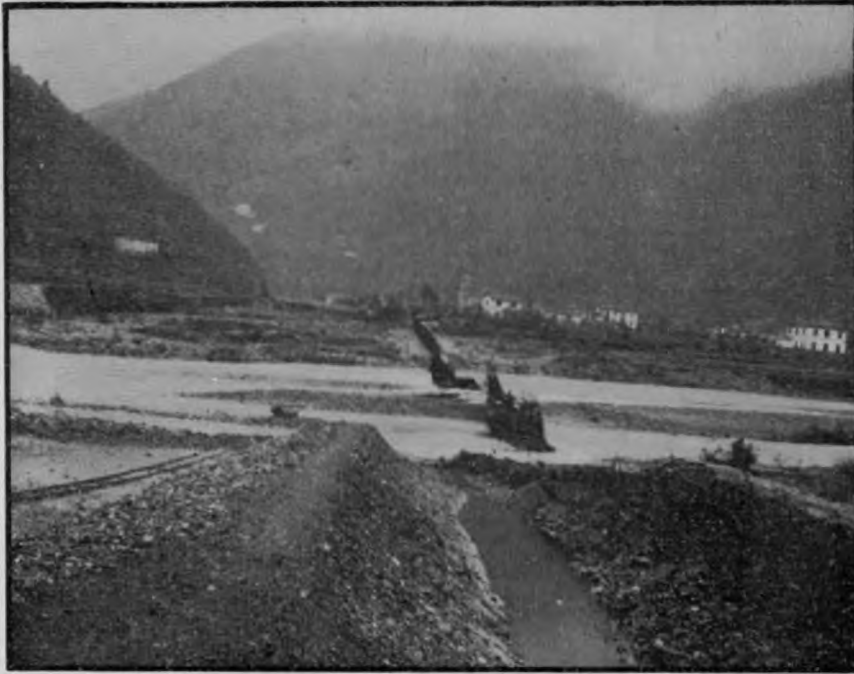
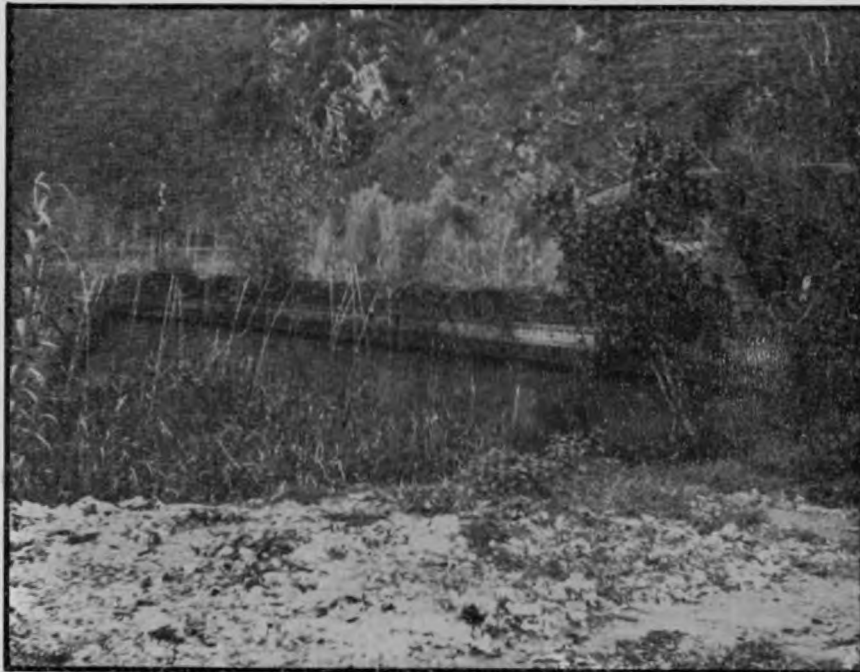
**ANTI-TANK DITCH AND WALL
ACROSS SERCHIO RIVER**

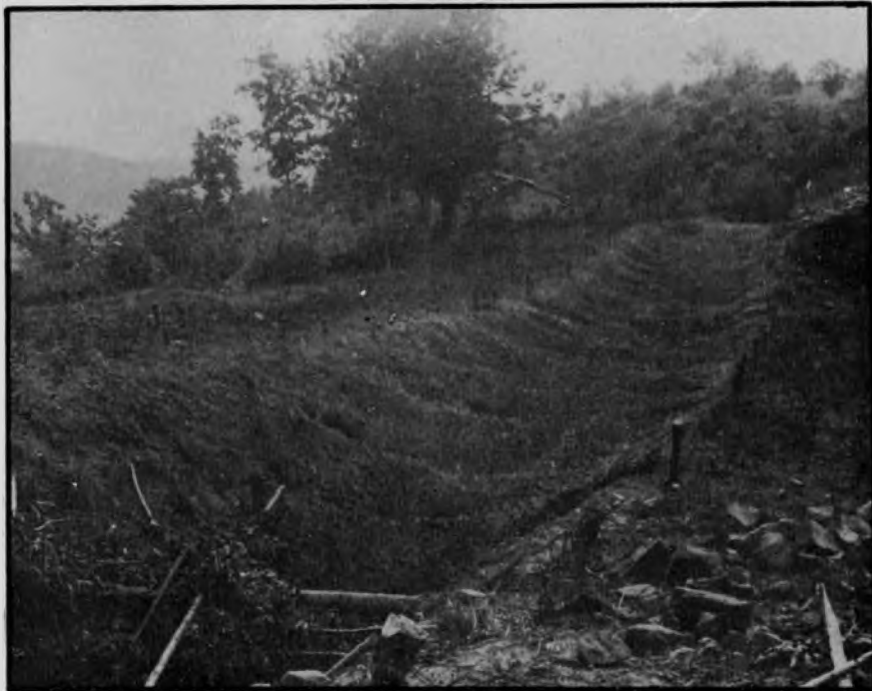
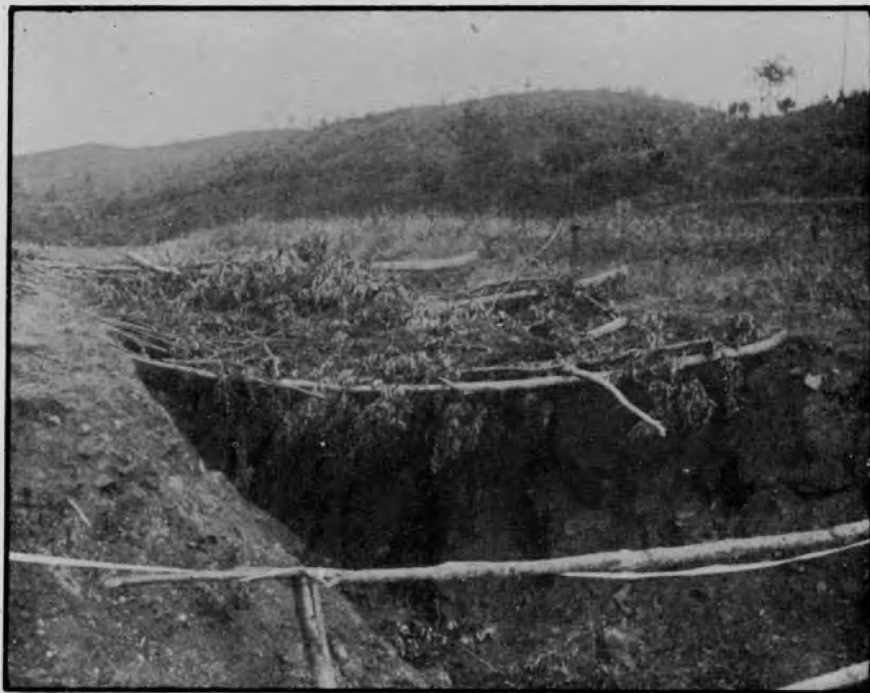
**GERMAN CAMOUFLAGED
ANTI-TANK DITCH**

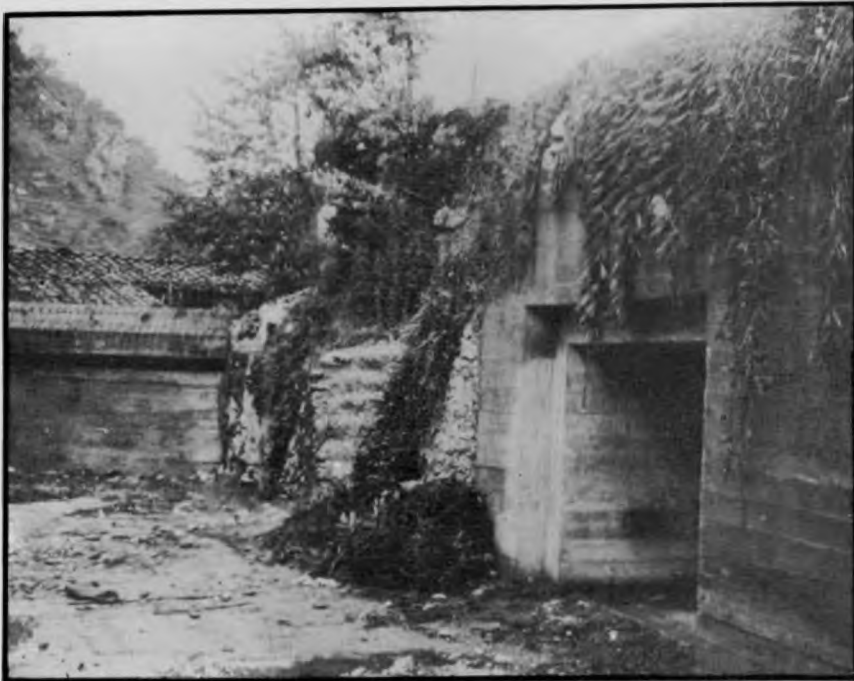
**GERMAN CONCRETE PILLBOX AND
ANTI-TANK WALL (LEFT)**

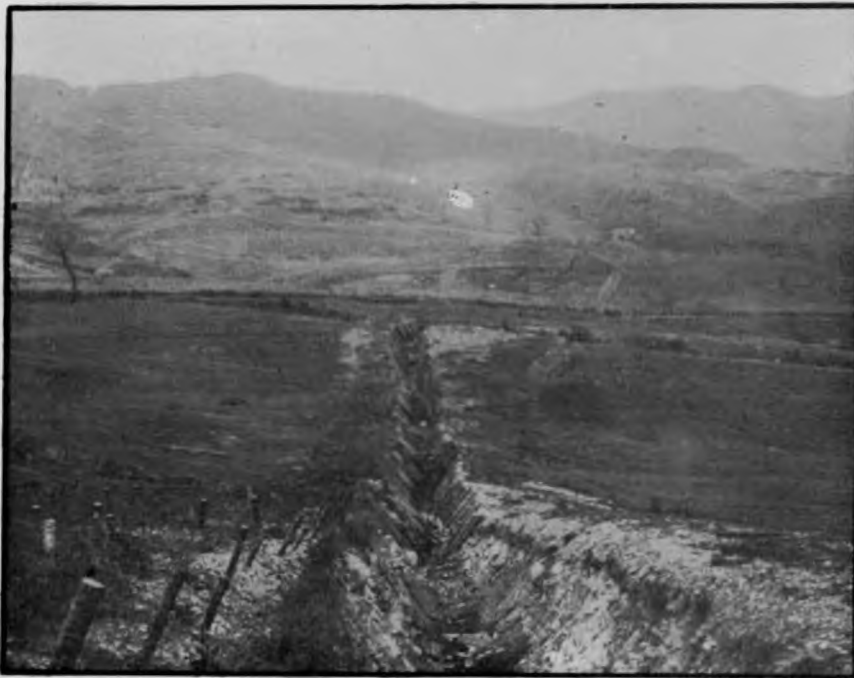
**ANTI-TANK DITCH, WIRE ENTANGLEMENTS
AND CONCRETE PILLBOX IN FUTA PASS DEFENCES**

1. Gothic Line Fortifications: The attached photographs were taken along the Gothic Line between the West Coast of Italy and Route 67 North-east of FLORENCE. In some cases, these defenses were still intact, the Germans apparently having fallen back before being attacked.

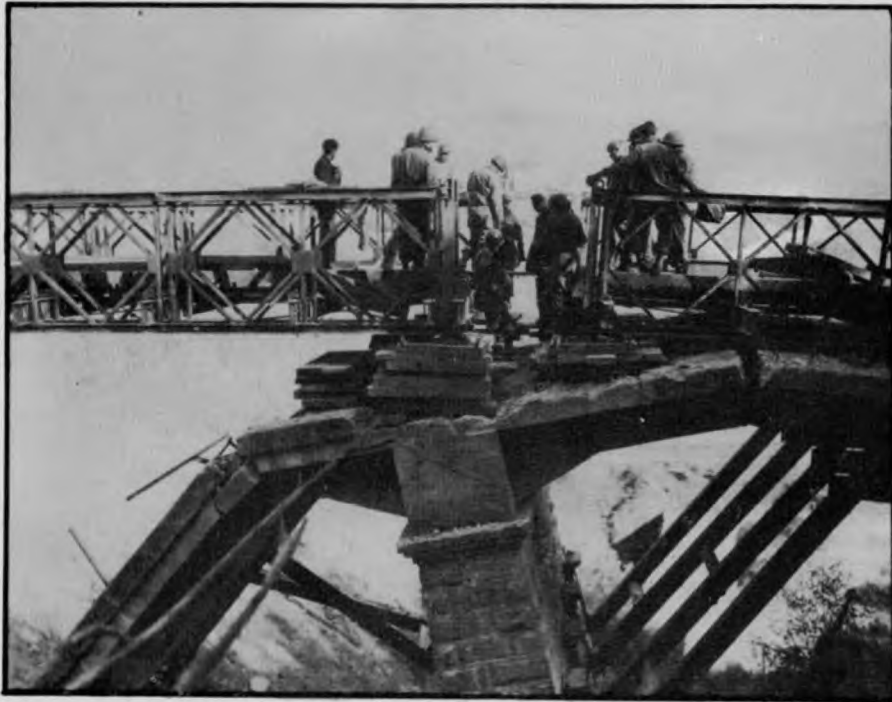
**PIER HEAD WITH PACKING
AND REINFORCEMENT**

b. The obstacle was a mountain stream of extremely steep slope but small drainage area, flowing in a deep V-shaped bed down the mountain side. The original bridge had been a reinforced concrete, slab-and-girder structure about 130 feet long, resting on two masonry piers, each about 20 feet high and 3 feet thick. The site was on a sharp curve in the road, and the bridge itself was slightly curved. It had been reinforced (presumably by the enemy) with steel knee braces and struts. The north span and pier were completely demolished. The center span had been sheared off at the north pier, and its north end was resting solidly in the rocky stream bed. The slab concrete had been cut a short distance on either side of the south pier, but the reinforcing steel remained intact. In falling, the center span had broken the south pier about halfway between top and bottom but had propped it solidly against tipping more than a few degrees from the vertical. The short south span had been dragged partially off its abutment by the tipped pier, and was humped where the slab had been cut south of the pier. Hence this span was unsafe for use. Enough of the German steel bracing remained to add considerably to the stability of the pier (see attached photographs).

d. Since the original bridge had been slightly curved, and the hillside and road curve restricted both ends, launching, which was done from the south, was a difficult matter. Packing for launching rollers for the 100-foot bridge (2' 6" high to allow clearance of the hump in the south span) was placed upon the north arm of the T-shaped pier head.

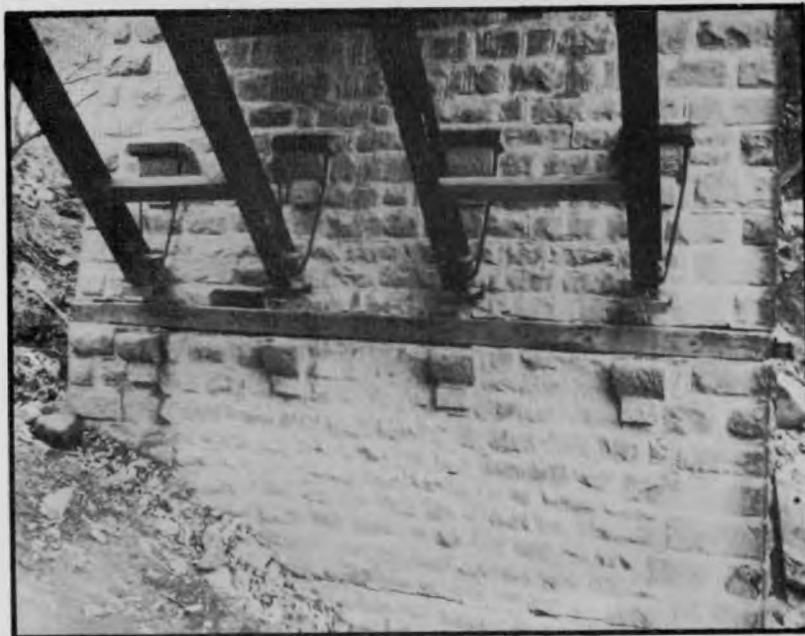
CRACK IN PIER AND WEDGE

c. Several solutions were considered, but it was finally decided to use the tilted pier, propped by the center span, as support for two Baileys - a 40-foot single on the south end and a 100-foot double on the north. The damaged pier seemed solidly supported by the slab, but bearing at the break in the pier was almost solely on the north edge. It appeared the remaining German steel braces would keep the upper half of the pier from kicking off, and that wedging the crack would serve to distribute the bearing.

g. The crack in the pier was wedged with a length of 8" x 8", adzed to fit. The heaviest load carried so far by the completed bridge has been an M-10 tank destroyer.

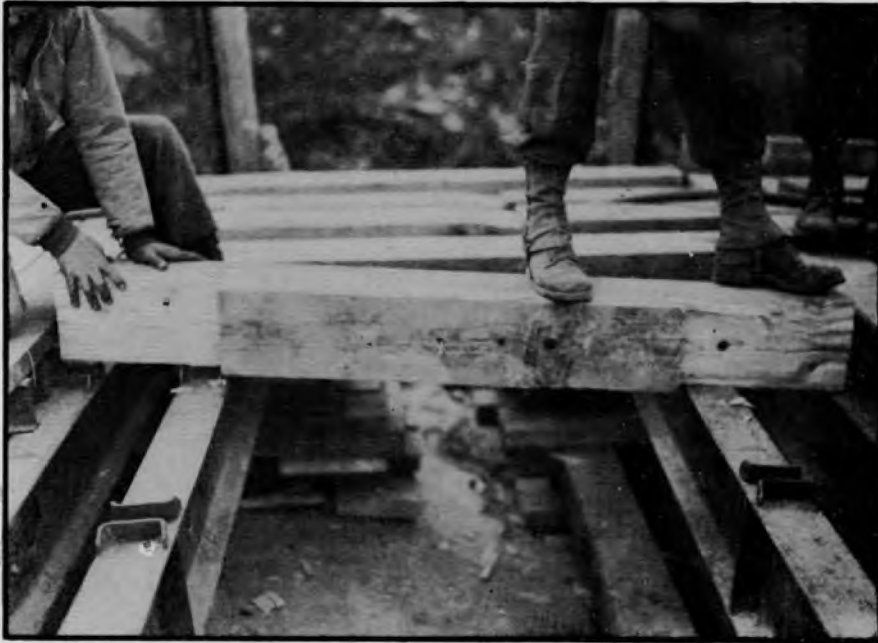
NOTCHED STRINGERS

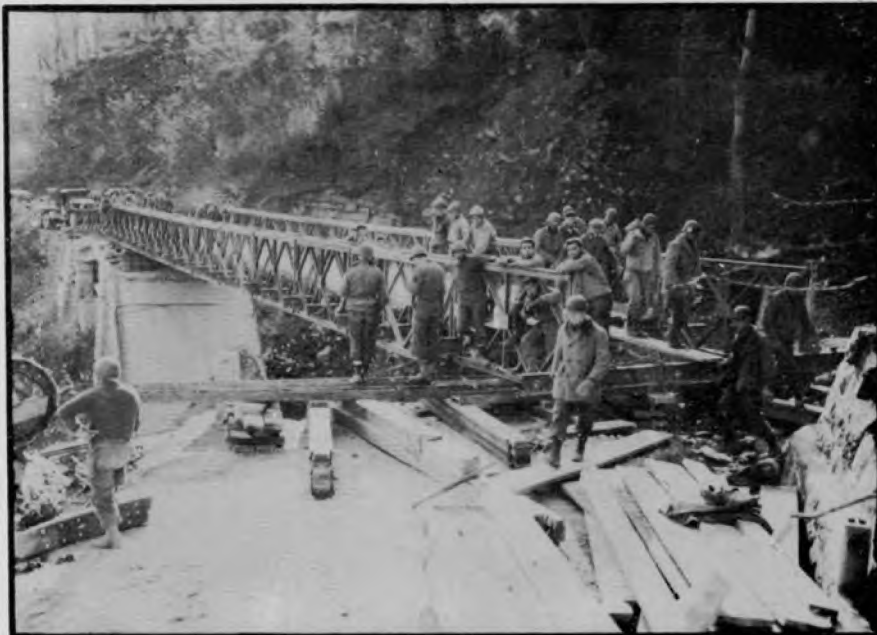
COMPLETED BRIDGE

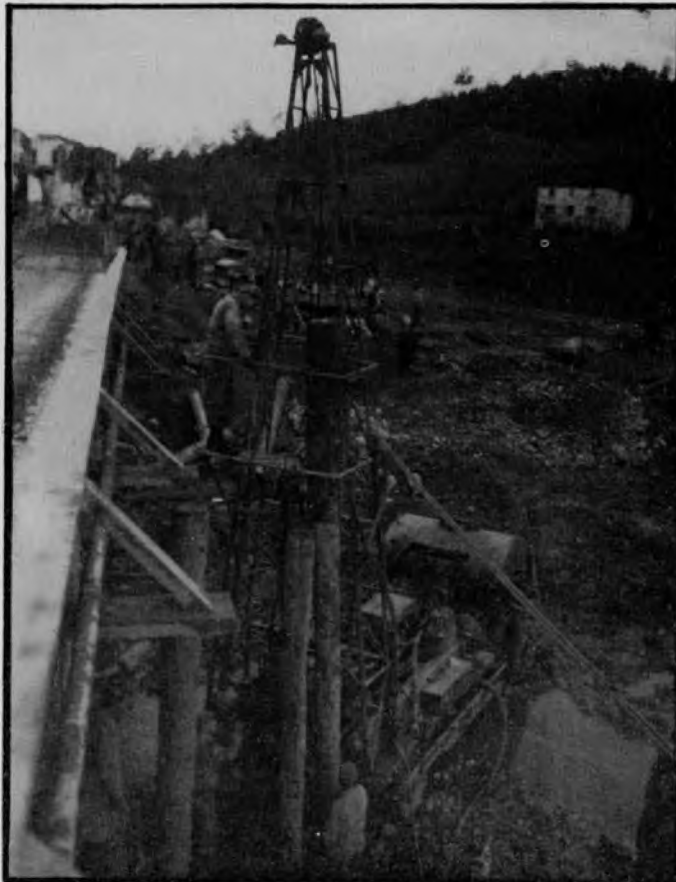
ROTARY: SETTING PILE

(4) Piling. The wooden piling, roughly 10" to 12" in diameter, was dressed on the lower end to hole diameter, and driven to the bottom of each hole. It was grouted in place.

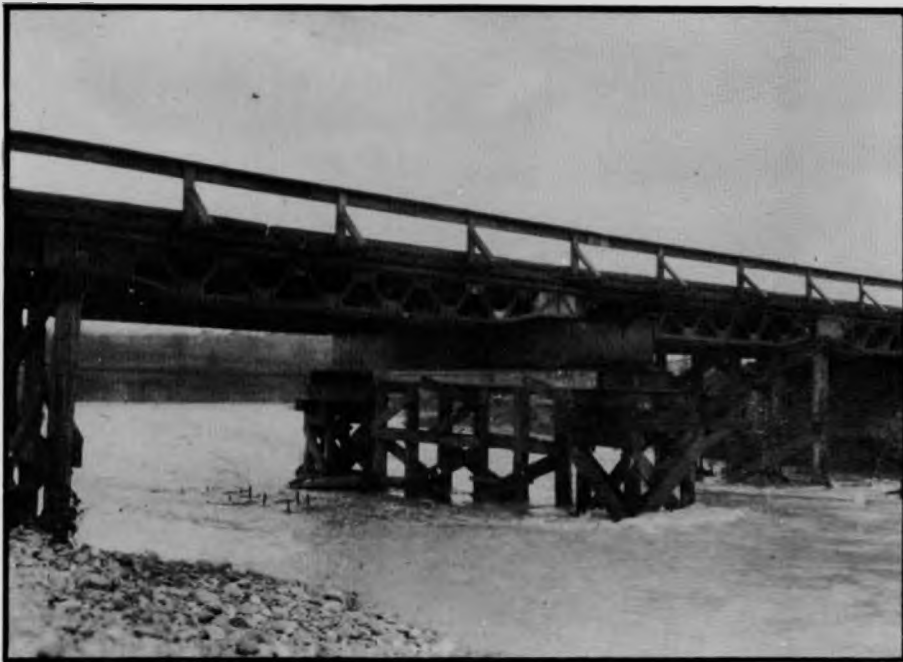
THE COMPLETED JOB: RIVER RISING

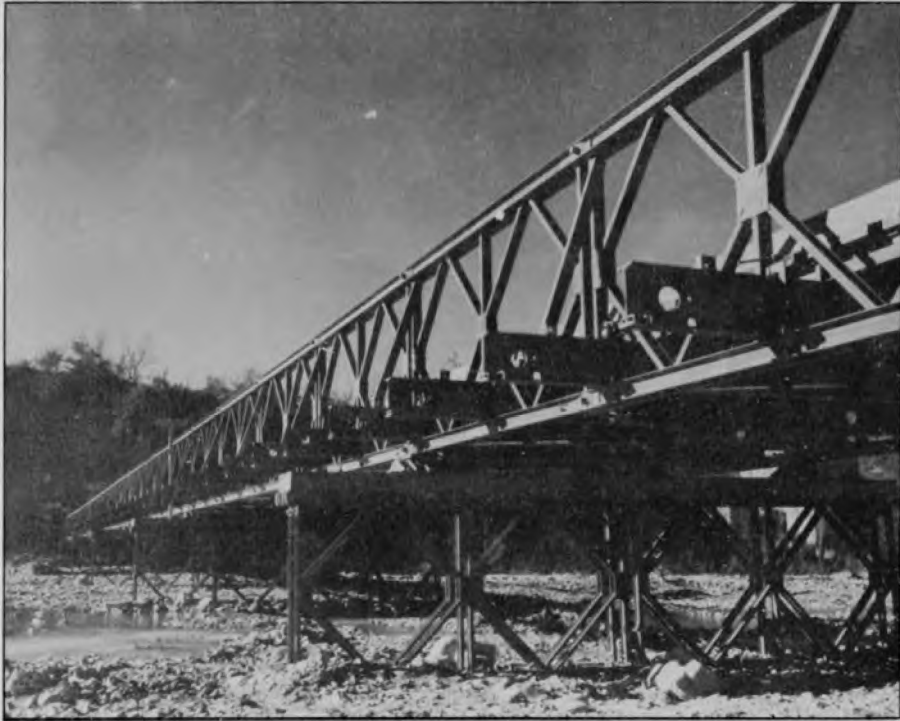
PIERS SET AT 40 ft.

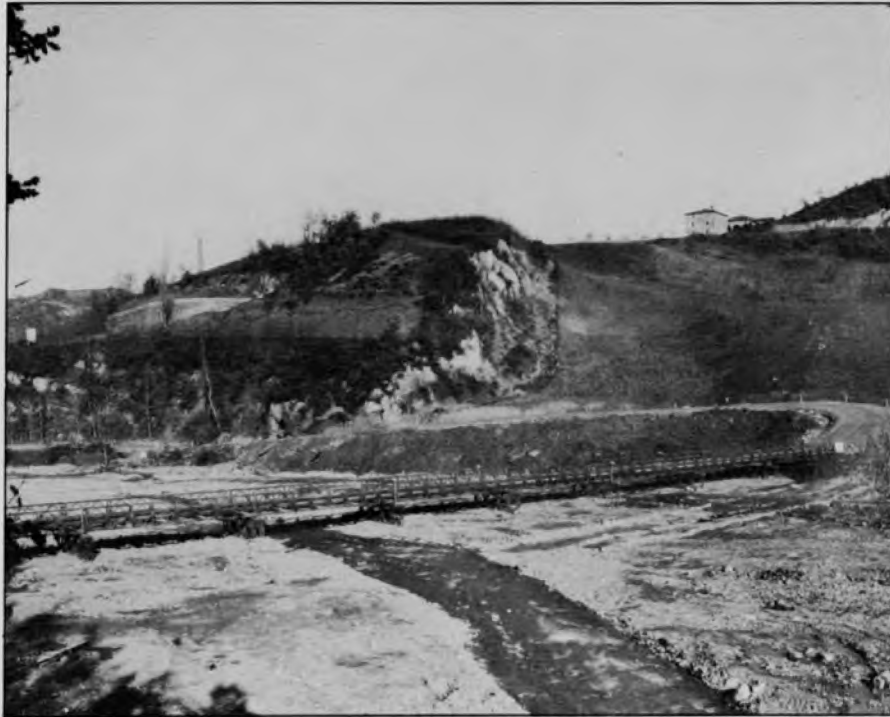
SOUTH VIEW

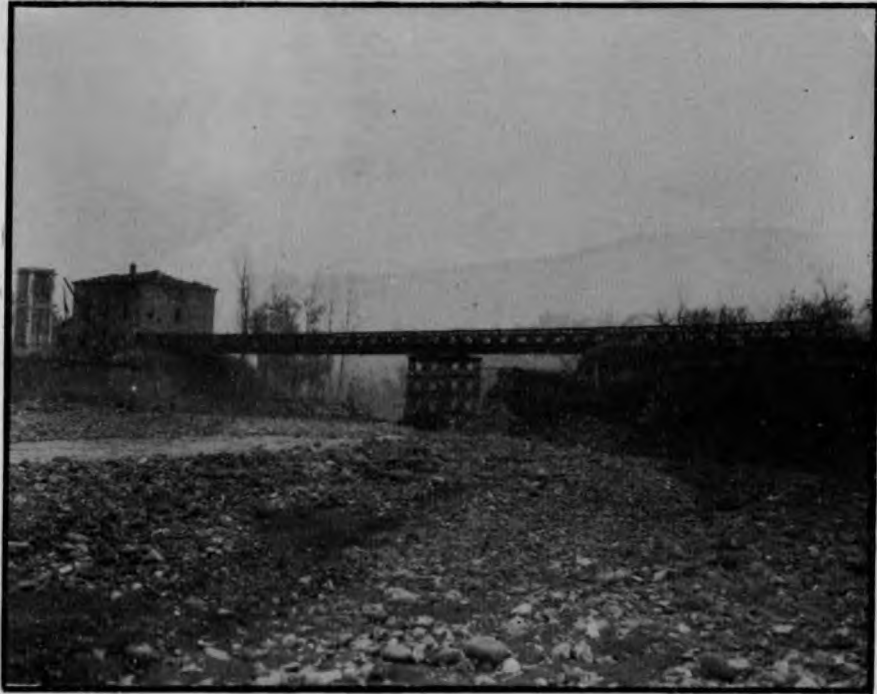
BEFORE CAMOUFLAGE

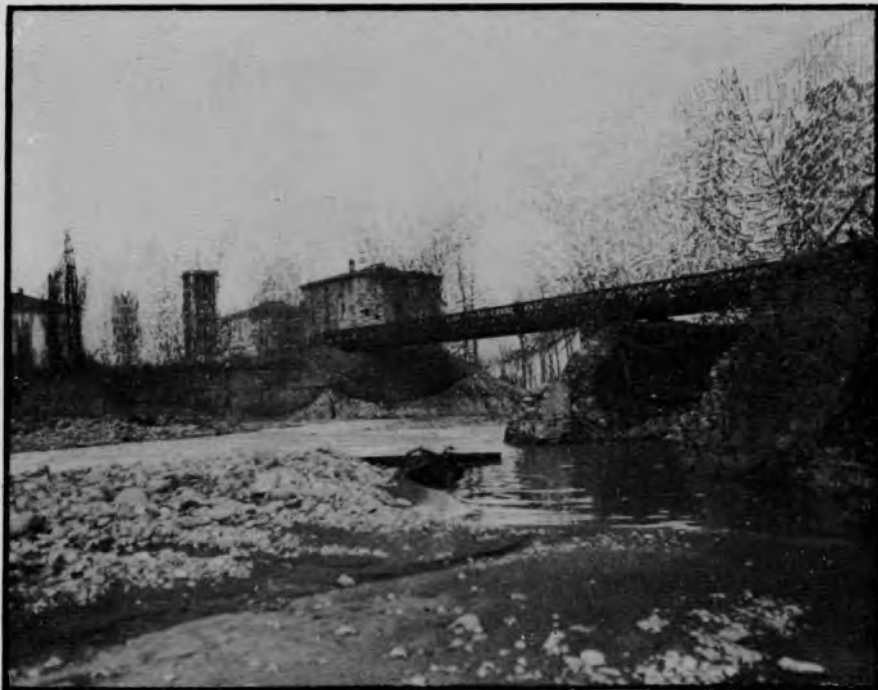
AFTER CAMOUFLAGE

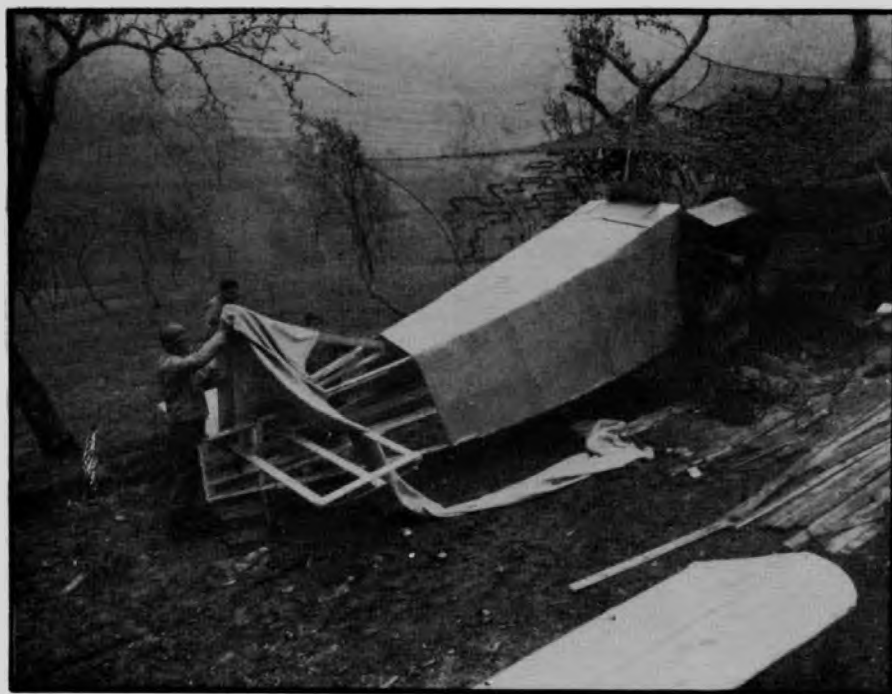
CONSTRUCTION

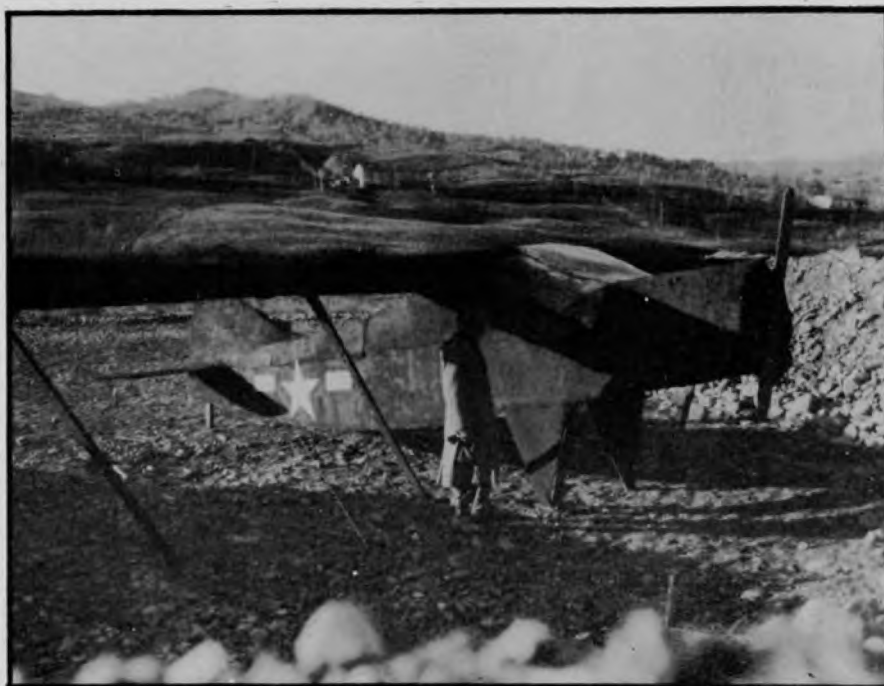
COMPLETE PLANE
