GUIDE TO THE AGEING OF EXPLOSIVE ORDNANCE IN THE ENVIRONMENT

ACKNOWLEDGEMENTS

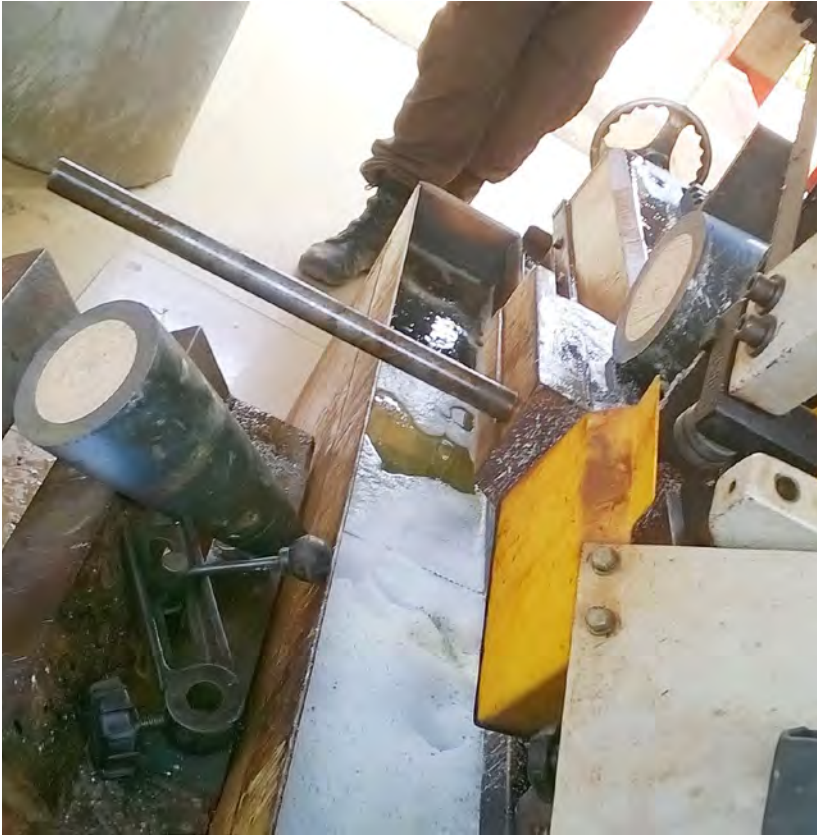
A cut on a Russian 152mm OF-540 high explosive artillery projectile at the Golden West Humanitarian Foundation (GWHF) specialist processing facility in Cambodia. The projectile casing and pressed TNT fill are in good condition and have not been subject to significant ageing in the environment. Image: Roly Evans.

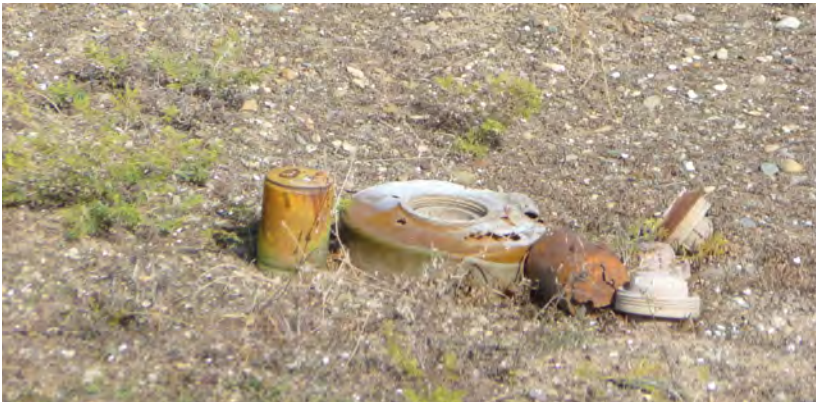
Various mines in the same environment show different ageing characteristics. The relatively thin plastic cased TM-62P3 anti-vehicle mine shows rupture of the casing, possibly accentuated by the effect of prolonged exposure to ultraviolet (UV) sunlight. The thicker cased MVP and MVCH mine fuzes seen on the right are more resilient, albeit their colour has bleached in the sun. The OZM-72 bounding fragmentation mine on the left shows discolouration of the protective paint but has broadly withstood the ageing process well. Image: Roly Evans.

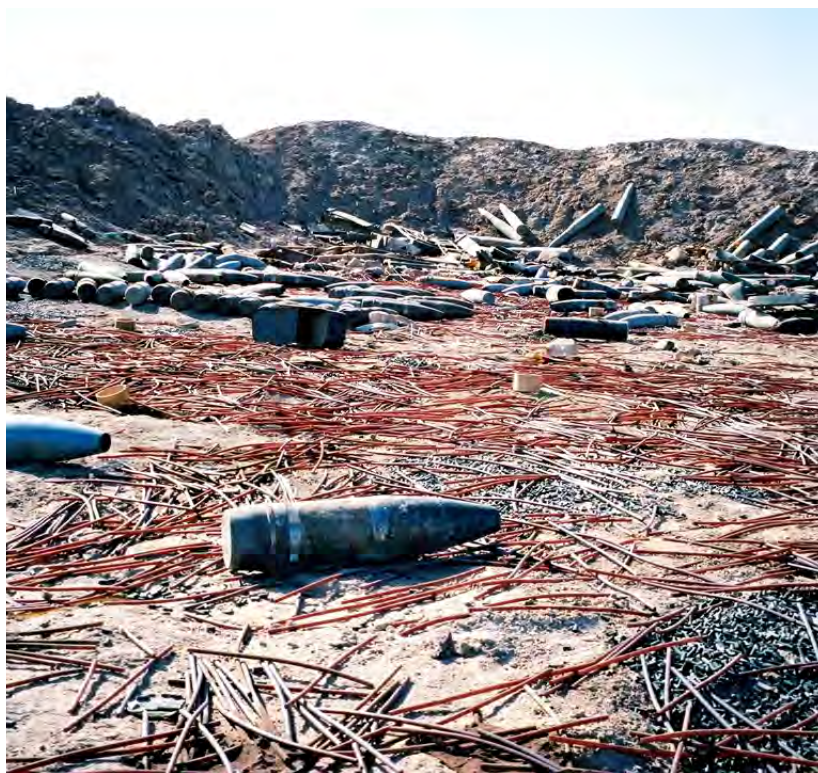
An ammunition depot in Iraq, 2003. Looters seeking brass cartridge cases have tipped unwanted double-based propellant out onto the ground, where it becomes dry and brittle in the hot sun. In this state, propellant is highly vulnerable to ignition by heat and friction. Image: Fenix Insight Ltd.

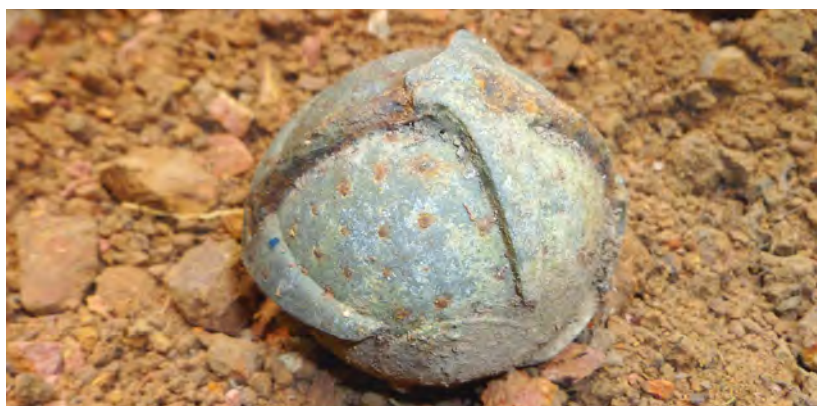
A BLU-26 explosive submunition found in Lao PDR. The steel alloy components can be seen by the difference in corrosion around the clamp ring join of the submunition and the ball bearing fragmentation beneath the main aluminium outer casing. The outer casing has an aluminium oxide layer that corrodes slower than steel alloy. This item has been on the floor of a primary jungle for over four decades, albeit on high ground with good drainage. While it is certainly weathered, the resilience of the casing is nevertheless evident. Image: Roly Evans.

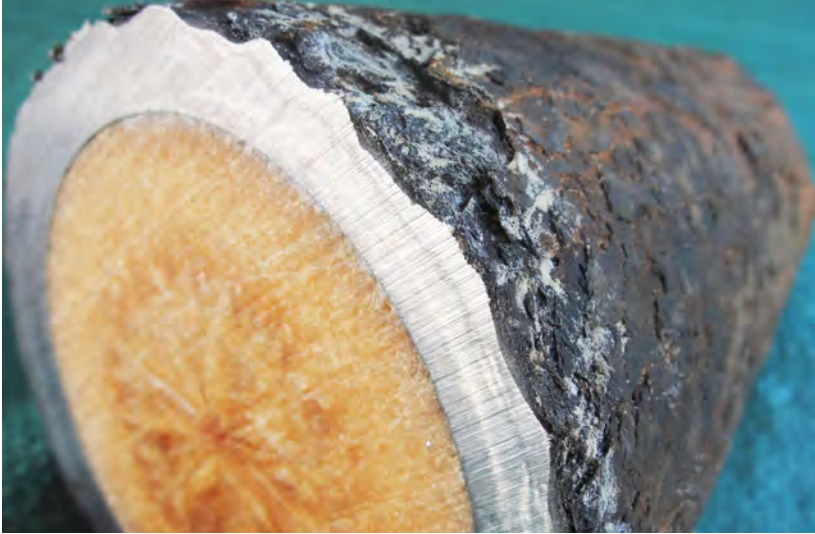
The casing of an unexploded M107 projectile, recovered around 50 years after it was used in Vietnam. A section through the projectile shows the surface is heavily corroded, although the steel beneath is in remarkably good condition. Under some circumstances, a superficial iron oxide rust layer may provide protection that slows down the corrosion process. Image: Fenix Insight Ltd.

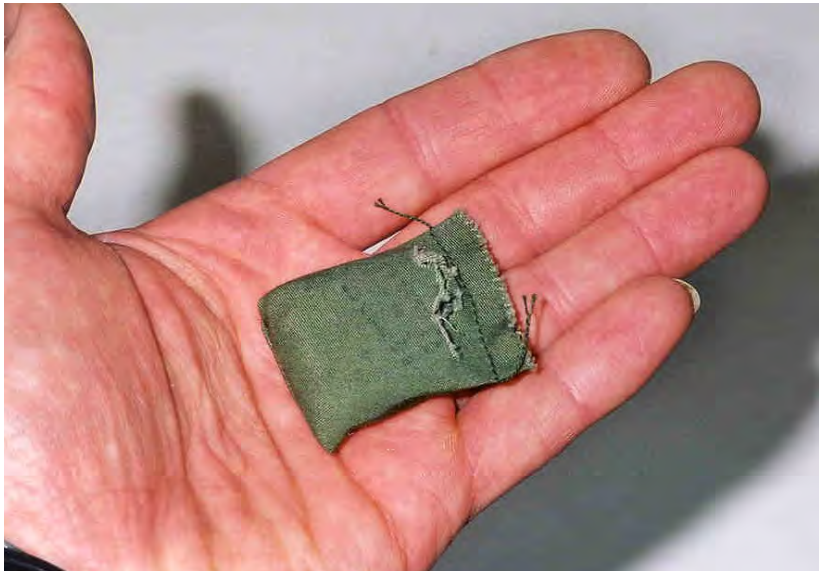
A XM45E1 'Gravel mine'. The cloth casing and explosive charge were designed to be very well protected during storage, and for a very short lifespan once deployed.
Image: Fenix Insight Ltd.

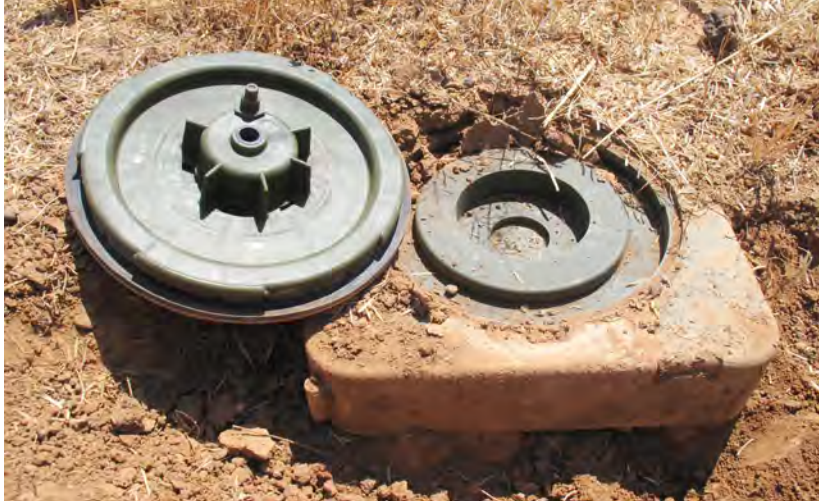
A United States M19 anti-tank mine in Jordan. The mine is fully functional and shows few signs of deterioration, despite having been buried for around 40 years. The relatively thick plastic and rubber seals around the threads protect the internal components of the mine. Many M19s cleared in Afghanistan have also been found in good condition. While more susceptible to UV damage if exposed to prolonged sunlight, buried mines with thick plastic casings can be very resilient, possibly as resilient as steel cased ERW in certain circumstances. Image: Fenix Insight Ltd.

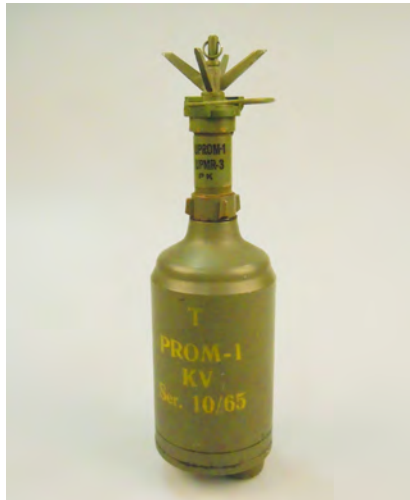
Good design and production, can make a munition more resilient. The PROM-1 has a sheet steel casing, but this is well protected and the few joints have robust hermetic seals. This is a product of experienced designers with a good understanding of the operational environment, and carefully controlled production. In Bosnia, the PROM-1 has proved the most resilient of the mines laid during the 1990s conflict, and the mine that poses the greatest ongoing hazard. Image: Dutch Defence Expertise Center EOD.

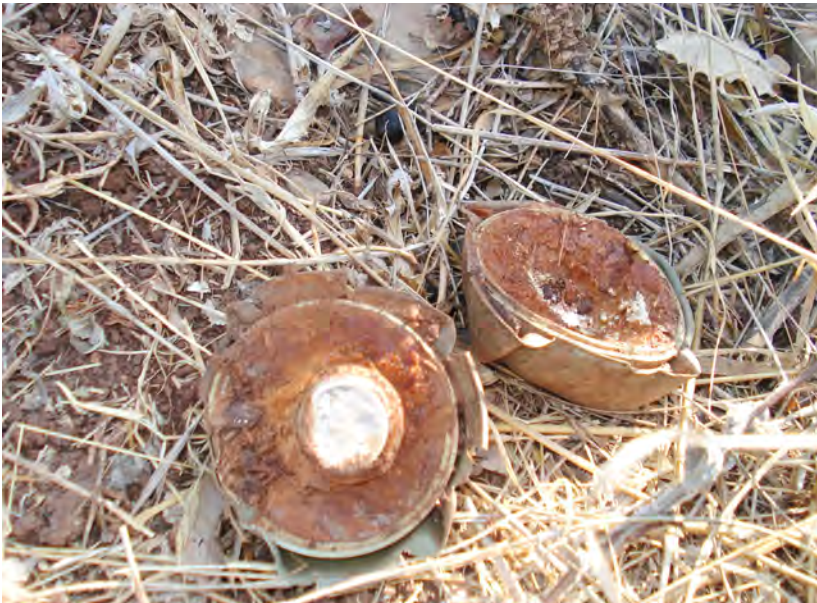
A BLU-63 submunition that has split apart on impact, exposing the cyclotol explosive fill and aluminium encased M219E1 fuze to the elements. This item will age far quicker than one that was undamaged on impact. Image: Roly Evans

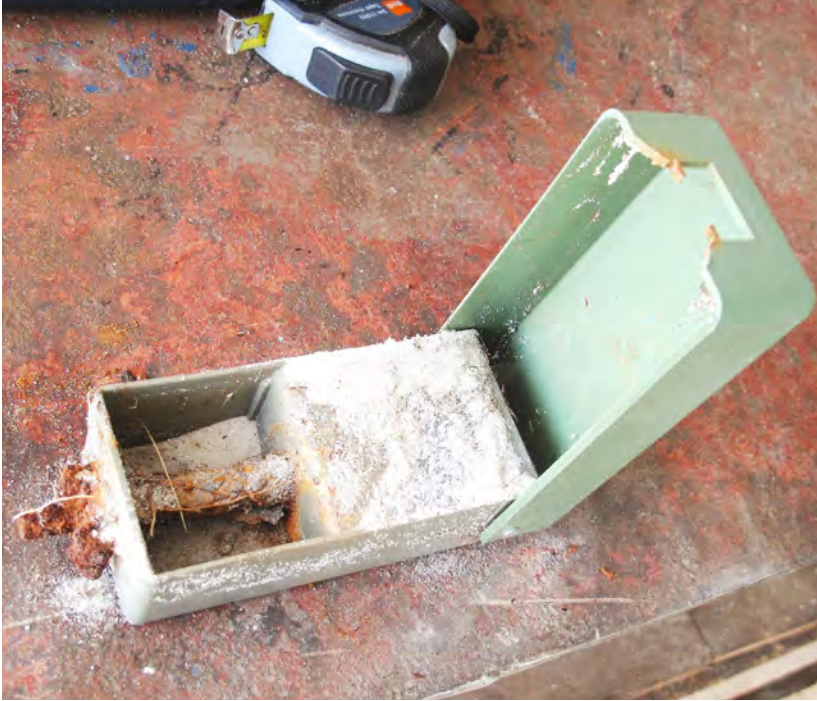
An Israeli No 4 anti-personnel mine in the Falkland Islands/Malvinas, recovered from a coastal minefield near Port Stanley in 2019. Water often carries fine particles, such as sand, which have an abrasive effect and can fill voids within the fuze mechanism, blocking its action. The No.9 fuze igniter seen here is heavily corroded and no longer functional although it still presents an explosive hazard. Image: Fenix Insight Ltd.

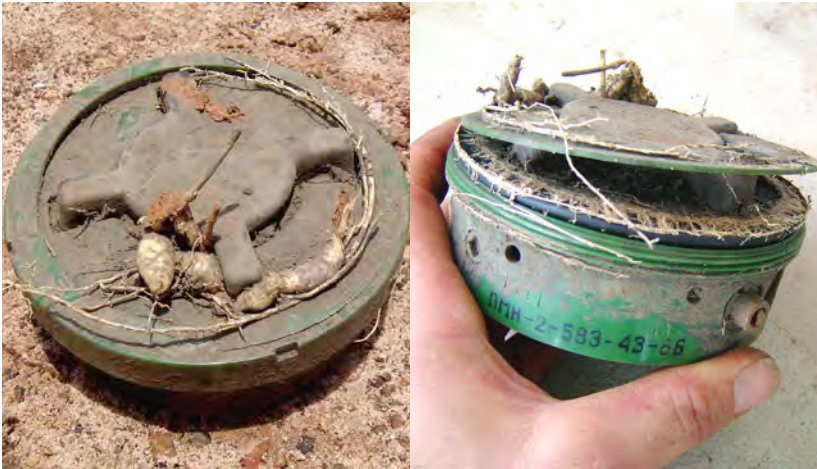
A Russian PMN-2 anti-personnel mine recovered from northern Cambodia in 2009. Small roots have spread into the small gaps and joins around the pressure plate. Disassembly of the PMN-2 mine shows that the root structure has penetrated the mine casing, levering components apart and allowing water to enter.
Images: Fenix Insight Ltd.

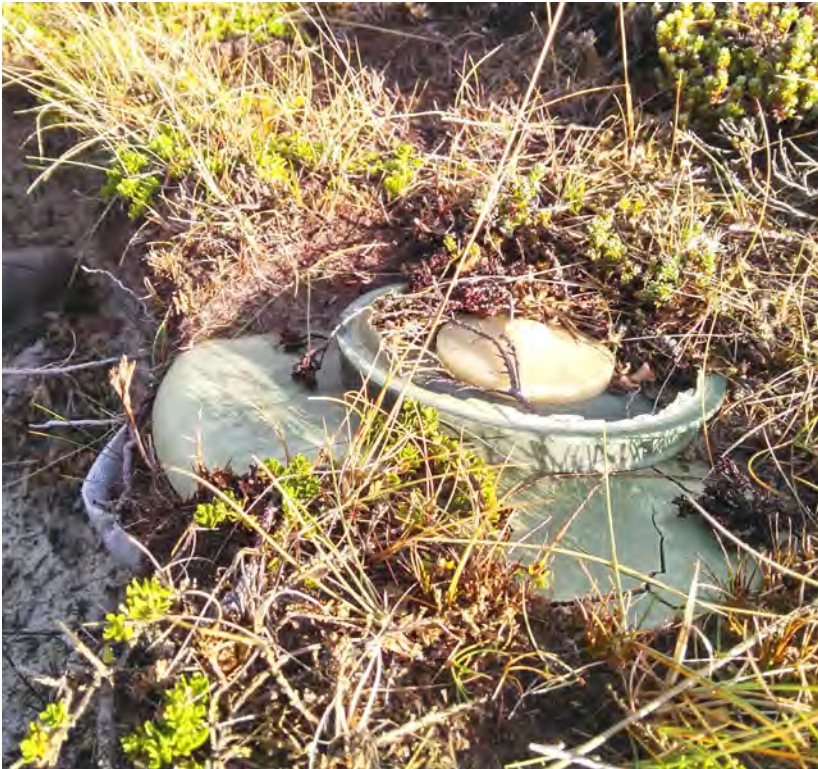
A C-3-B anti-vehicle mine found in the Falkland Islands/Malvinas in May 2018. The mine has been on or near the surface for approximately 36 years and shows case cracks consistent with damage from UV light. Image: Guy Marot.

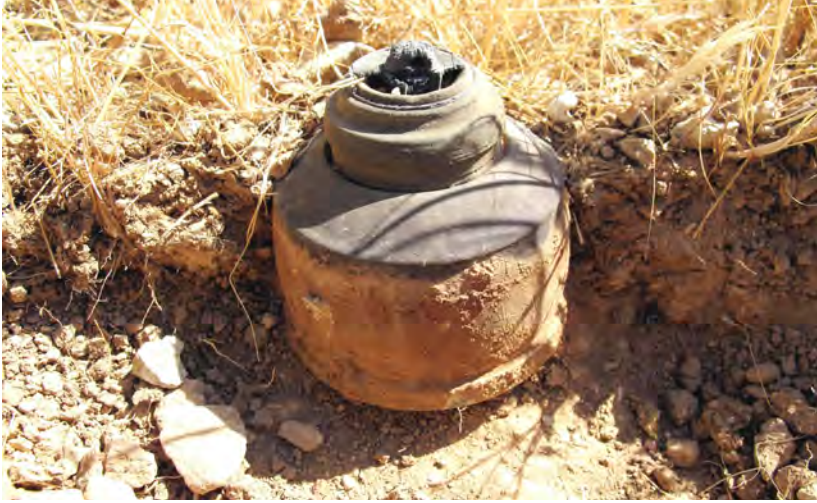
A Belgian M35 anti-personnel mine in Jordan, 2010, where a brush fire has swept through the minefield. The majority of the mine was buried, so reasonably well protected, but the fuze was burned and is no longer waterproof. The TNT explosive filling in the lower body of the mine has swelled, bulging the normally flat top surface and discolouring the plastic. As the body cooled, it remained in this position, so that the new shape and colour make the mine difficult to recognise.

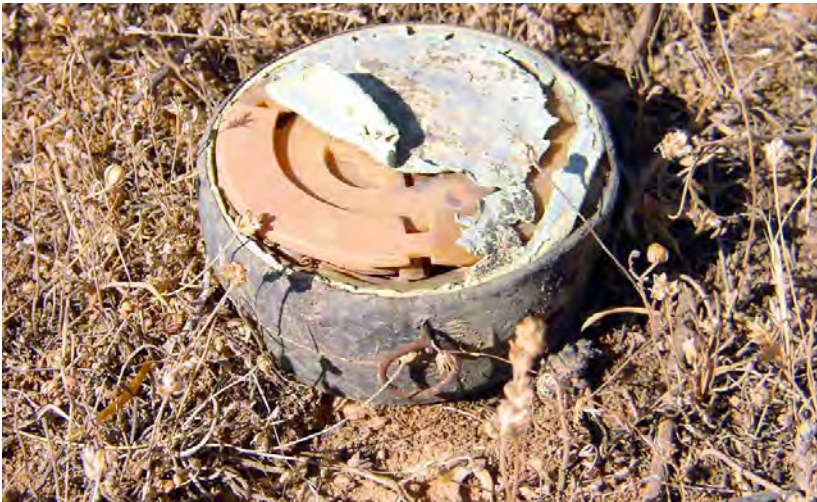
Thin rubber is certain to perish after decades of exposure to an outdoor environment.

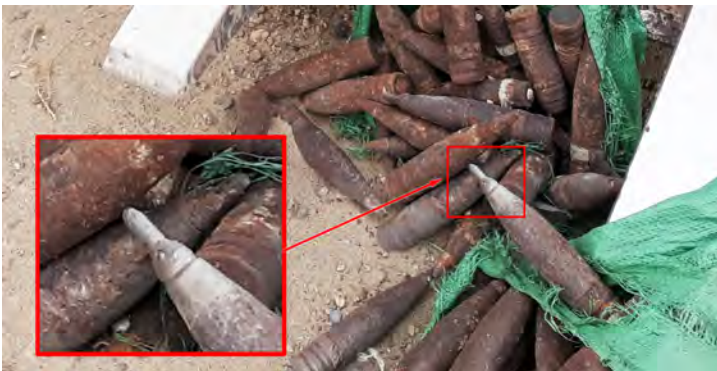
Russian 30mm cannon ammunition in Afghanistan, 2020. Some of the A-670M fuzes have lost their windshields, allowing water to penetrate the fuze body. Image: The HALO Trust.

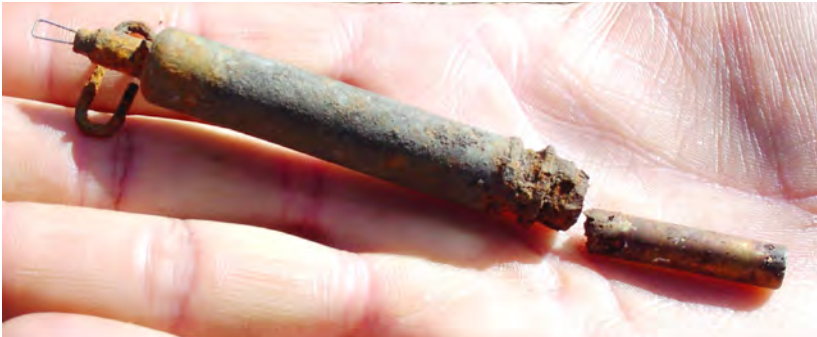
A Russian MUV-2 fuze from a PMD-6 anti-personnel mine recovered in Cambodia, 2010. The upper hollow section of the aluminium detonator capsule has corroded away, separating the explosive from the fuze. Since the mine was buried, this gap was then filled with earth and probably would have prevented the fuze from functioning. Image: Fenix Insight Ltd.

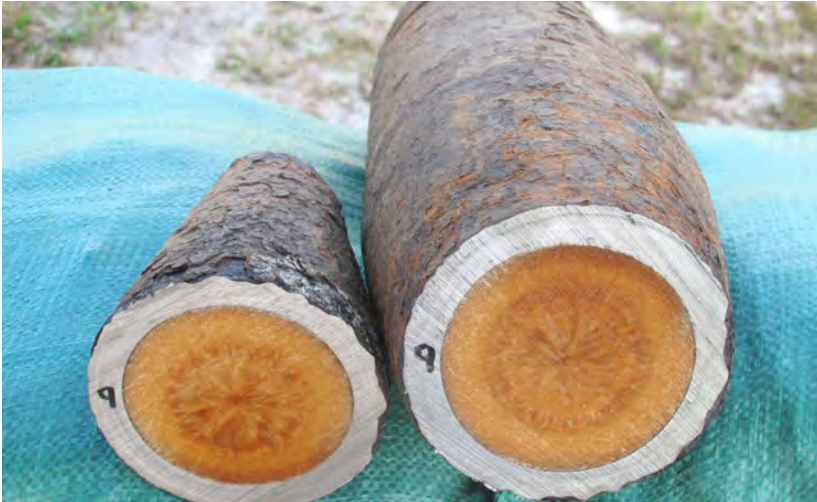
Externally, this Vietnam-era US M107 155mm HE projectile, recovered in 2018, appears heavily rusted. However, once cut open to reveal the HE filling, the thickness of unaffected steel becomes apparent. This is typical of many steel-cased munitions, such as mortar rounds, projectiles and air-dropped bombs.

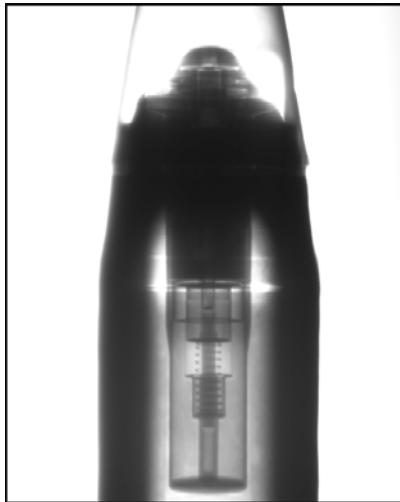
An x-ray image of a German GrZ04 fuze in a remarkable condition, with springs still intact. Many World War I artillery projectiles had fuzes that were largely internal to the fuze pocket and have therefore been protected by the thick steel casing. What is not visible is any ageing of the pyrotechnic holding devices within the fuze that often degrade due to humidity. Image: Belgian EOD Group (DOVO-SEDEE).

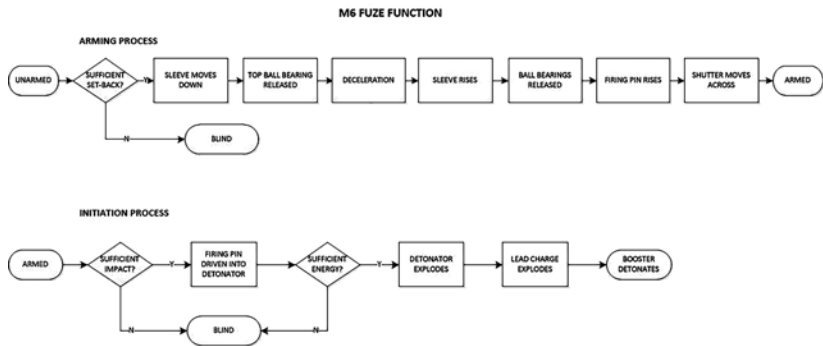
Even a simple fuze, such as the M-6, involves a number of steps within its arming and actuation process. A failure of any step, or interference between them, is likely to result in the fuze failing to function, and the main charge remaining unexploded.

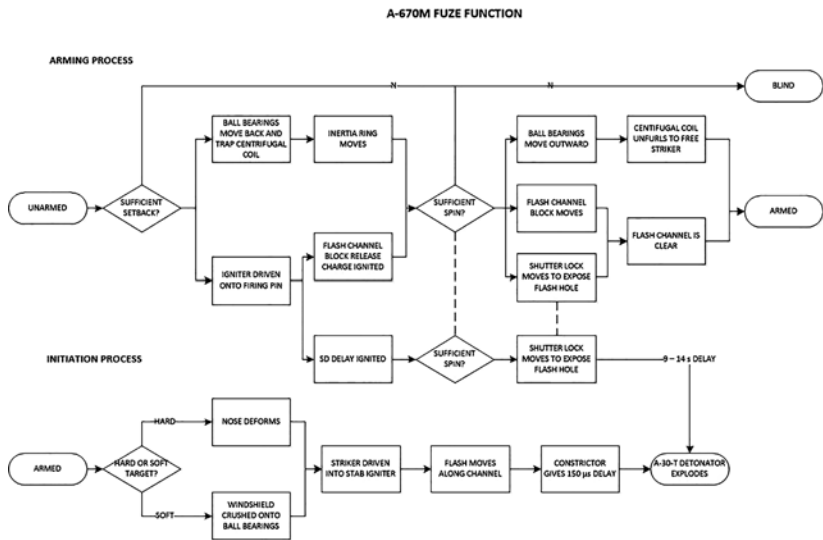
The processes of arming and initiation within the Russian A-670M cannon ammunition fuze. The sequences involve a number of parallel processes, which provide opportunities for initiation to bypass a point of failure.

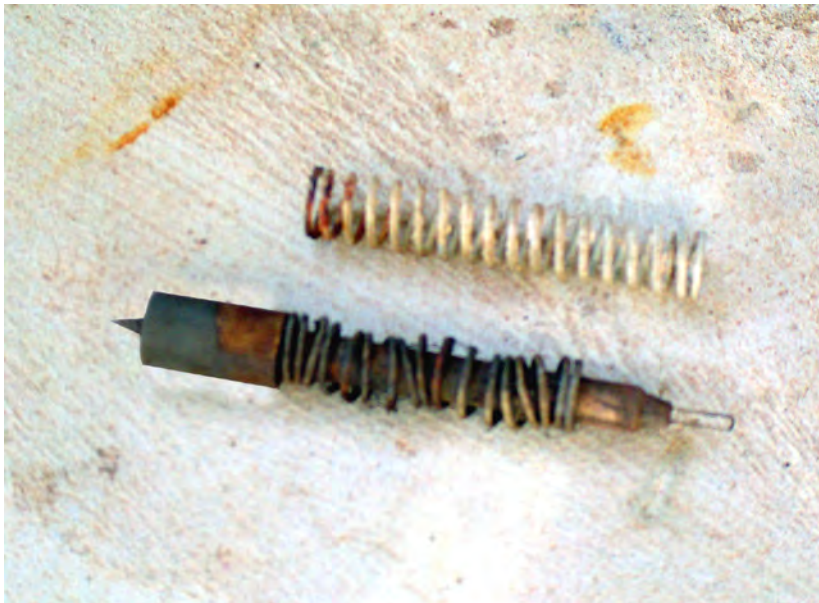
The striker and spring from a Russian PMN mine recovered in Cambodia, 2014, with an example of the spring in good condition, above. The corroded spring has lost its ability to drive the striker into the detonator assembly; in other words, it can no longer supply the energy needed to allow the initiation sequence to reach the next stage. This will prevent the mine from functioning as designed and is typical of many such applications within fuzes. Image: Fenix Insight Ltd.

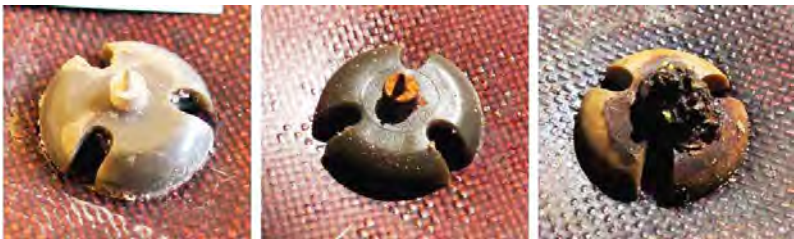
Firing pins recovered from United States M14 anti-personnel mines in Jordan during the early 2000s. The pin on the left is virtually as-new, but the pins in the centre and right have become shorter and blunter. These are unlikely to initiate the mine's stab-sensitive detonator. Corroded firing pins will also make the mine even harder to detect.

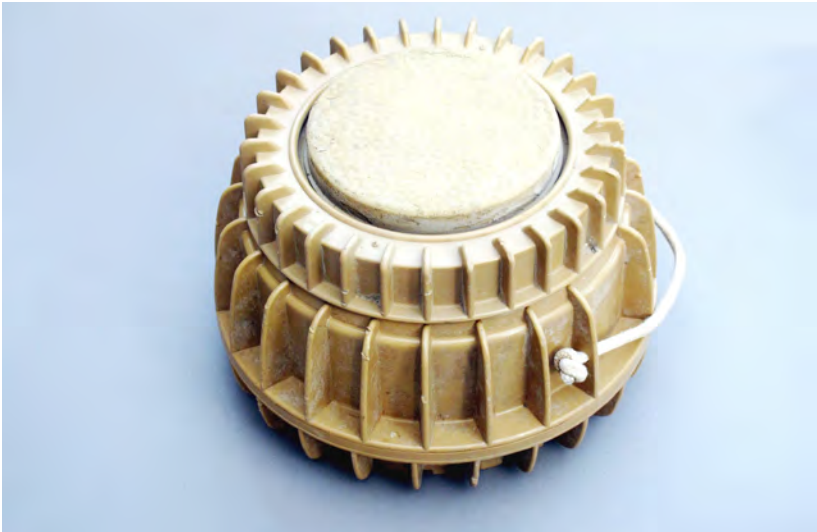
The Italian TC/6 anti-tank mine is one of many designs that use a pneumatic transfer system. When mines are exposed to heat or sunlight for prolonged periods, the elastomer pressure plate becomes brittle, causing the seal around the shoulder to fail. Once air is allowed to escape from beneath the pressure plate, the pneumatic actuation system can no longer operate. Image: Fenix Insight Ltd.

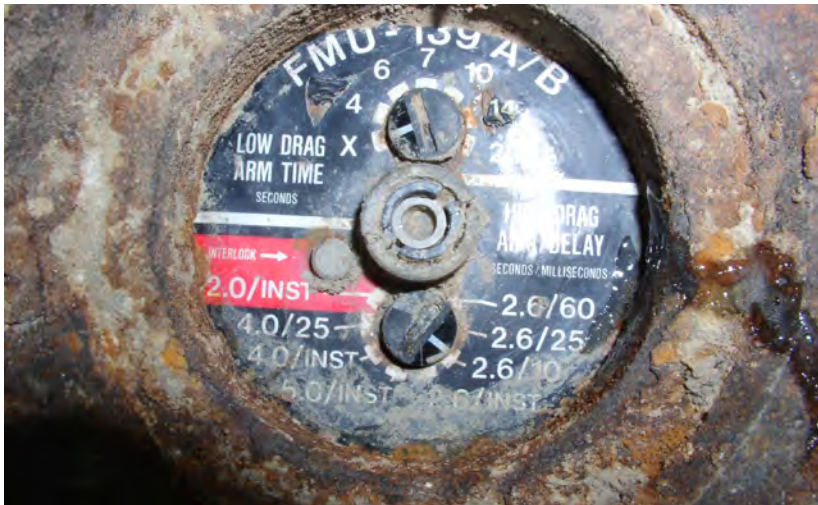
An FMU 139 A/B electro-mechanical fuze in the tail of a MK-83 aircraft bomb in Iraq. The fuze contains capacitors charged from the employing aircraft prior to being dropped. The charge has long since dissipated. Image: Roly Evans.

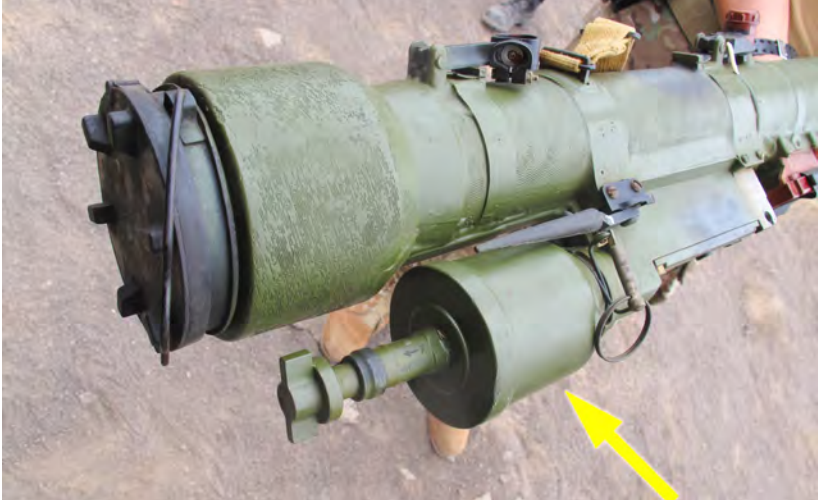
Shoulder fired air-defence systems such as the Russian SA-7, SA-14, SA-16 and SA-18 missiles use thermal batteries. These are fitted to the launcher and activated by twisting a key at the end of the battery assembly. Once heated up, the battery provides power for a few minutes before it cools and expires permanently. Image: Fenix Insight Ltd.

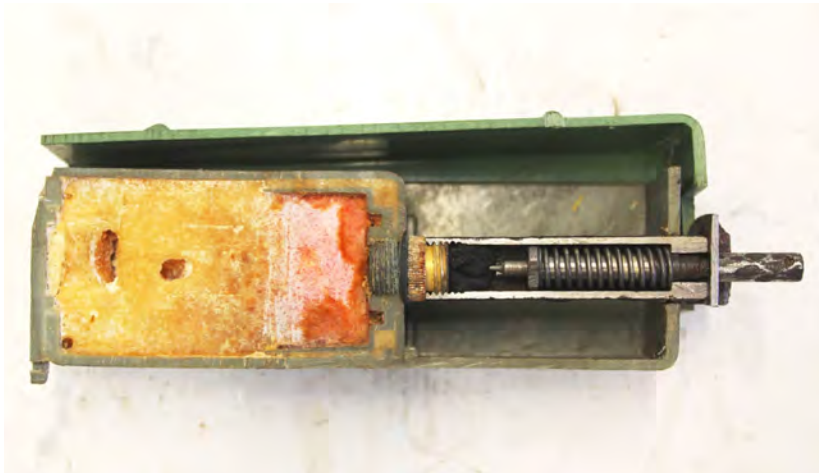
This Israeli No 4 mine was laid in the Falkland Islands/Malvinas in 1982 and recovered 35 years later. A section through the mine reveals that, although the striker is seized, the remainder of the critical mechanical and explosive components are present and functional. While tests showed this striker could not be made to function due to corrosion and expansion of moving parts, in other instances sufficient vibration or impact could free such a striker. Image: Fenix Insight Ltd.

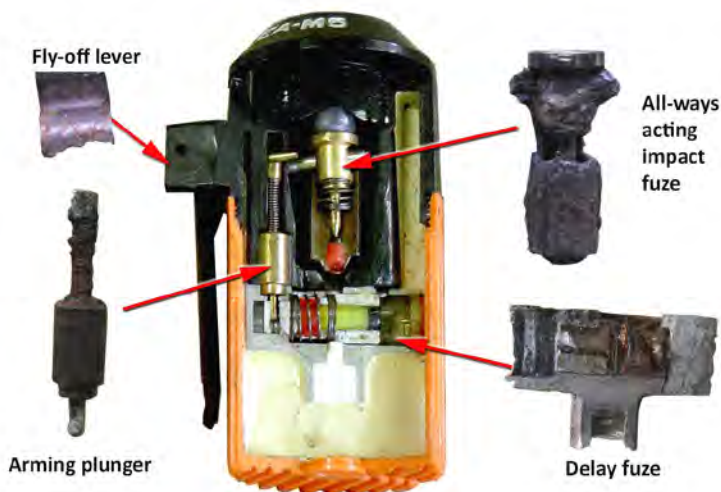
The Spanish M-5 is a complex hand grenade incorporating both delay and impact fuzes. This image shows a section through a new grenade, along with aged components from an example recovered in the Falkland Islands/Malvinas in 2015, 33 years after the war. The multiple points of failure among both mechanical and energetic components meant that the risk from the aged grenade was minimal.
Image: Fenix Insight Ltd.

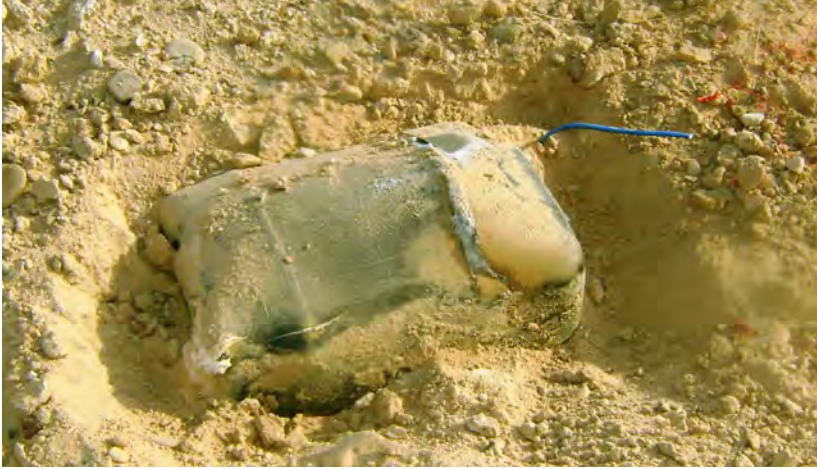
An expanded aluminized ammonium nitrate charge in a 20 litre plastic container, Jalawla, Kurdistan Region of Iraq, August 2016. Expanded charges would routinely split plastic casings. Image: Bob Gravett.

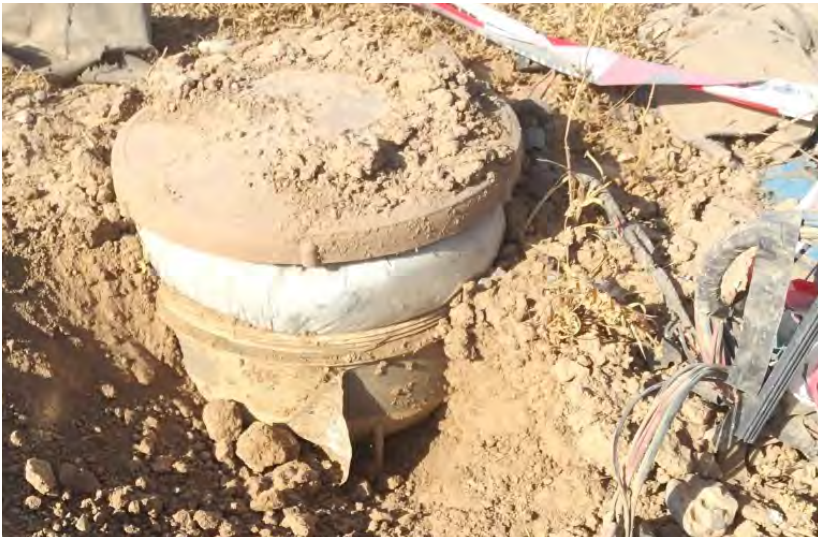
Image top shows a heavily corroded improvised mechanical fuze used in the mechanical version of the VS-500. Image bottom shows expansion of the aluminized ammonium nitrate main charge in an electrically initiated VS-500. Both images: FSD.

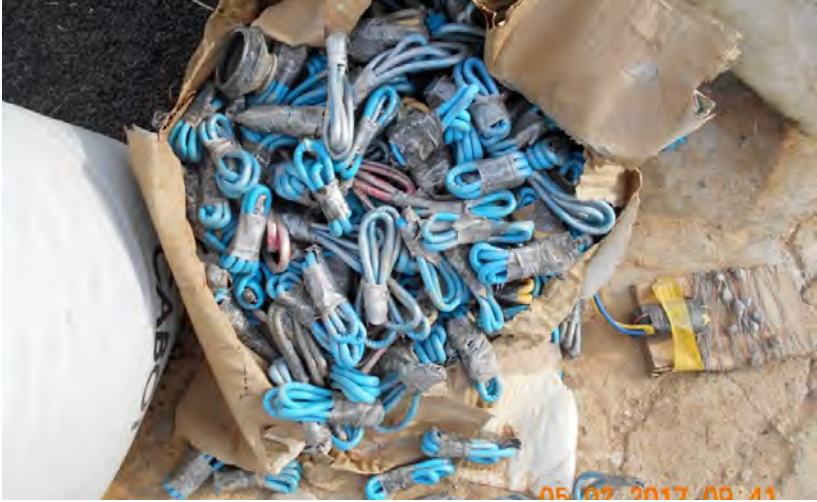
Detonation cord knotted to make improvised boosters. Detonation cord, whether military or commercial, is susceptible to hydroscopic action and potential failure in the presence of moisture. Also note the 9v battery linked to the crush wire on the right hand side of the image. Image: FSD.

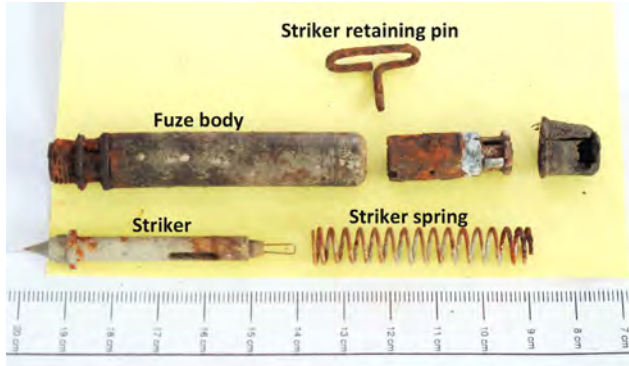
An aged Russian MUV-2 fuze is a simple illustration of a potential increase in danger, as the striker retaining pin corrodes and weakens. However, in many such fuzes, other effects, such as the seizing of the striker into the fuze body and weakening of the striker spring, are also occurring. These increase the likelihood of failure and may offset the hazard associated with the retaining pin. Image: Fenix Insight Ltd.

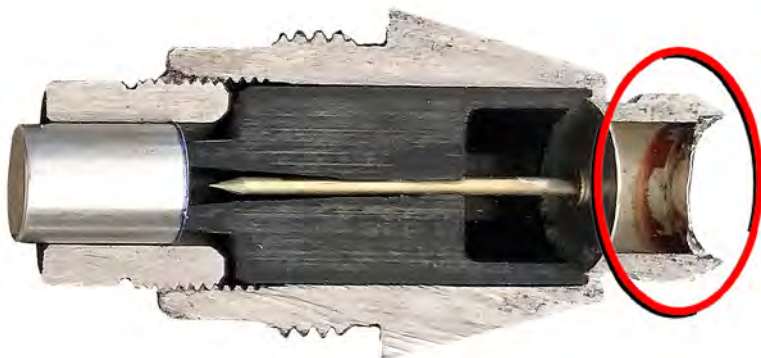
The Russian AM-A fuze is extremely simple, with a firing pin positioned in line with a detonator and with no safety or arming mechanism, just a block as a holding device that is crushed on impact. The front of the fuze casing (circled in red) is designed to protect the firing pin, but also has the thinnest section of steel (where it is designed to collapse or shear). If this section of the casing were to disintegrate, the firing pin would be more vulnerable to impact, and the fuze would become more sensitive. AO-1SCh submunitions using AM-A fuzes were known to have high failure rates when employed in Syria. Image: Fenix Insight Ltd.

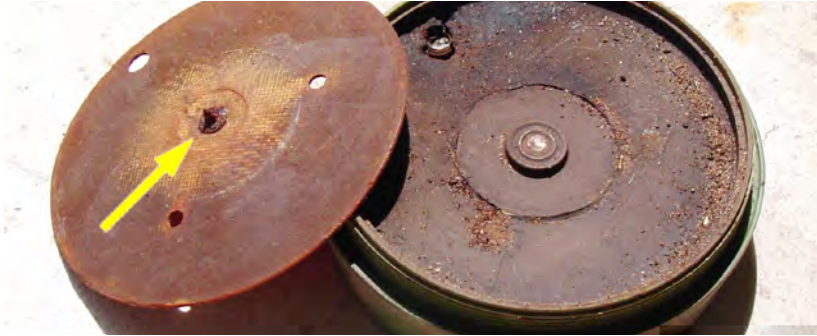
The Chinese Type 72 anti-personnel mine has a firing pin (arrow) weighing just 0.12g, which makes it barely detectable. Any significant loss of metallic mass, as the pin rusts, may take it below the detectability threshold, even though the pin may still be long enough to fire the stab-sensitive igniter. This may have been the case with some of the mines examined in Cambodia in 2015. Image: Fenix Insight Ltd.

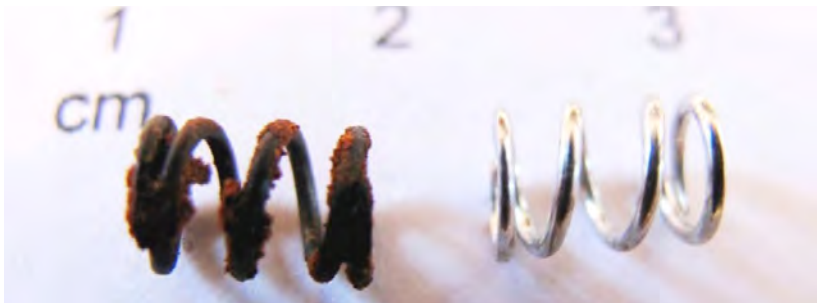
Springs from P4B minimum metal anti-personnel mines, one corroded, another not. The corroded spring's conductivity will reduce making the mine harder to detect. For minimum metal mines, corrosion of the only metallic components makes them even harder to detect. Image: Fenix Insight Ltd.

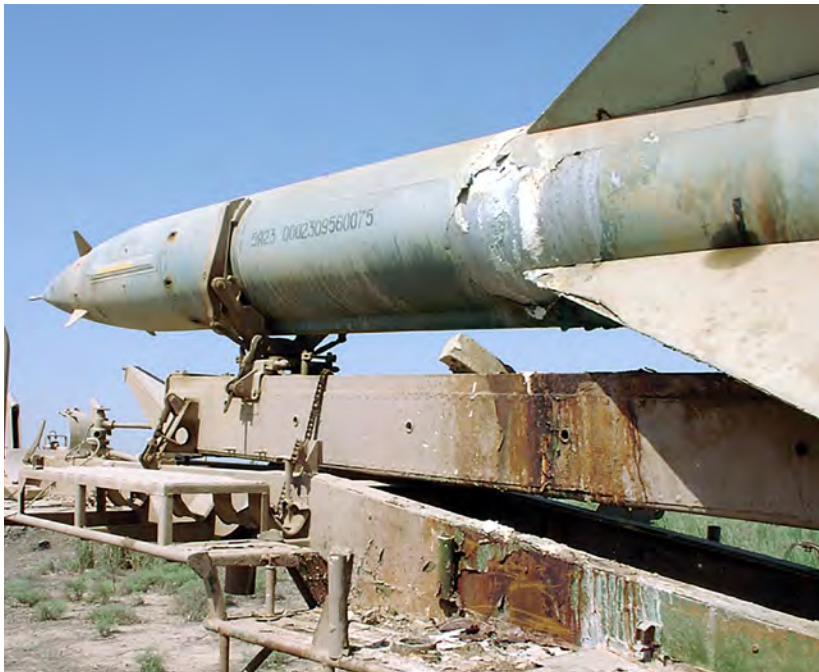
An SA-2 missile in Iraq following the war. Liquid fuel and oxidant from the rocket motor is leaking and contaminating the ground. Image: Fenix Insight Ltd.

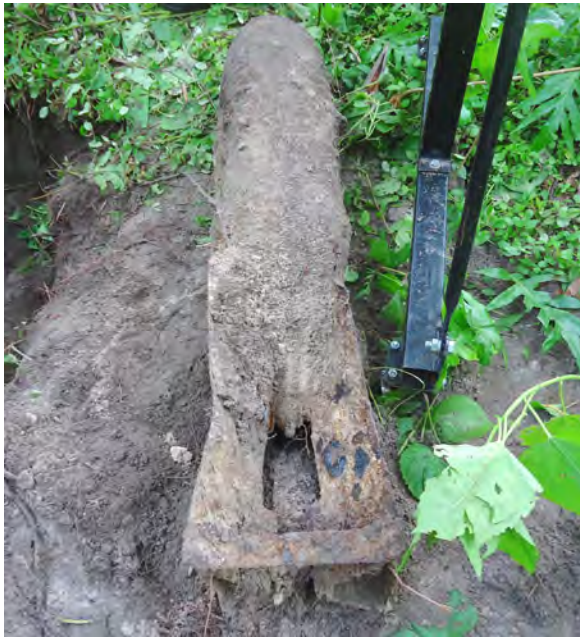
A shallow-buried Japanese Type3 No25 Mk8 Bomb Mod1 – 4, recovered in relatively good condition with the tail fins still intact. Between the fins, at the rear of the bomb casing, is the remains of the tail fuze, no longer functional. Image: Len Austin.

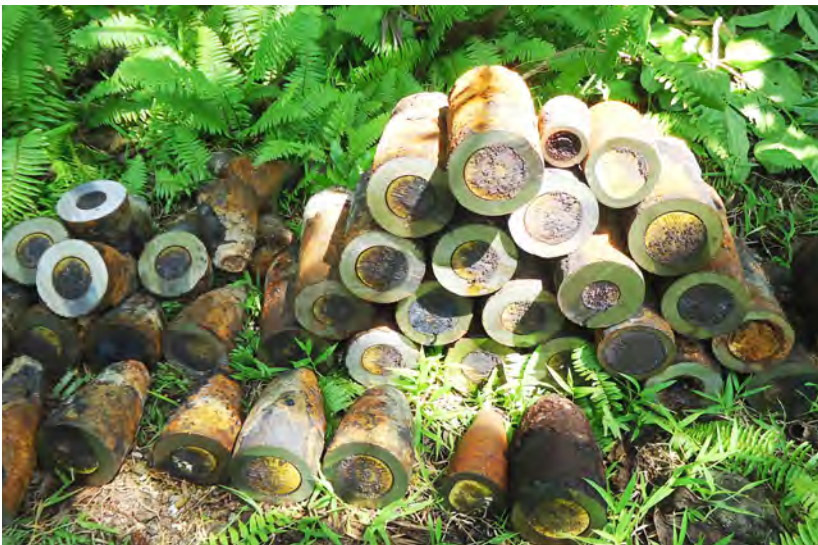
Projectiles that have been cut and inspected await final disposal. Image: Len Austin.

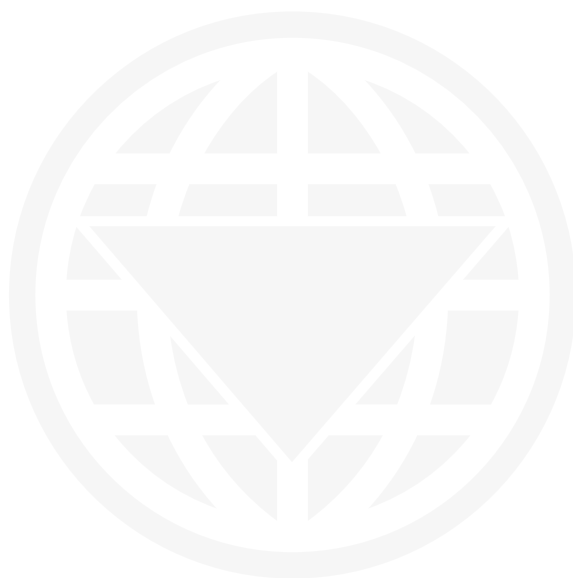
Geneva International Centre for Humanitarian Demining (GICHD)
