DESIGN, DEVELOPMENT, AND FABRICATION  
OF THE  
FMU-63/B BOMB FUZE

HONEYWELL INC.

TECHNICAL REPORT AFATL-TR-71-157

DECEMBER 1971

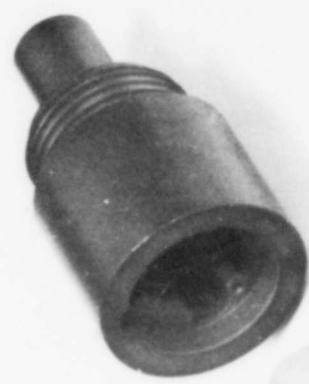
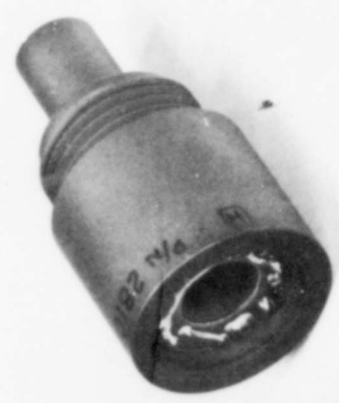
ELECTRICAL BFD

PIECE PARTS LESS INITIATOR

Figure 5. Electrical BFD
