AFATL-TR-76-105 ✓

**DEVELOPMENT OF XM714A3
DELAY FUNCTION FUZE**

**HONEYWELL INC.
GOVERNMENT AND AERONAUTICAL PRODUCTS DIVISION
HOPKINS, MINNESOTA 55343**

FINAL REPORT: DECEMBER 1975 - AUGUST 1976

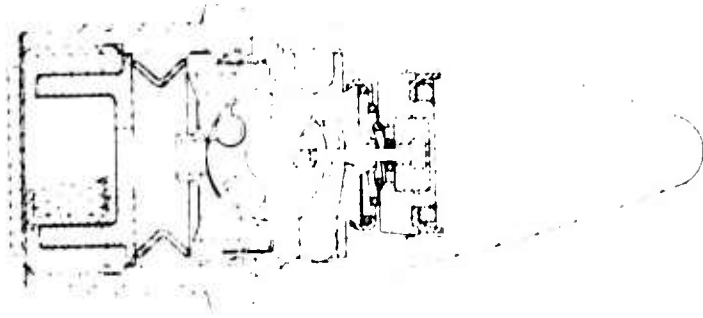
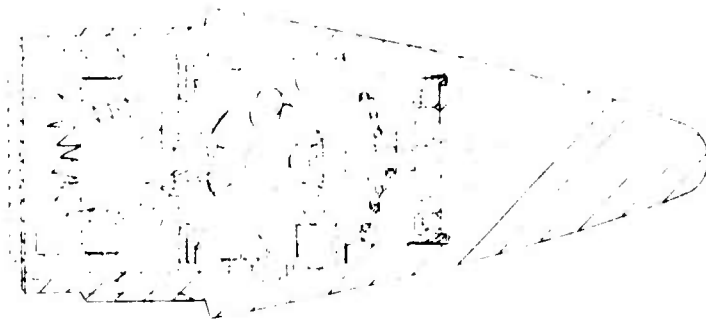
Figure 5. Fuze Operational Modes

SAFE

SETBACK

ARMED

DETONATION

The XM714A3 delay function fuze is shown in its safe, setback, armed, and detonation operational modes in Figure 5. The fuze is subjected to high spin and acceleration as the projectile travels down the barrel. These forces cause both the piston assembly and body assembly to setback, permanently deforming the crushwasher. Air originally in the bottom of the fuze is displaced through ports into the chamber above the piston. High spin forces occur almost simultaneously with the setback force, causing the centrifugal lockweights to move against their springs. This removes one constraint on the rotor in the safe position. Centrifugal force also causes the rubber piston seal to spin out against the inner bore of the ogive to provide the necessary sealing of air.

As the projectile exits the muzzle, the acceleration force dissipates, and the piston is free to move forward under forces exerted by the piston spring. A finite time that can be controlled is required for the piston to move forward fully since air must move through the porous metal restrictor. This action provides an arming delay of 5 to 50 meters over a temperature range from -60° to +155°F in the 20mm projectile environment.

When the piston reaches the forward position, the firing pin withdraws from the rotor and allows it to rotate to the armed position. Centrifugal force acting on the roller weight causes it to move into a groove and lock the rotor in the armed position. The fuze is fully armed when the detonator is in line with the firing pin and the lead assembly.

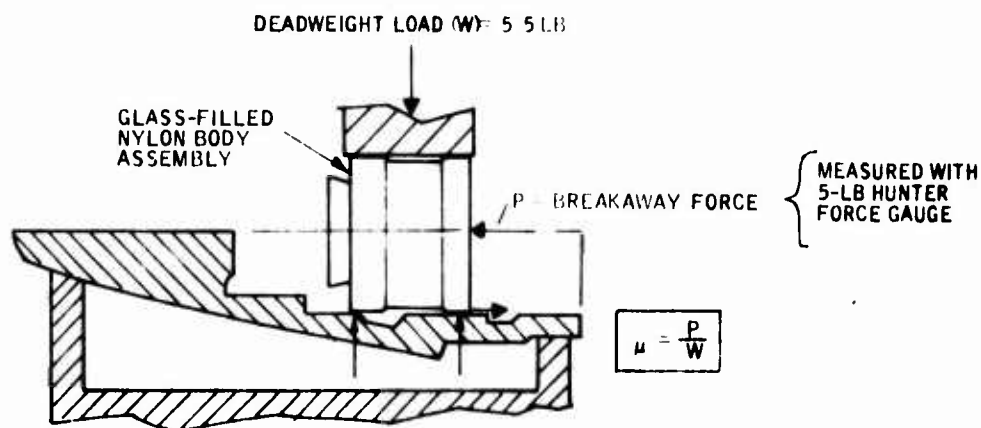
Figure 10. Ogive Salvage Analysis Test Setup

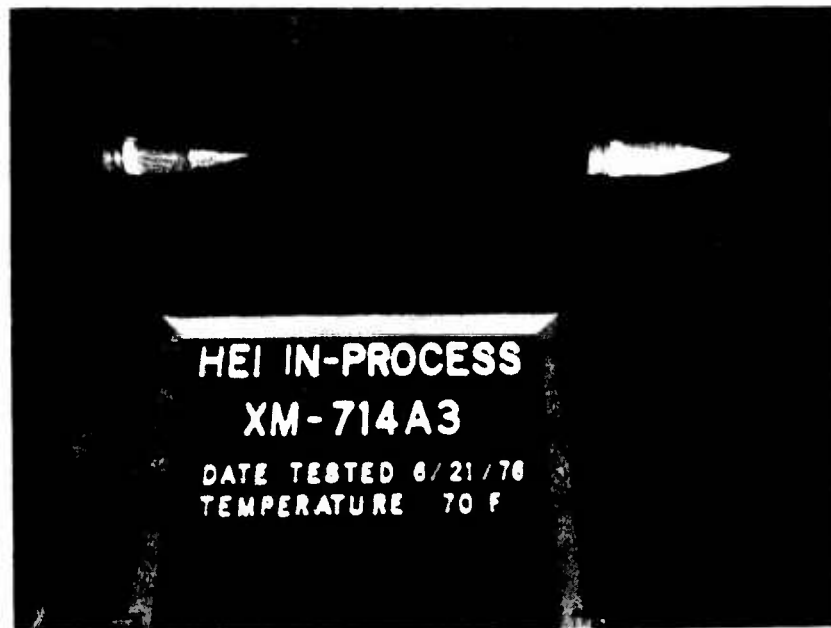
(a) Single Exposure of Projectile

(b) Double Exposure of Projectile

Figure 15. Inflight Photographs of Polarylene-Banded Projectile Assembly (Shot No. 795) after Exposure to 28-day Temperature and Humidity (Test 105 of Mil-Std 331)

Post-delivery tests also verified projectile accuracy (standard deviation of radius = 0.81 mil at a 1707-inch range), polyarylene rotating band retention after 28-day T&H exposure, and long (500-meter) range delay function against 0.125-inch 2024-T3 aluminum at a high (3700-ft/s) muzzle velocity launch condition (17 for 17 delay functions).

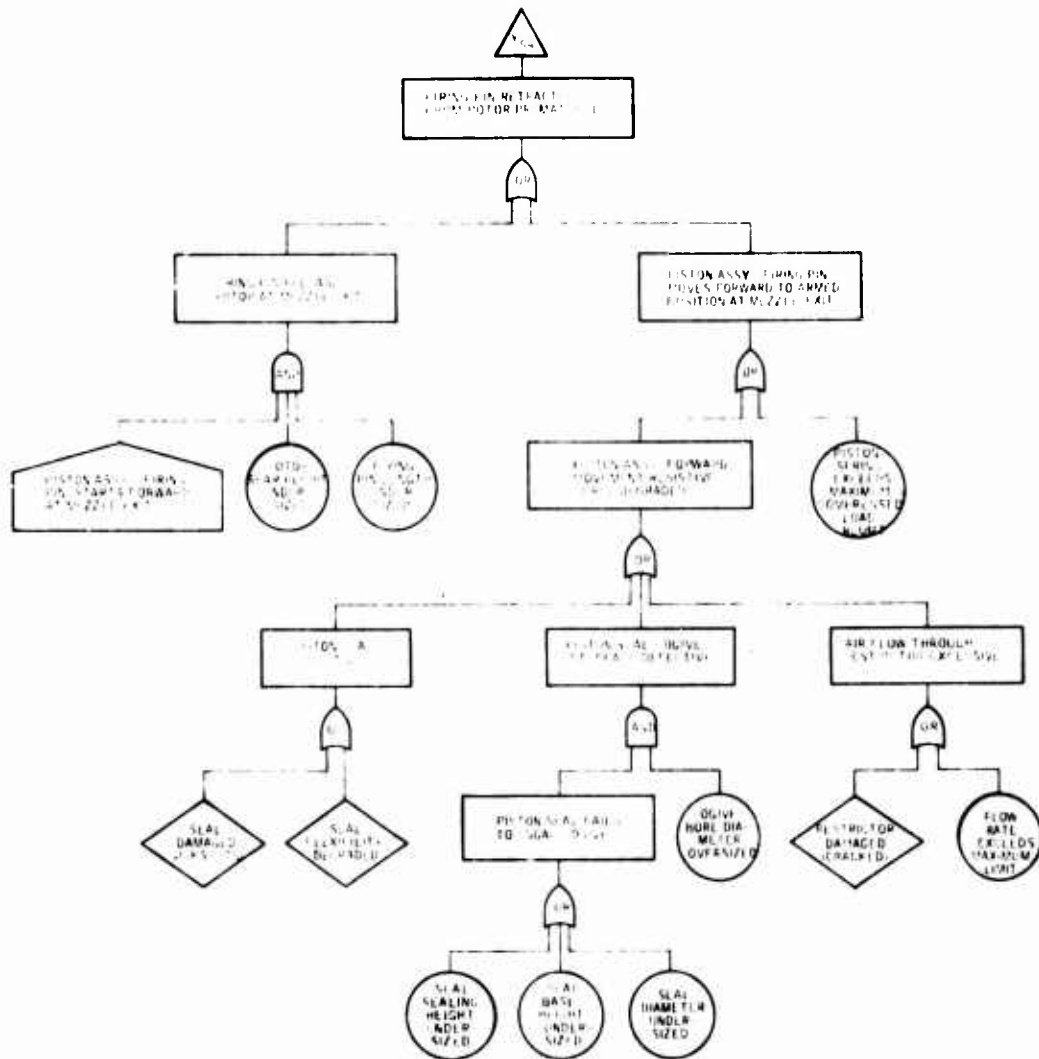
Figure A-6. Muzzle Exit plus One Meter Fault Tree

Figure A-6. Muzzle Exit plus One Meter Fault Tree (Concluded)

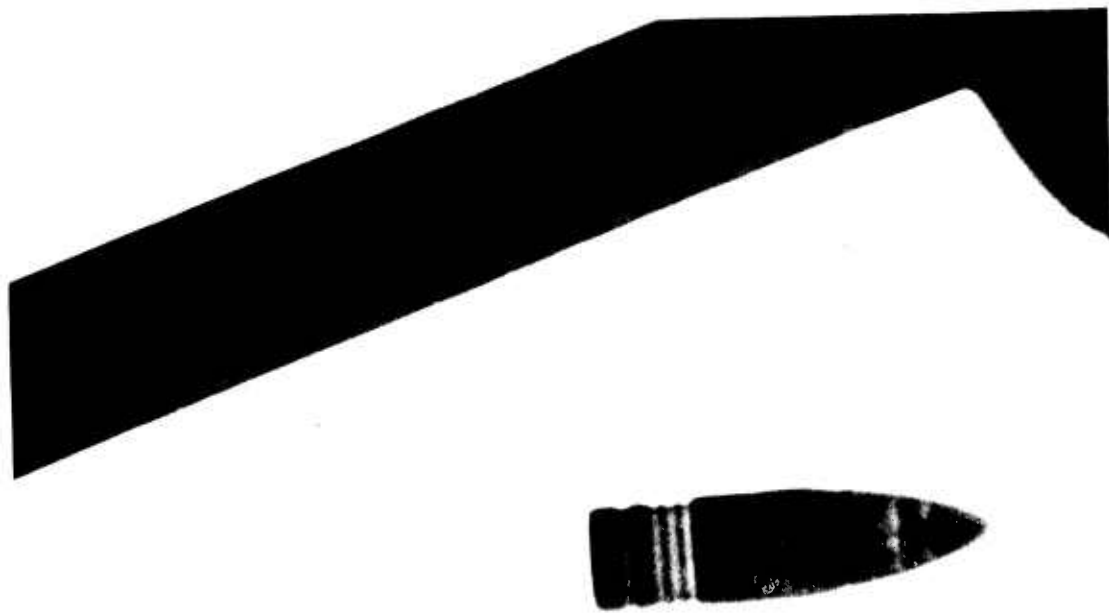
Figure B-7. Flash X-Ray - Mod III Fuze with 0.05-inch-Walled AISI 1144 Ogive 311 microseconds after 3600 (+) - ft/s Impact with 0.09-inch 2024-T3 Aluminum at 70-degree Obliquity (The x-ray shows the detonator is just beginning to function, indicating a delay of approximately 13 inches. This fuze was evaluated with an inert-filled, polyarylene-banded, thin-wall projectile body and was recovered intact from the softcatcher.)
