## INTELLIGENCE

### BULLETIN NO.1

# HQ.EIGHTH ARMY

### APRIL 1945

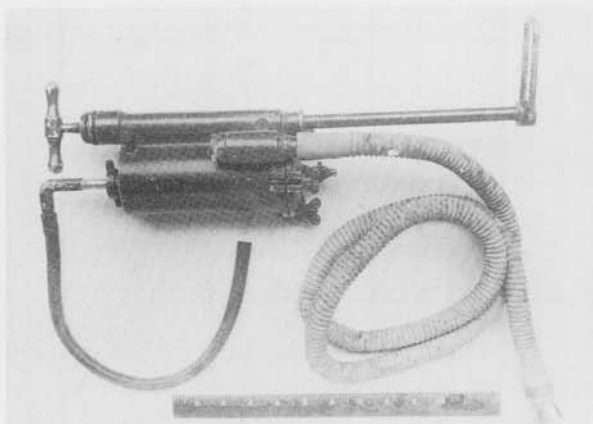
Completely Assembled Unit  
(Note Extension)

The Jap hand operated water filter (see photo below) and other Japanese water purifiers using the ceramic candle principle are being found in some quantity. They should not be used by allied troops for purifying water for their consumption without proper chlorination. Infinitesimal cracks, which cannot be seen by the naked eye, often occur in the ceramic filters, allowing the passage of bacteria.

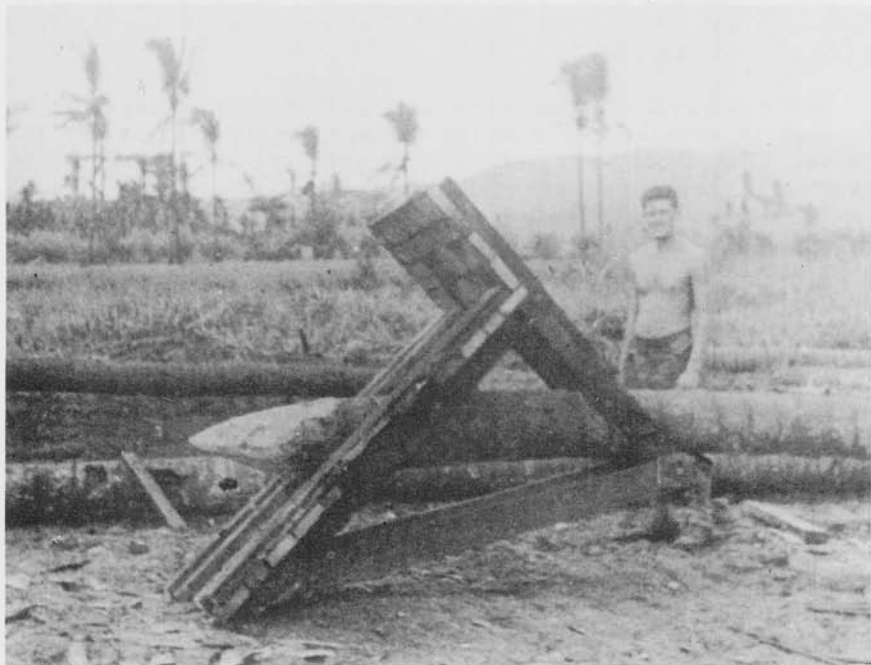
## MUD SHOES

The 302d Engineers had a bridge to build that entailed the placing of bents in a stream with a mud floor. This mud floor had no bottom and the regular type shoes would not hold. The shoe illustrated below in the photograph was developed as an expedient and used effectively in this 36-ton bridge. The bridge is subject to constant traffic and the shoes are holding well.

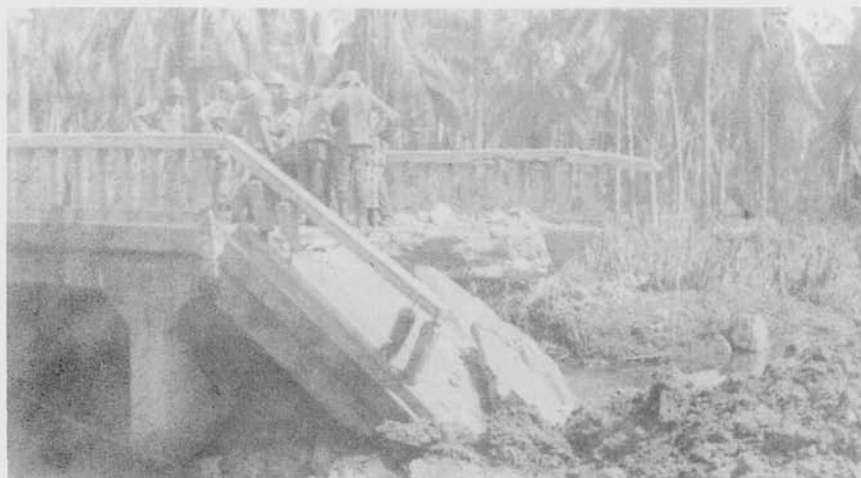
Result of Jap demolition of Bridge over BALIWASAN River, looking northwest. Repairs were effected by dumping river gravel to fill the break and using remaining span to carry the river flow.

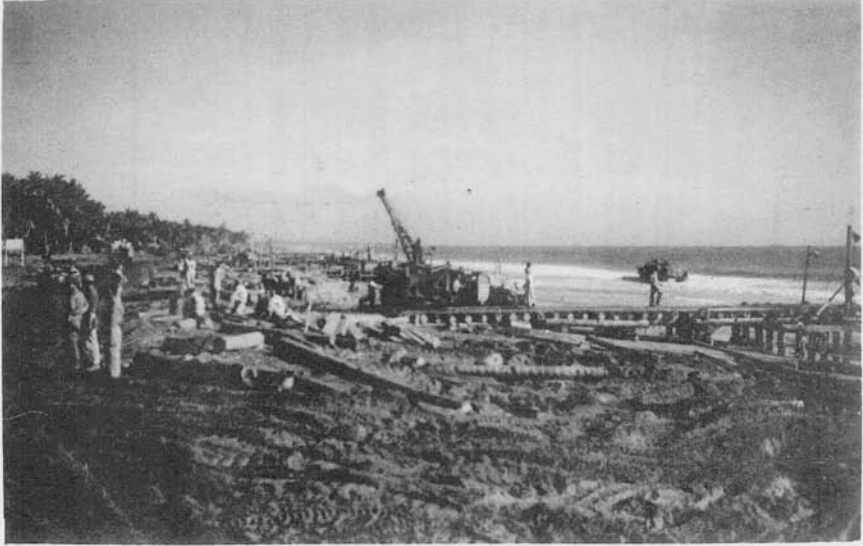
Constructing LST Ramps at Tarragona.

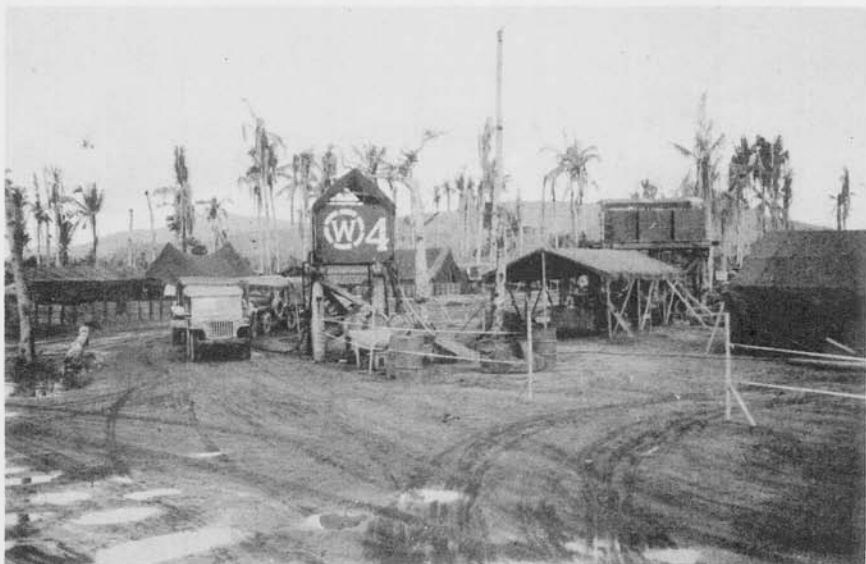
This waterpoint at San Jose installed by the 170th Engineer Combat Battalion is typical of water points on the east coast of Leyte.

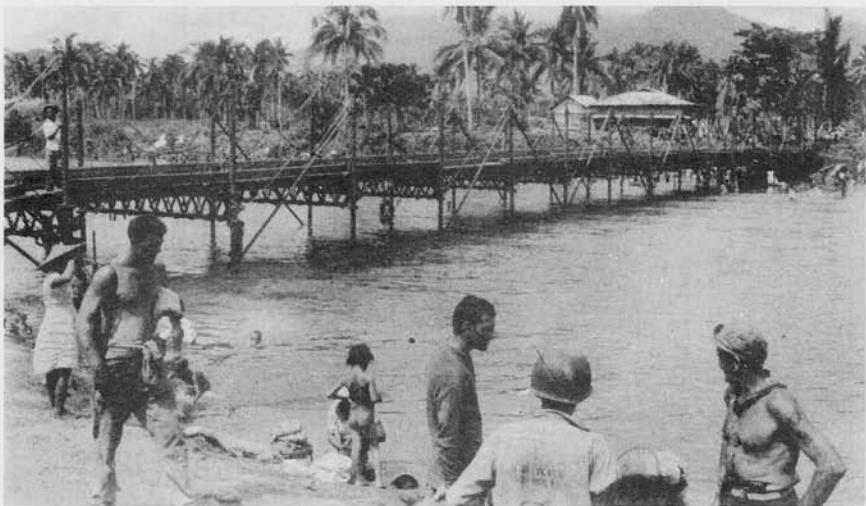
A 271 foot Ponton Trestle Bridge built over the Daguitan River south of Burauen, Leyte.

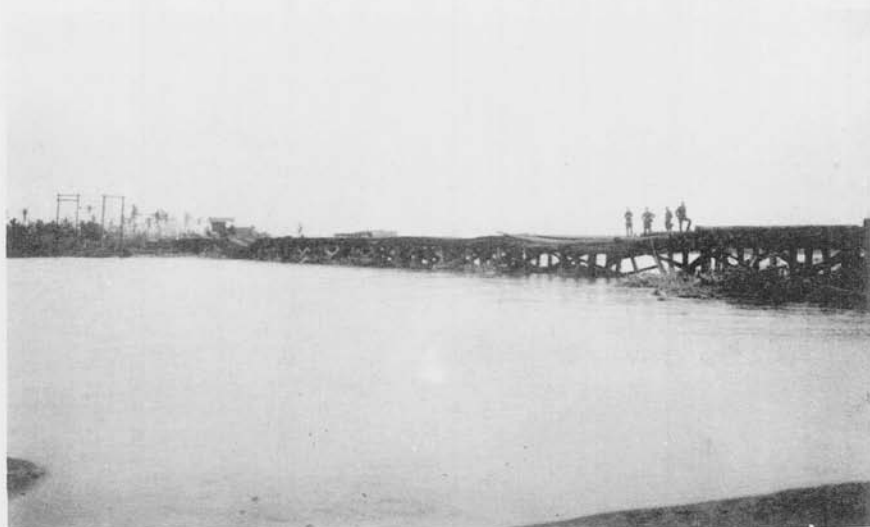
The same bridge completed, and, after a flash flood hit it two weeks later.

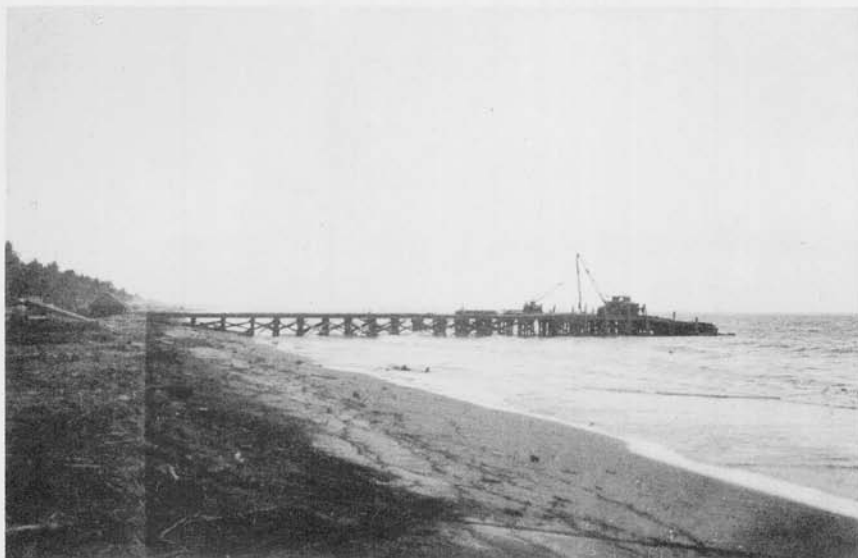
387 foot pier at Abuyog.

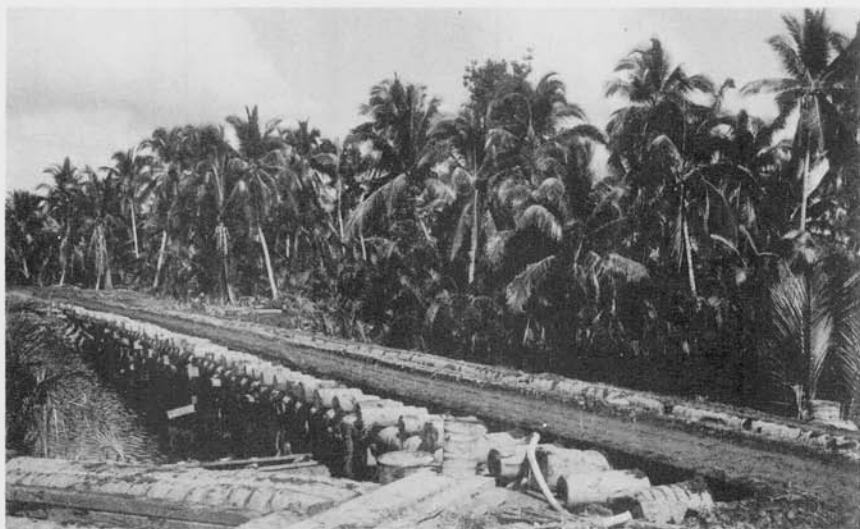
Pile bridge with tread and center curbing.

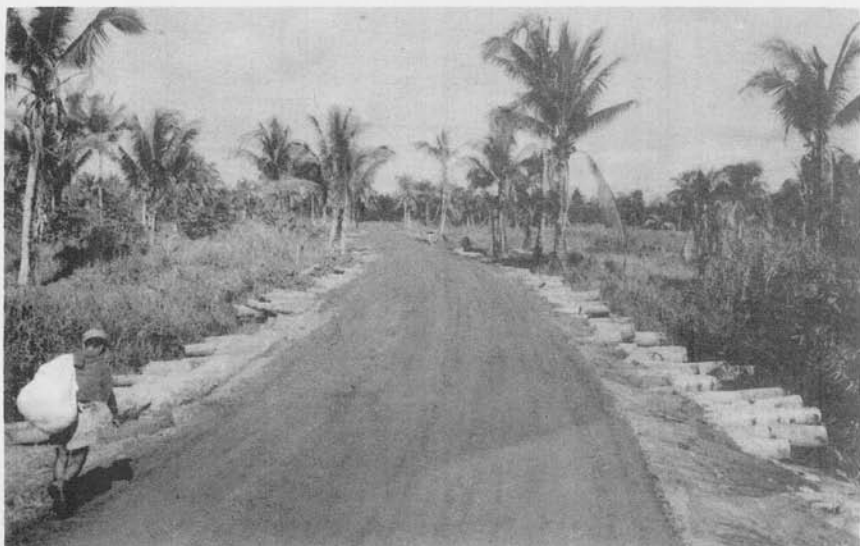
Corduroy road with beach sand surface.

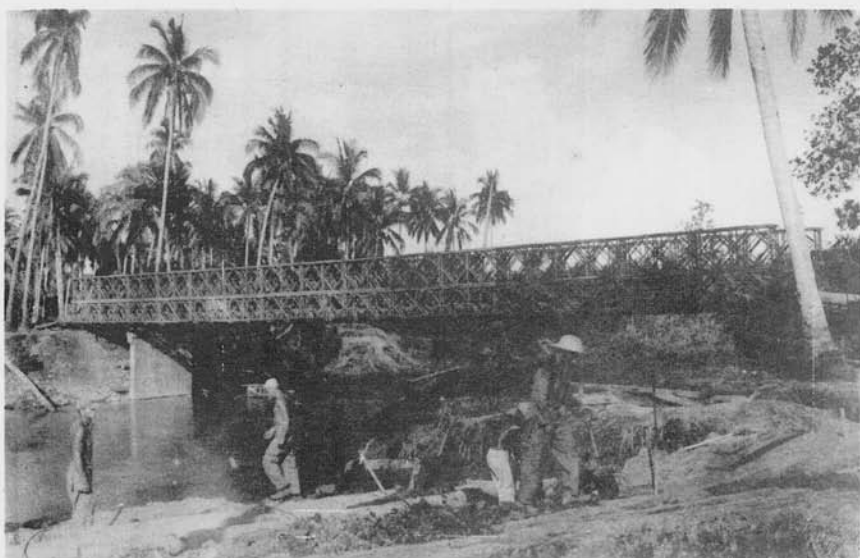
200 foot Bailey Bridge over Bito River.

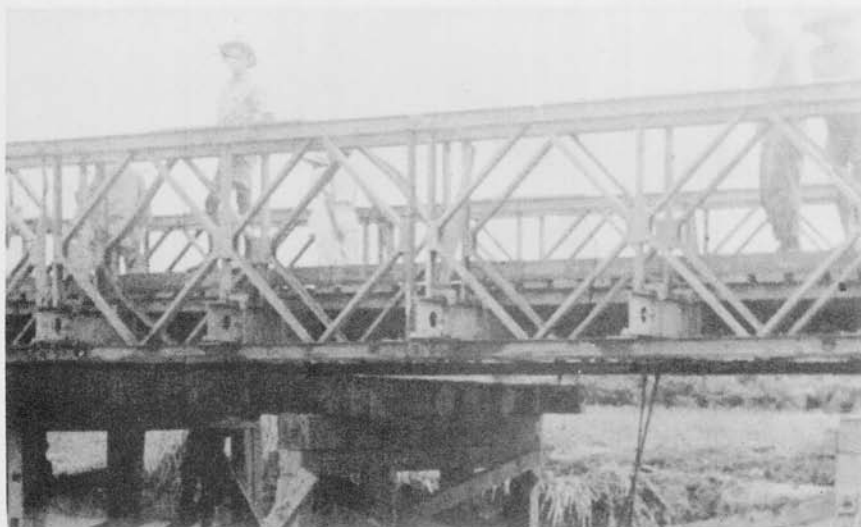
Replacing a 80 foot Bailey Bridge with a timber trestle bridge with minimum interruption of traffic. There was a total delay to traffic of only 4 hours.

One of the missions assigned to an engineer combat battalion included replacing a bridge on the MSR with minimum interruption of traffic. The new bridge was constructed on the bank beside the existing bridge. It consisted of a single span assembly of stringers and decking. During the night the existing bridge was removed and new bridge seats placed. Then the new bridge was lifted into place by two cranes, one placed on each bank. This procedure reduced traffic delay on this important road to less than three (3) hours.

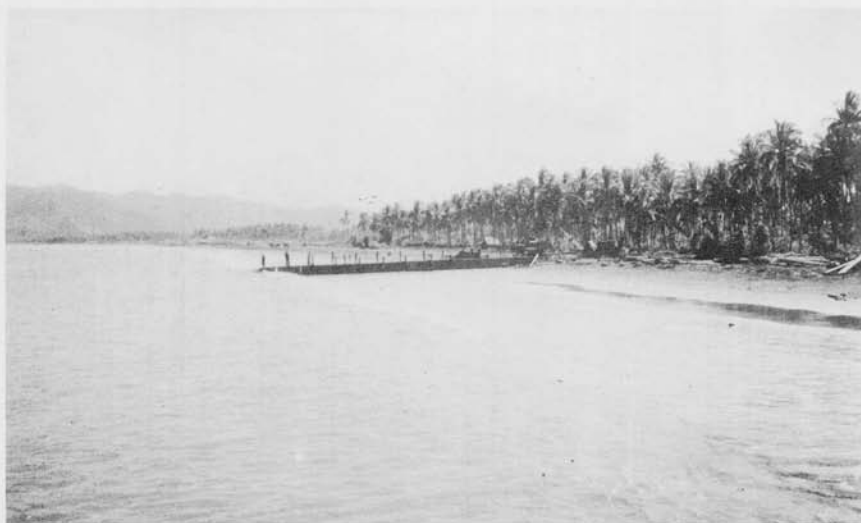
Pontoon dock at Abuyog.

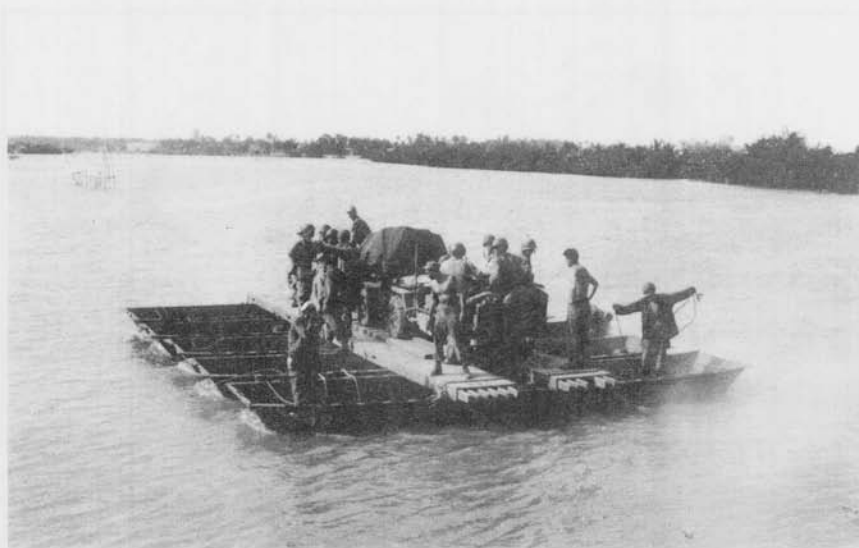
Infantry support raft ferry - Luzon Operation
