U S NAVAL PROVING GROUND  
DAHLGREN, VIRGINIA

REPORT NO. 1136

**BOMBS AND ASSOCIATED COMPONENTS**

Test of Mk 77 Mod 0 Bomb (Fire-750 lbs.) with Canted Fins

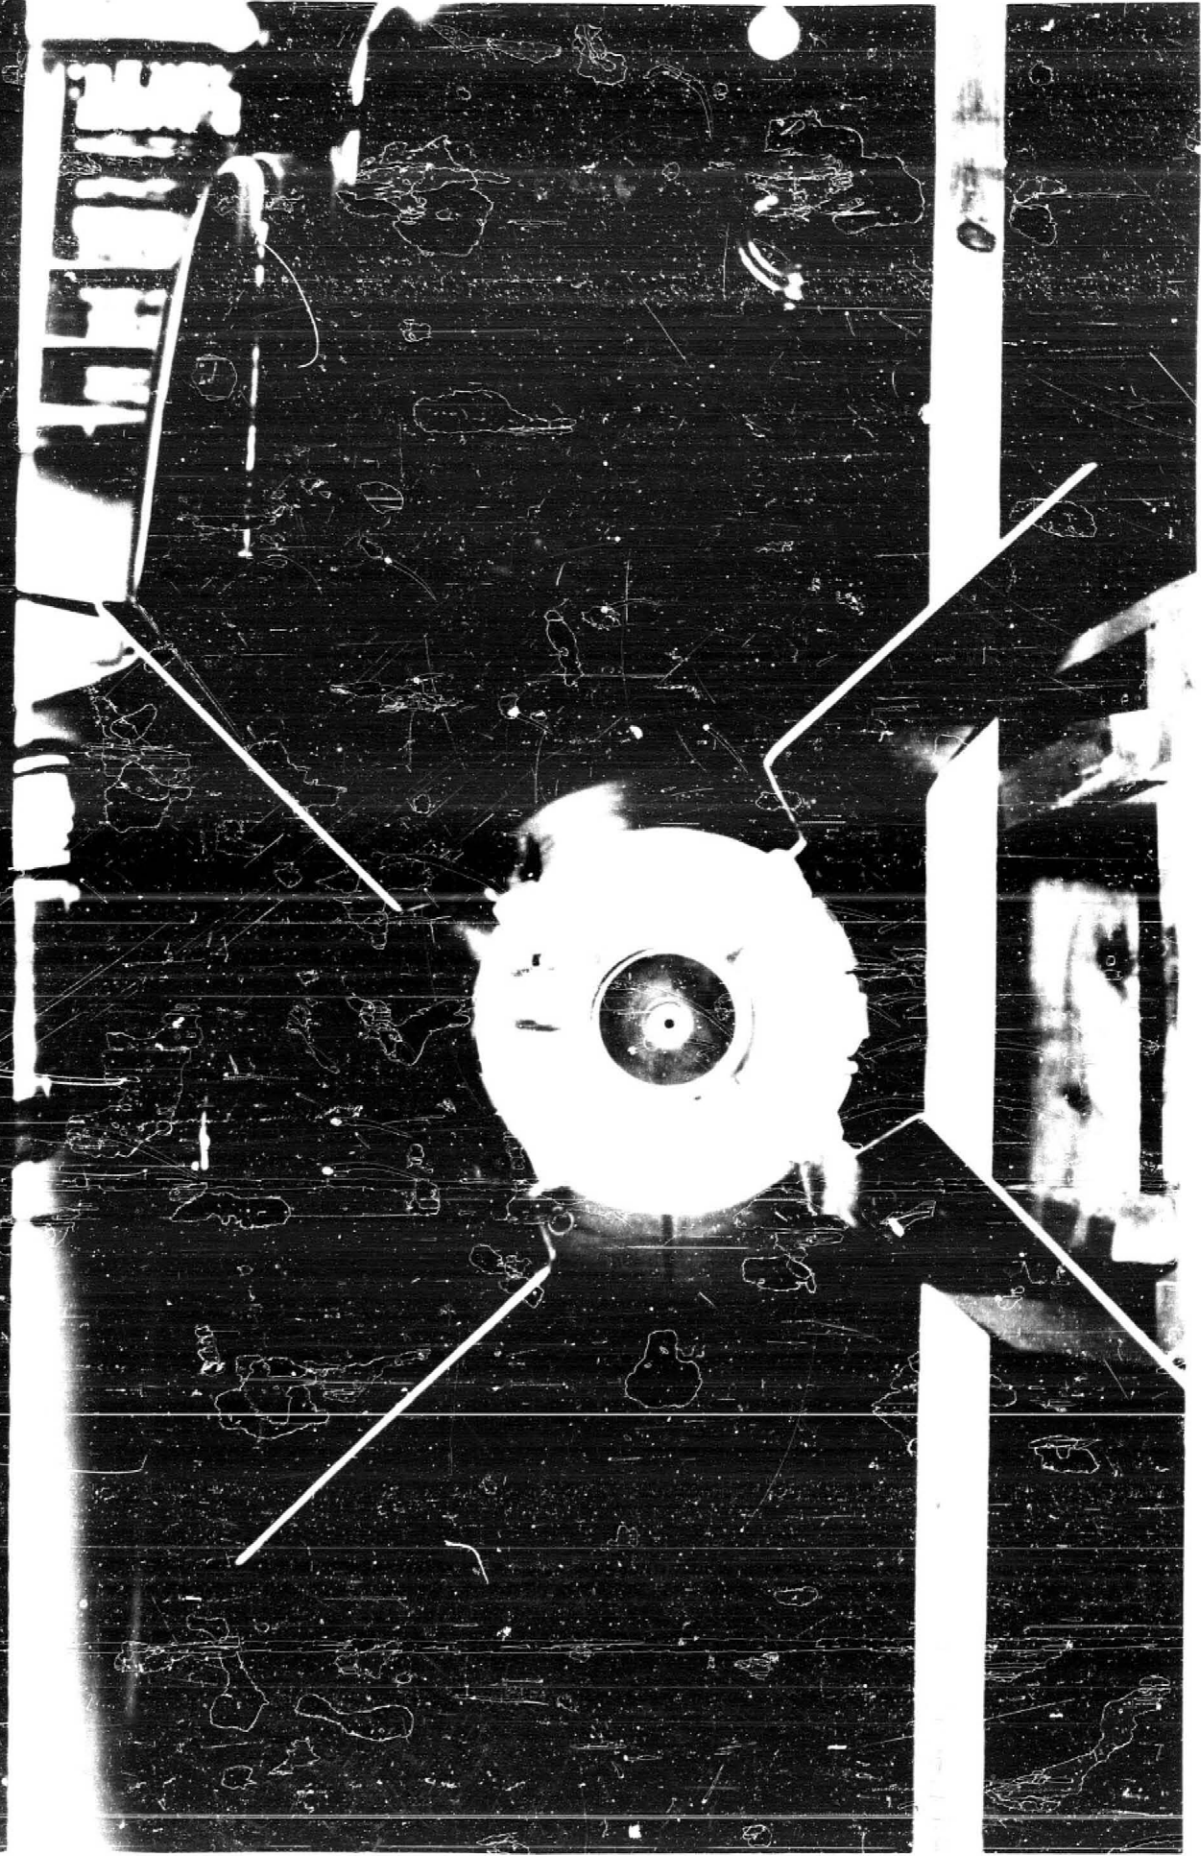
2 April 1953  
Figure 1

PP-63004  
Mx 77 Mod C Fire Bomb

before modification, rear view.

The bomb tested was a standard Mk 77 Mod 0 Bomb (Fire-750 lbs.) inert loaded and equipped with inert M23 Igniters and inert M173 Fuzes and further equipped with modified canted fins instead of the standard fins or fins and shrouds. The nose and tail cones were not installed. The fins are manufactured of 5T aluminum, 3/16 inch in thickness and 18 inches in length along the root chord. The fins were welded at an angle to an adapter which bolted to the bomb. The angle of fin to the fore and aft centerline of the bomb, and to the adapter, is about 10 degrees. Actual measurements are given in Table I. Reference (c) authorized the modification of the fins as follows: The fins were strengthened by bolting a 3/8 inch steel rod 1-1/2 inches down and in from the outboard after corner of two (2) adjacent fins, and bolting rods between the next two (2) fins as close as practical to the bolts used in the first two (2) fins. Figures 1 through 4 show the bomb before and after modification.

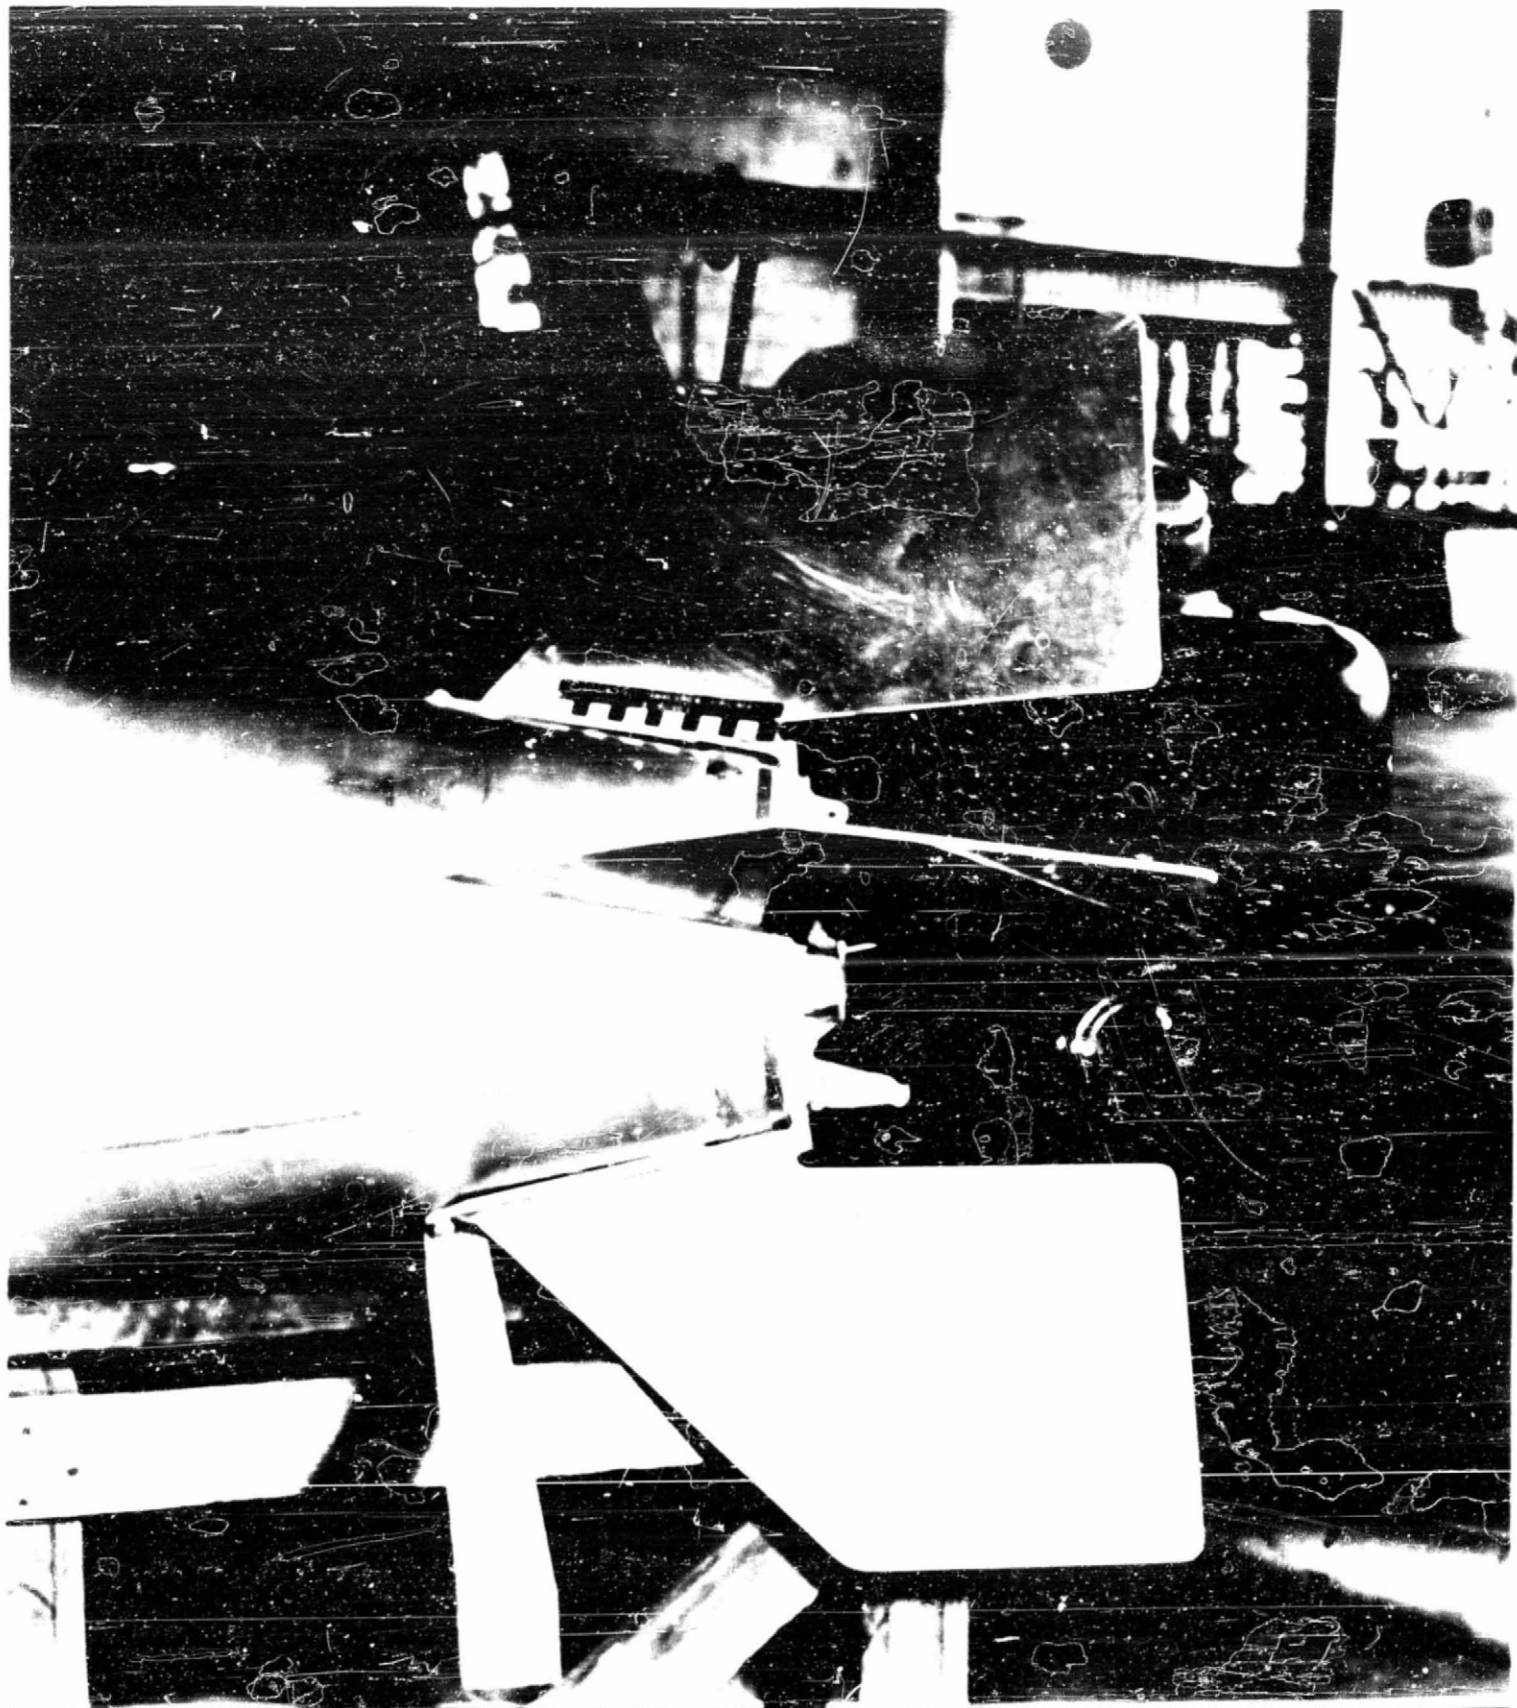
Figure 2

M7 Mod 0 Fire Bomb equipped with canted fins before modification,  
side view.

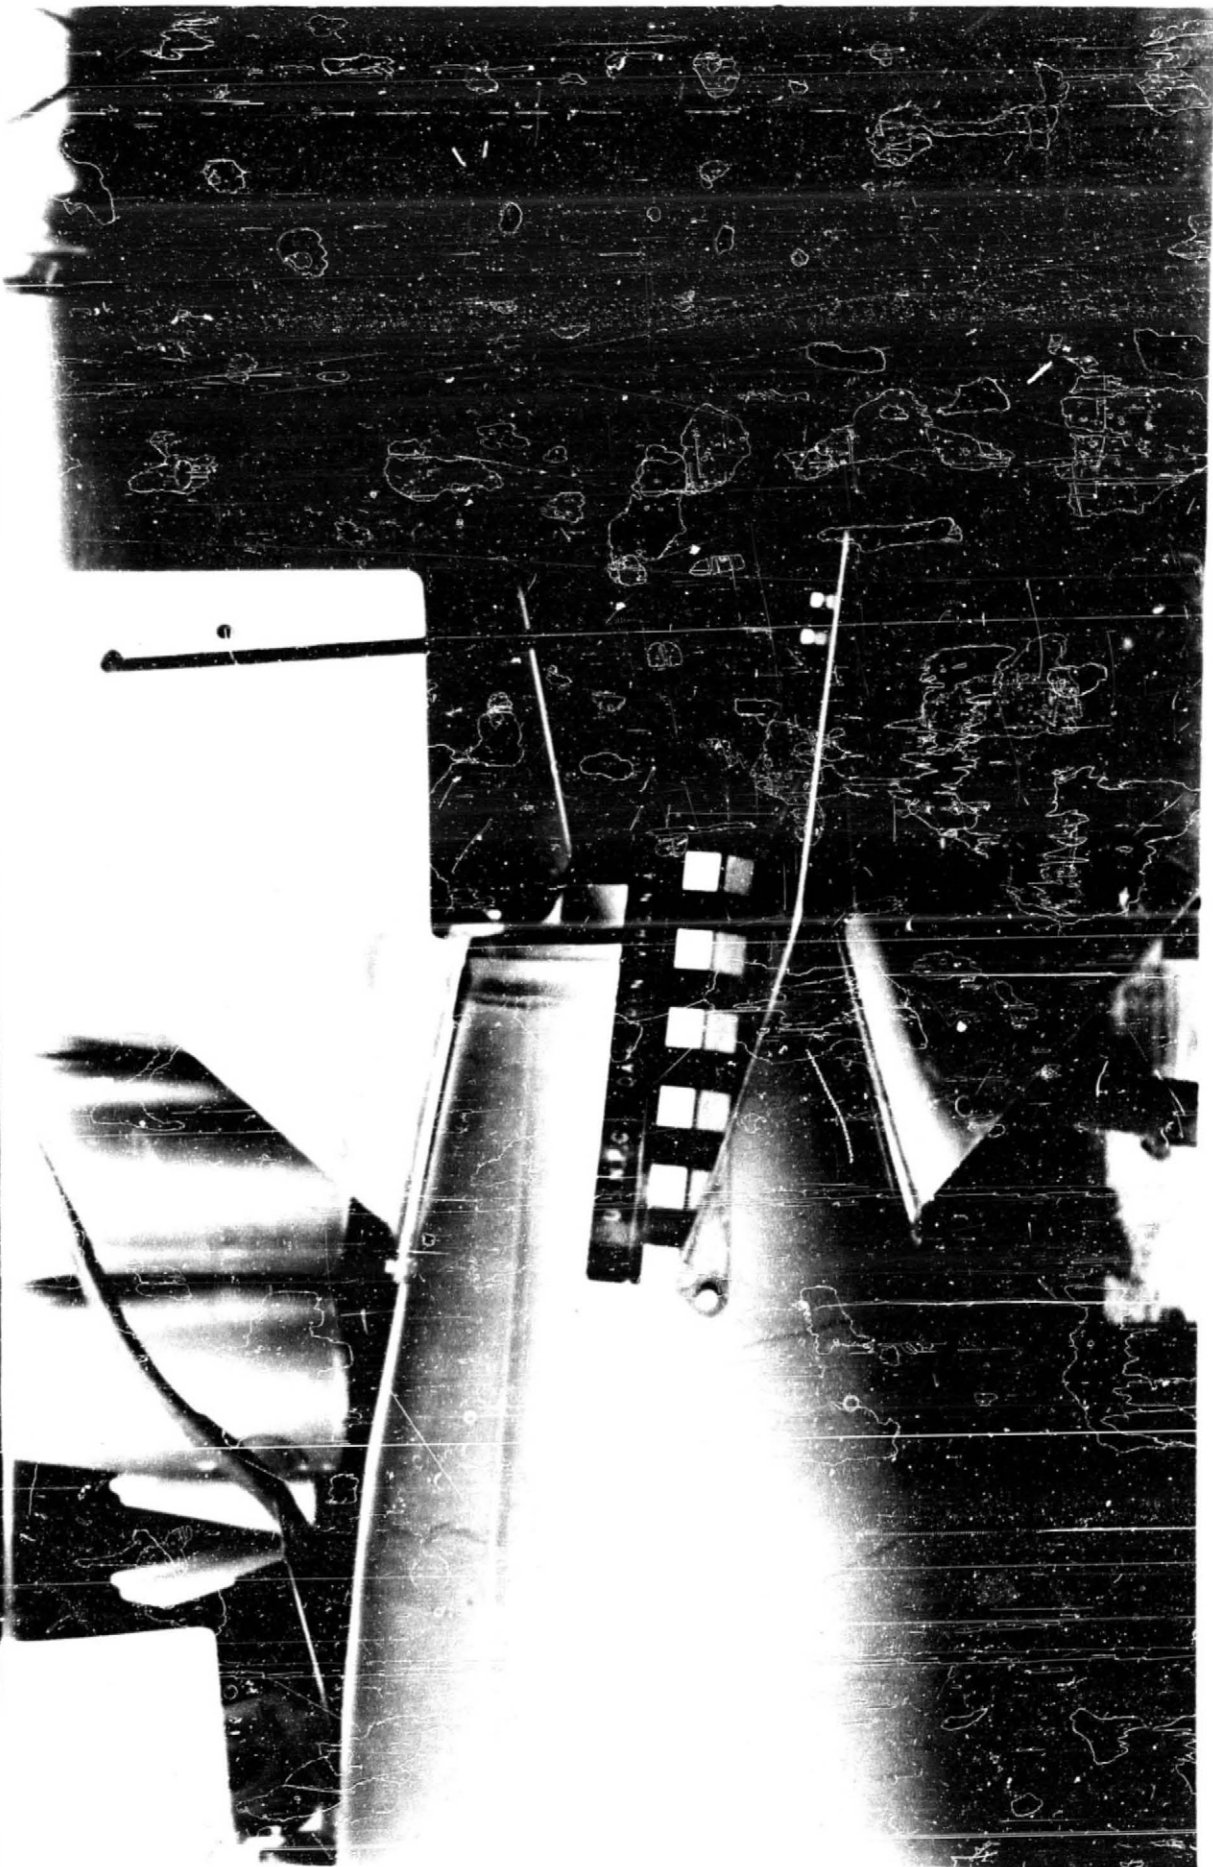
Mk 70 Mod 0 Pipe Bomb equipped with canted fins, after modification, side view. Figure 3

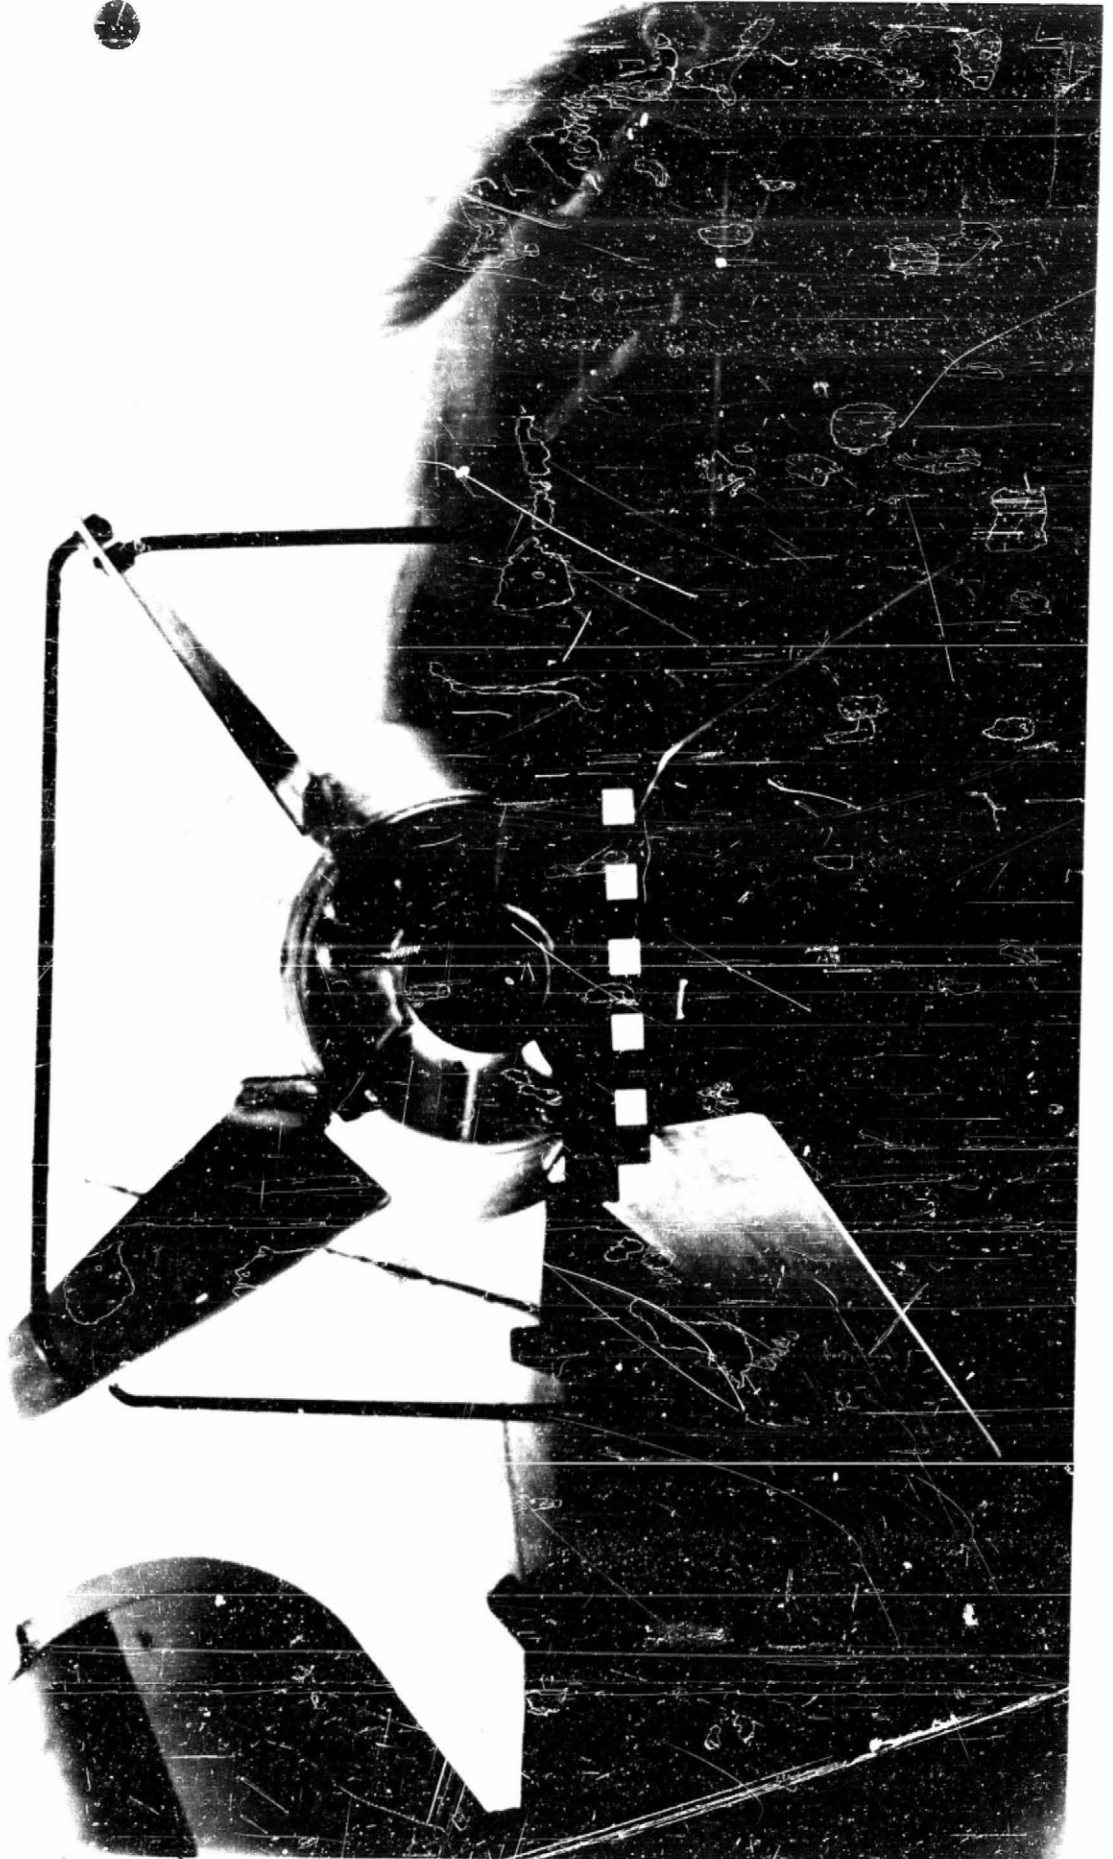
Mk 77 Mod C Piro Bomb equipped with canted fins, after modification, rear view.

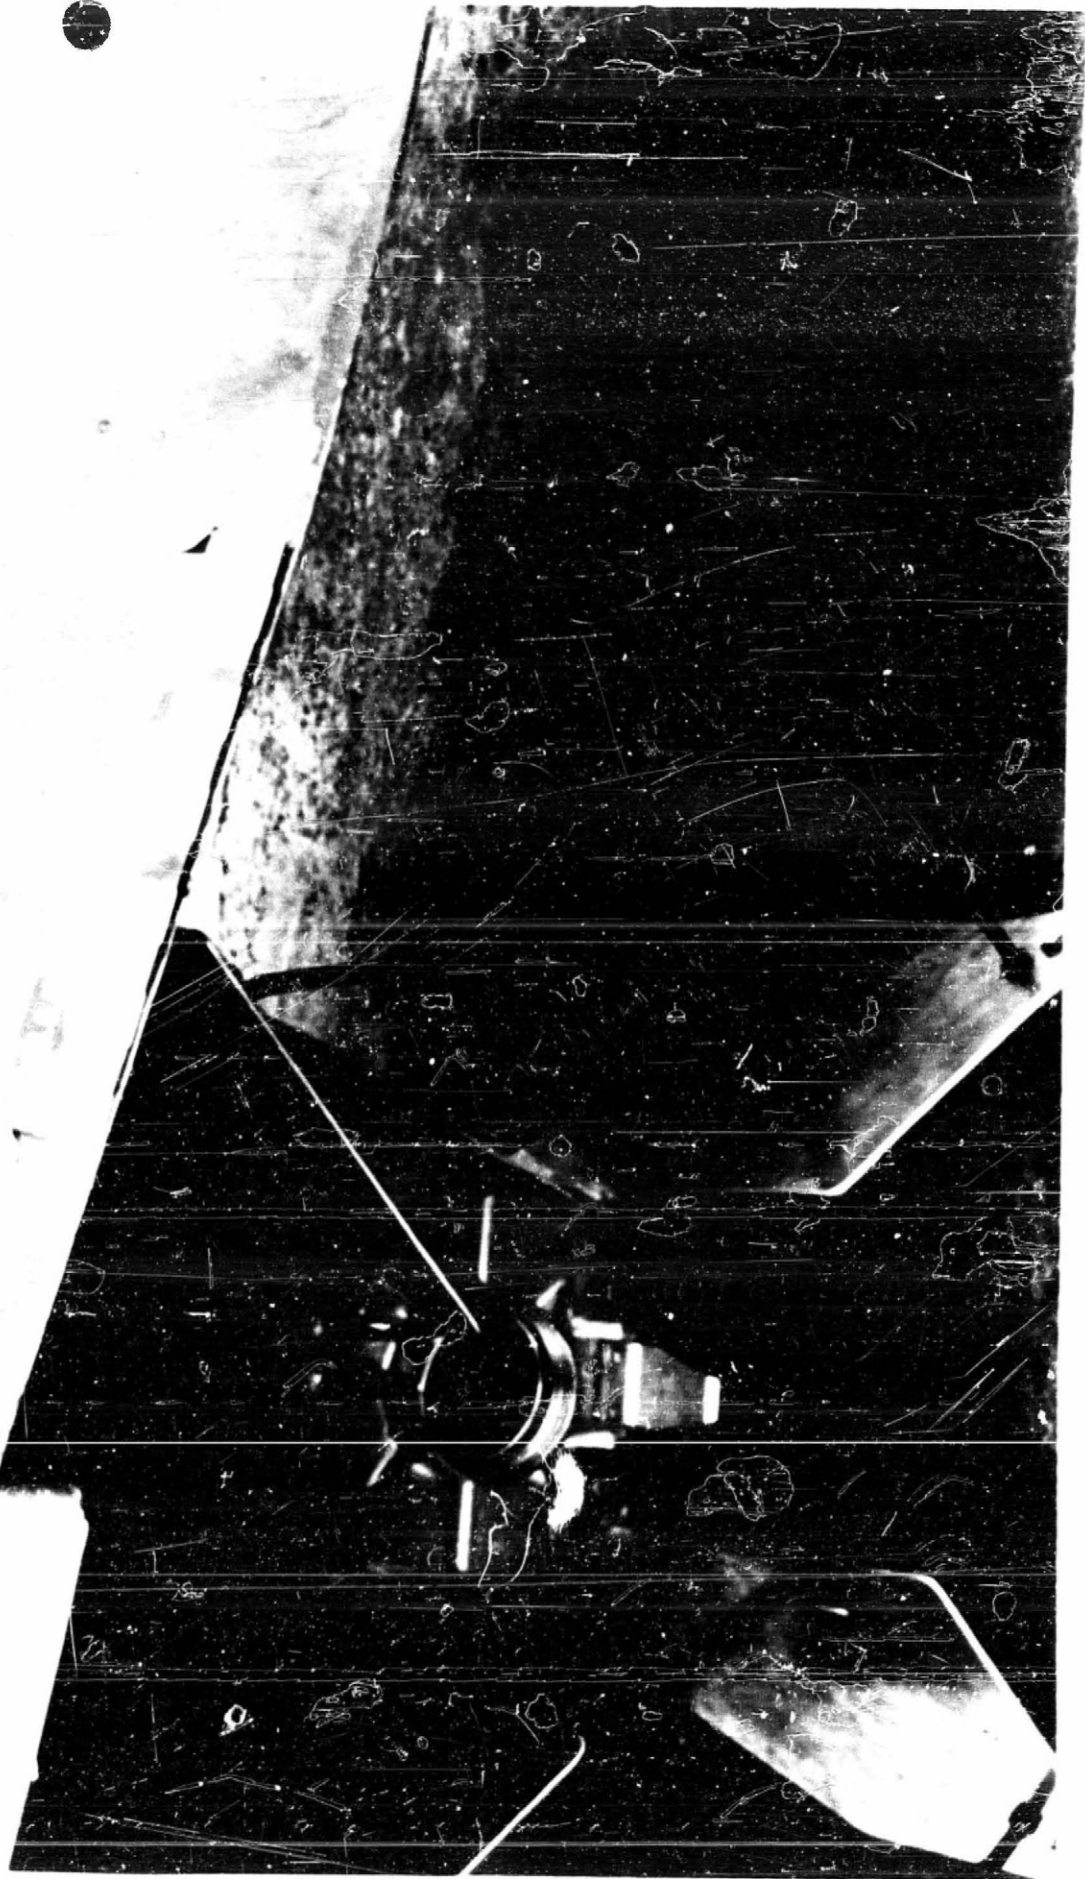
7 April 1953  
Figure 6

NP9-63137  
Mx 77 Mod C Fire Bomb with canted fins on starboard pylon of F4U-5, flaps down 200, bare clearance.
