EXAMINATION OF ITALIAN PROJECTILES

REPORT NO. 7-45

47mm A.P. PROJECTILE  
47mm H.E. PROJECTILE  
105mm H.E. PROJECTILE  
120mm COMMON PROJECTILE  
149mm H.E. PROJECTILE  
6" H.E. PROJECTILE  
6" COMMON PROJECTILE

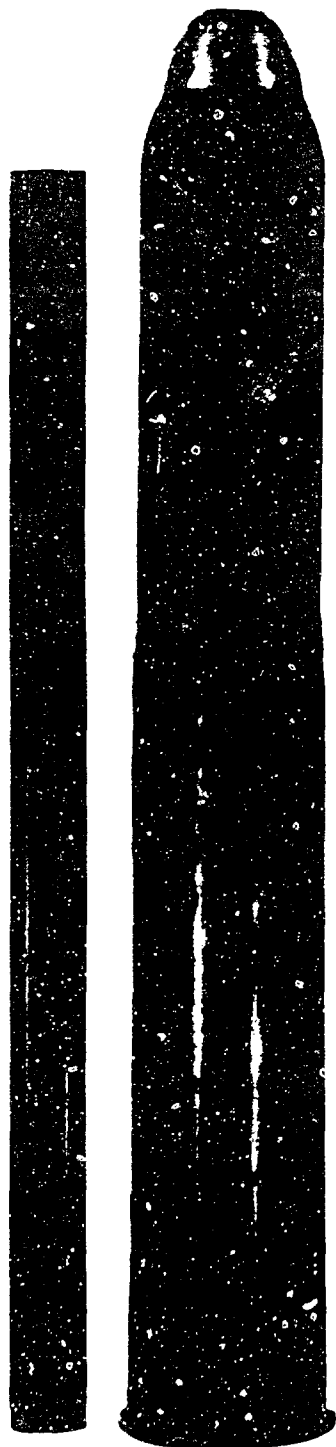
Figure 1

NFG Photo No. 1350 (APL).  
As received and disassembled view of Italian 4.7mm H.E.  
round. CEE No. 3662.  
15 May 1945

The complete round, as received and disassembled, is shown in Figure 1-. The projectile extends into the case nearly half its length, and is fitted with a narrow rotating band near its center. A contact type nose fuze is provided. The markings found on the round are shown in Figure 2 and indicate that the case was manufactured in 1941, but give no indication as to the date of manufacture of the projectile. The colors used to identify the projectile and its loading are also given in Figure 2.

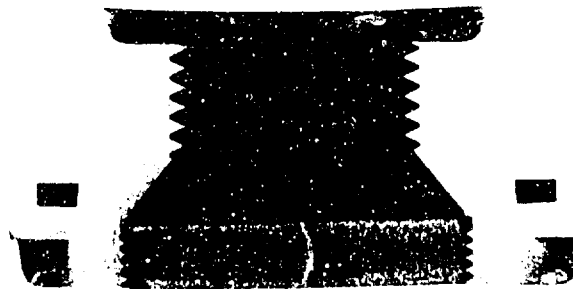
Bottom view and deep etched section of base plug of  
Italian 120mm Common projectile CEE No. 3437.  
15 May 1945

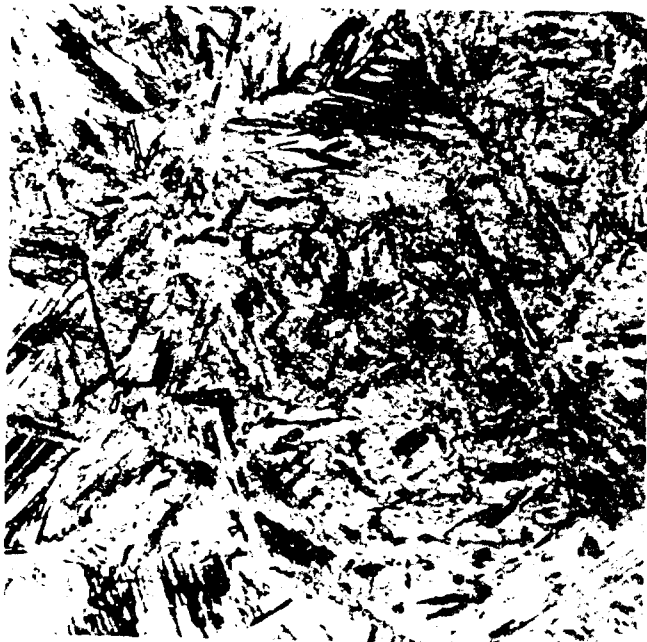
Figure 5

MICROSTRUCTURES OF  
ITALIAN 120mm COMMON  
PROJECTILES

PROJECTILE NOSE Martensite  
with Bainite Needles

Hardness - 600 VPN  
Magnification - 1000X  
Etch - Picral Nital  
M495

PROJECTILE BASE Tempered  
Martensite

Hardness - 350 VPN  
Magnification - 1000X  
Etch - Picral  
M496

Photomicrographs of the projectile body are given in Figure 5. Both the nose and base are quenched and tempered structures consisting of carbides and tempered martensite. The microstructure of the base plug and wind-shield are shown in Figure 6. The base plug has a structure consisting of spheroidized pearlite and the windshield is largely ferrite with traces of pearlite.

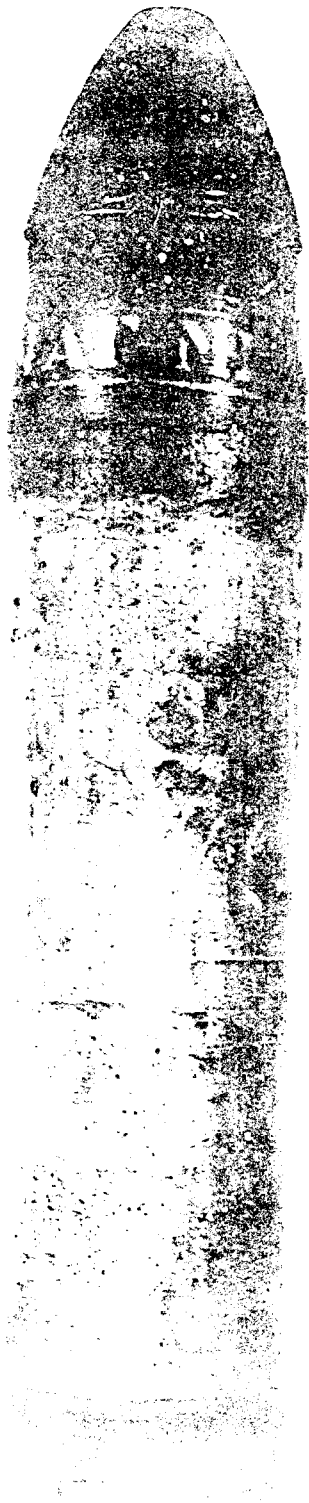
Figure 1

NPG Photo No. 2793 (APL).  
As received and disassembled view of Italian 149mm  
H.E. projectile, CEE No. 3648.  
15 May 1945

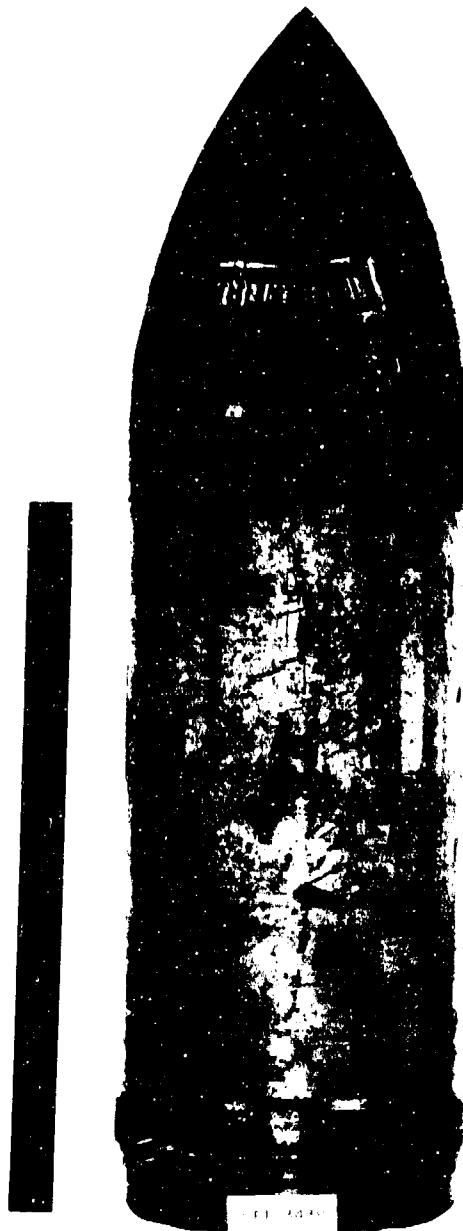
Figure 1  
NPG PHOTO NO. 1403 (APL)  
Italian 6" Common Projectile, CEE No. 3438, as Received  
and Disassembled View.  
15 May 1945

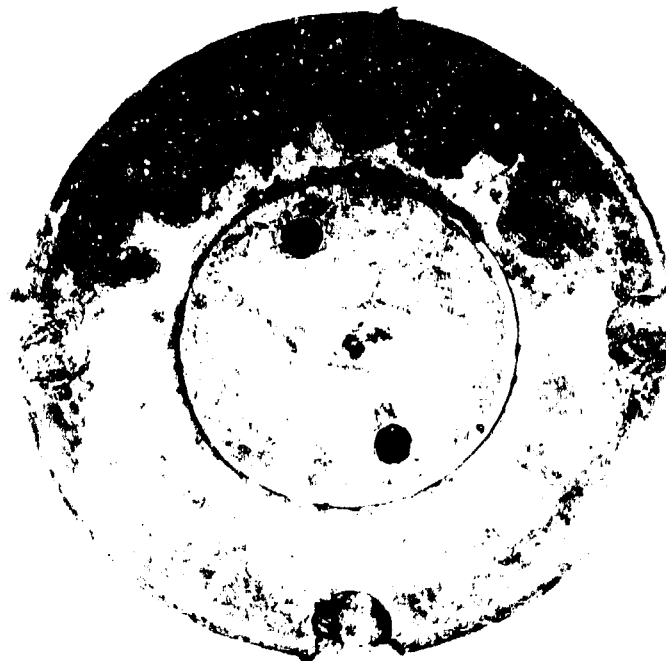
Figure 3  
NPG PHOTO NO. 2557 (APL)  
Bottom View and Deep Etched Section of Base Plug from  
Italian 6" Common Projectile, CEE No. 3438.  
15 May 1945
