NWL TECHNICAL REPORT TR-2943
January 1973

SURVIVABILITY OF AIR LAUNCHED GUIDED WEAPONS IN A FIRE ENVIRONMENT

Tests were conducted to establish fast cook-off characteristics of the following guided weapons: (a) SIDEWINDER (AIM-9), (b) WALL-EYE (MARK 1 MOD 0), (c) SPARROW III (AIM-7), and (d) SHRIKE (AGM-45A). The type of reaction that occurred, the time to reaction and time-temperature data were obtained for each guided weapon when engulfed in fire from burning JP-5 fuel. These data are applicable to the design of thermal protection systems and the development of safer fire fighting procedures.

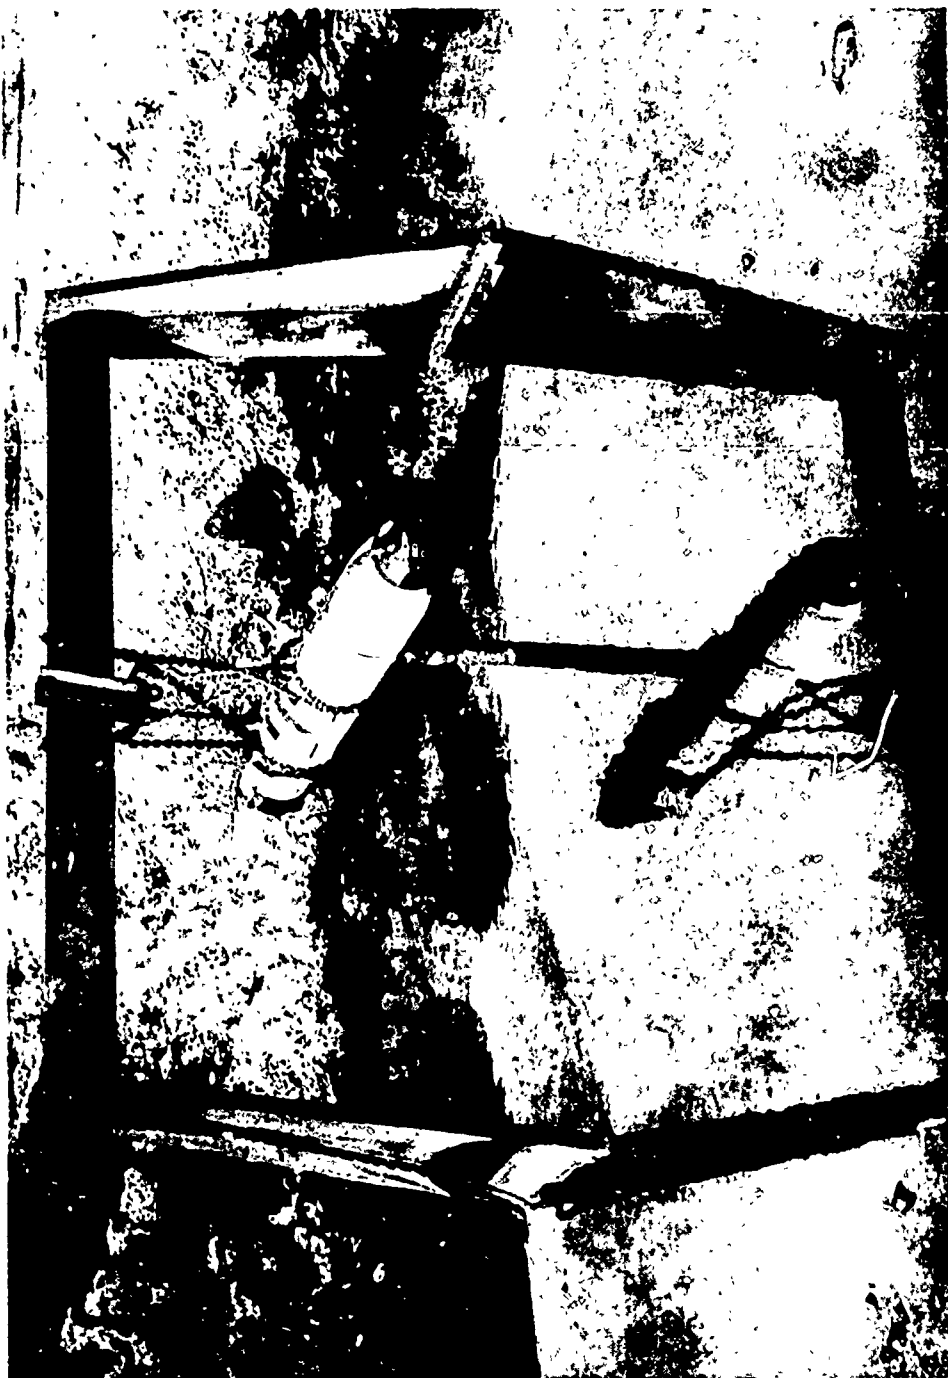
Open pit used for fast cook-off tests of the WALLEYE guided weapons.

Figure 3 is a view of the open pit. It was used to test the WALLEYE guided weapons which are not designed to react propulsively. The walls of the pit were banked to a height of approximately eight feet, and the pit contained a 30-foot square burning surface.

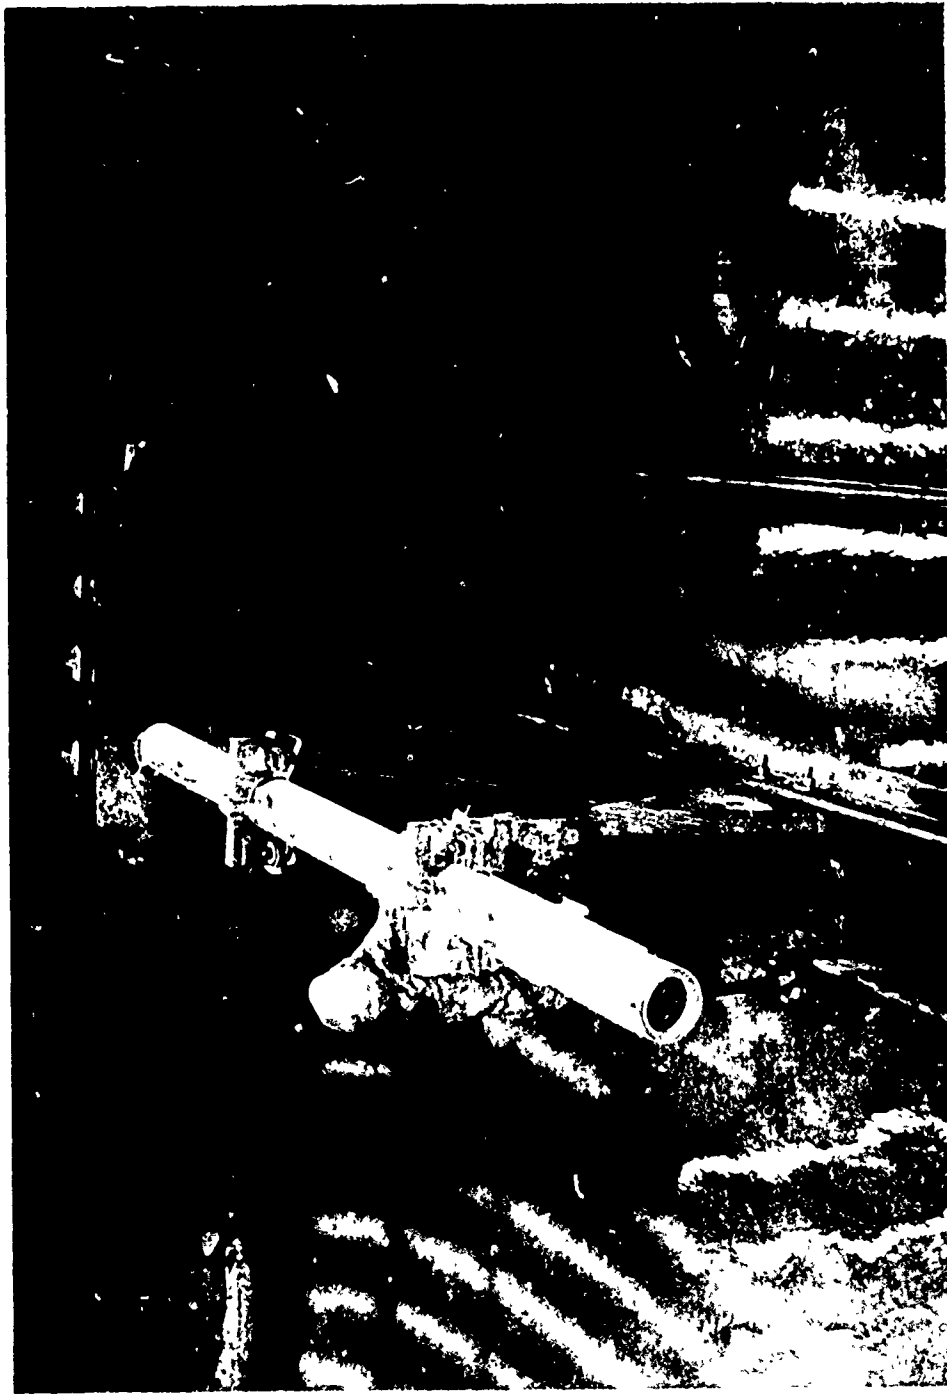
SIDEWINDER AIM-9 Missile pre-test configuration.

Facility: 30' x 30' retainer cage with encaged fuel pit
and test stand, Figure 4

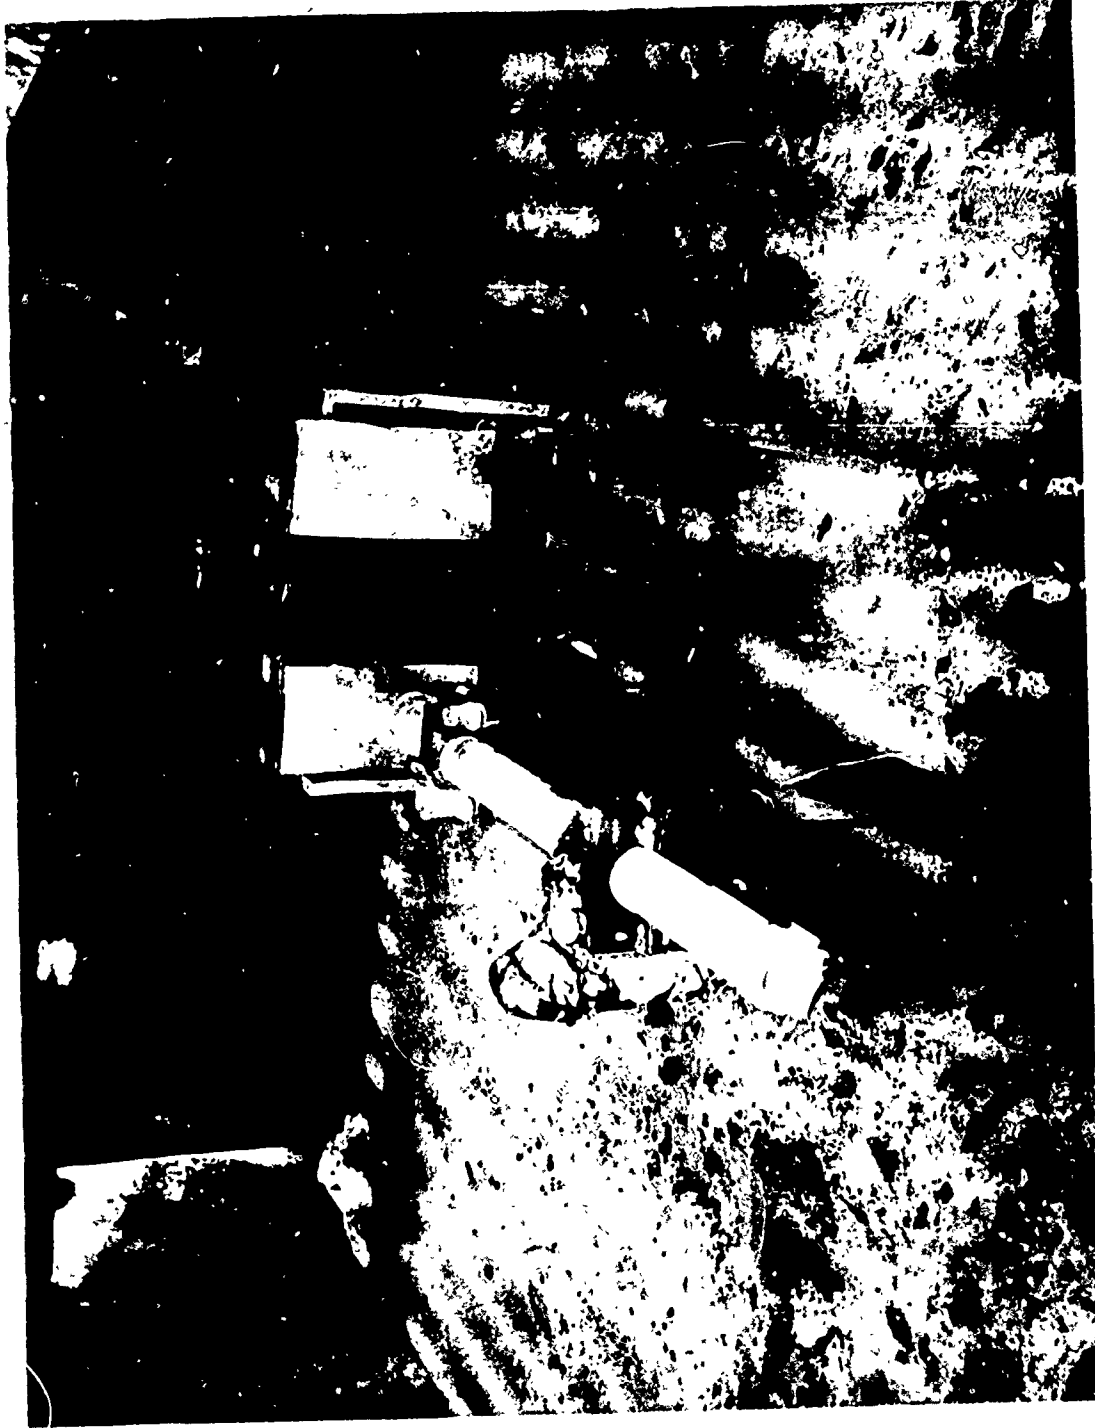
SIDEWINDER AIM-9 Missile after fast cook-off test No. GM-1.

View: Indentation on the retainer stand caused by the missile being forced forward by motor re-
action.

Inspection of the missile, after the test, showed
that the missile had exploded near the aft hanger.
Approximately 18 inches of the motor was missing
as shown in Figure 5. The motor reaction forced
the missile forward into the retainer stand.
Figure 6 shows an indentation on the retainer stand
that was caused by this reaction. The center of
the warhead section was bulged as shown in Figure 7.
The safe and arm device burned.

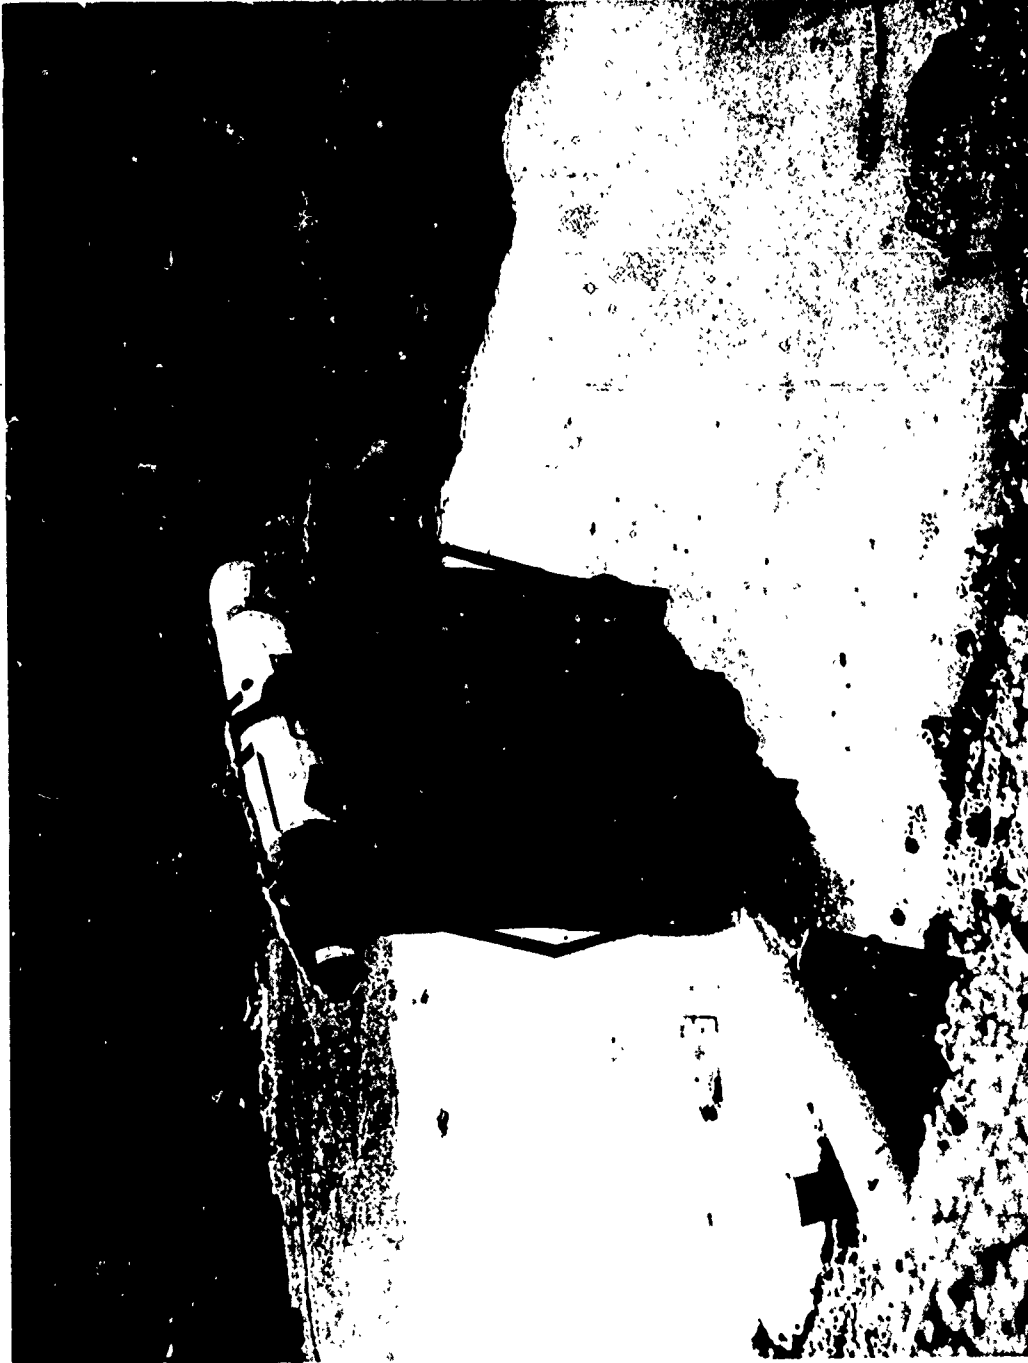
WALLEYE Guided Weapon MARK 1 MOD 0 pre-test configuration.

Facility: 30' x 30' open pit with test stand, Figure 9

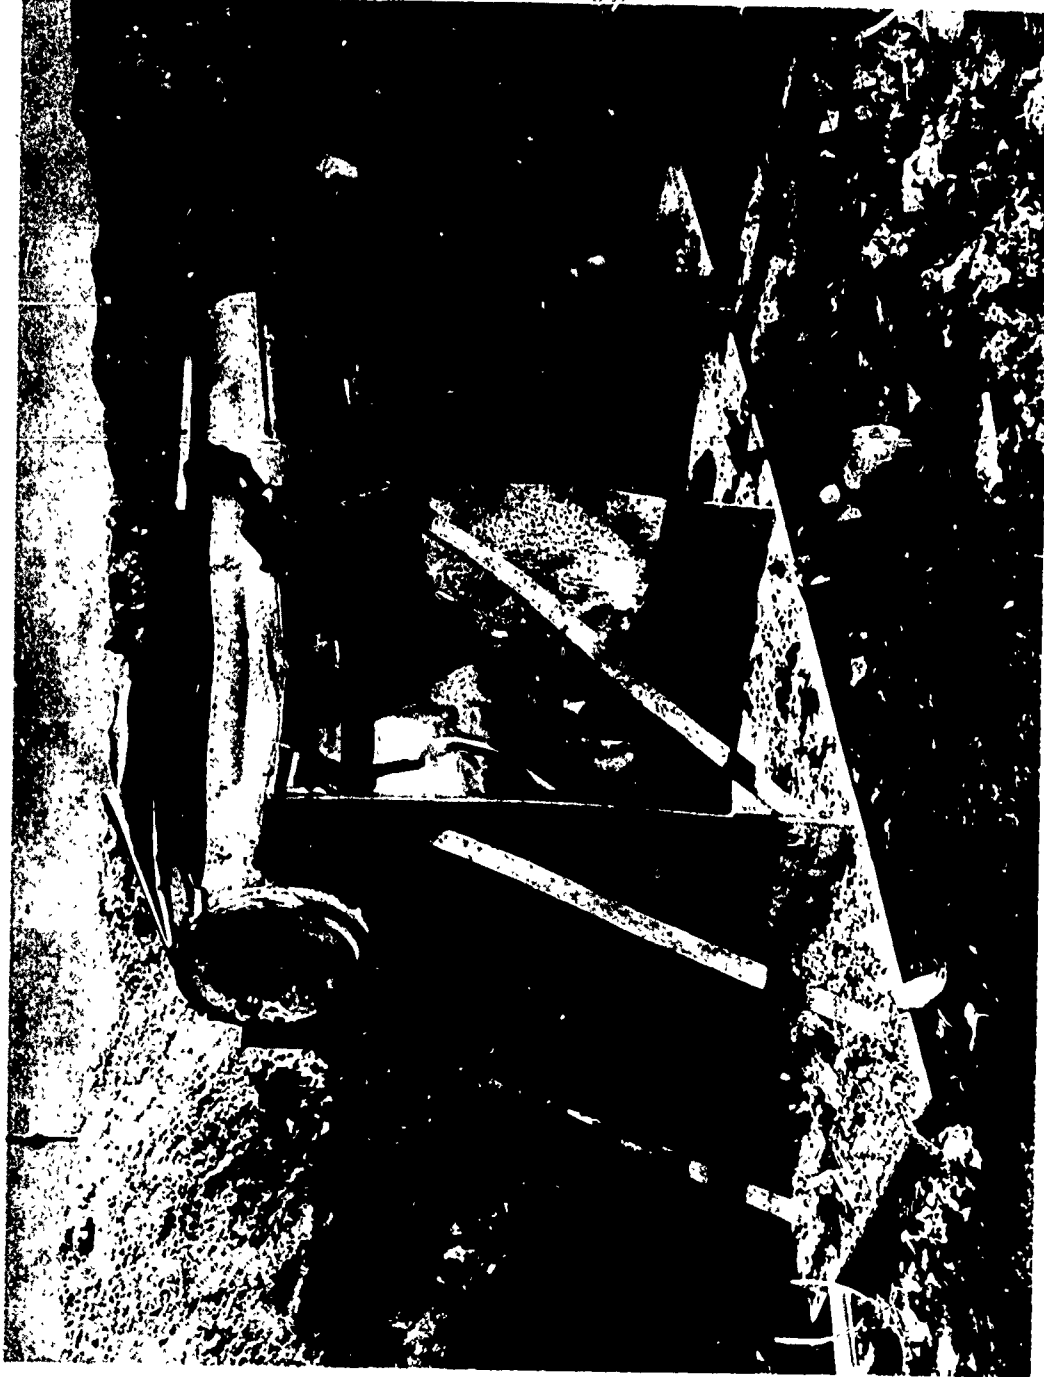
Rupture in the MARK 58 MOD 0 WALLEYE case caused by a deflagration in fast cook-off test No. GM-4.

Results: At two minutes 57 seconds after the fire was
ignited, the warhead deflagrated. Burning
occurred for three minutes 33 seconds, causing
the booster to deflagrate mildly. Figure 10
shows some unburned Comp-B explosive and the
rupture in the warhead case caused by the initial
reaction.

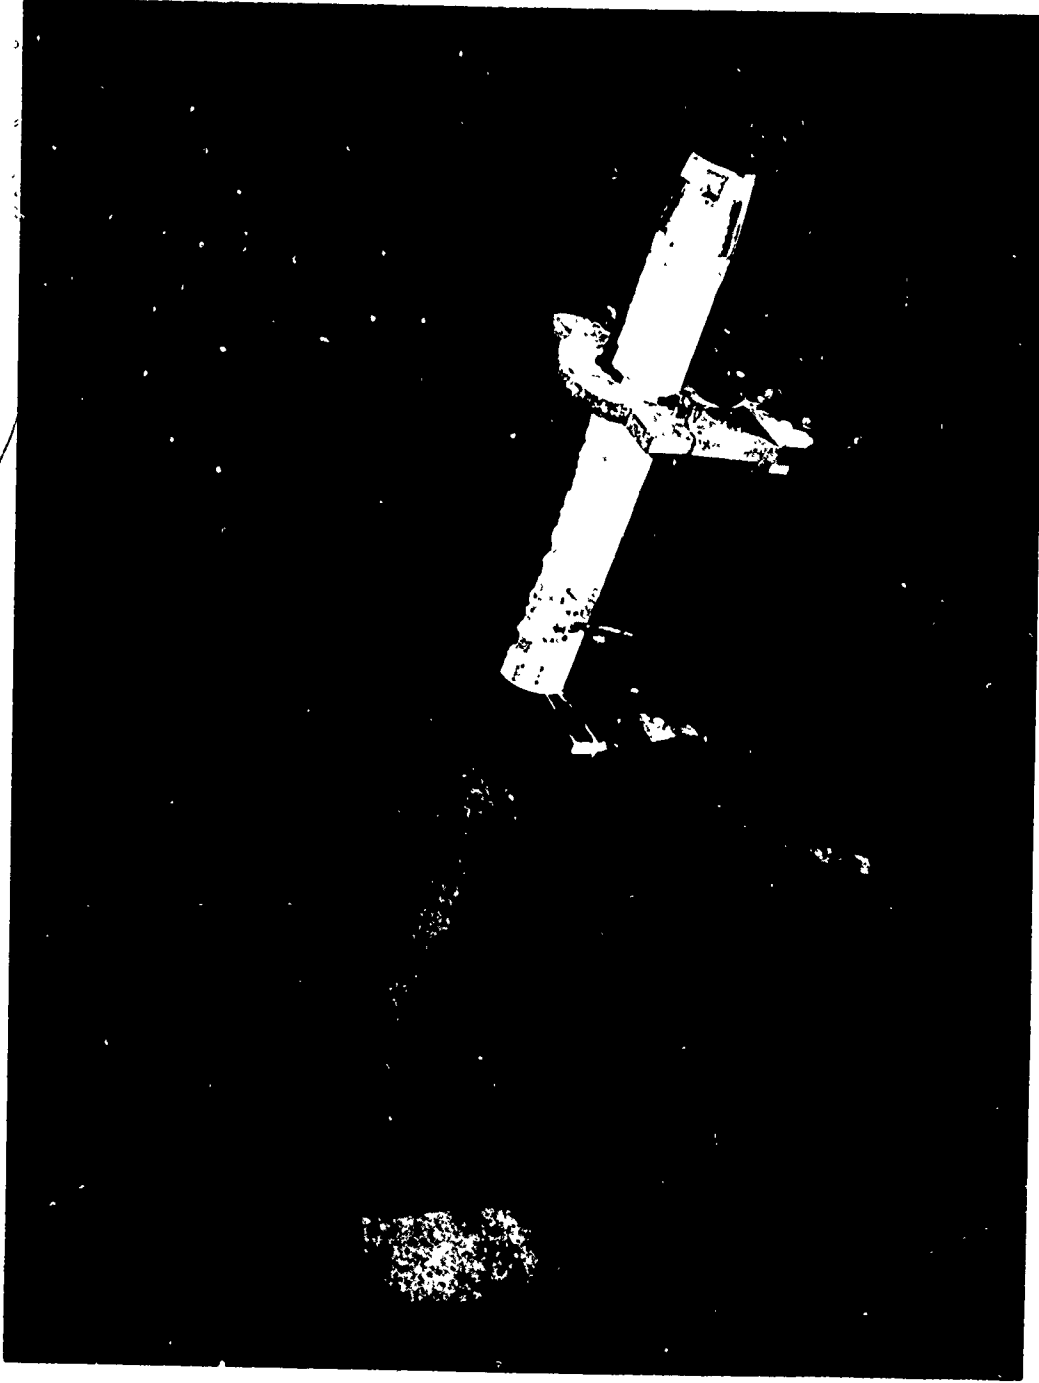
Figure 11

SPARROW III AIM-7 Missile pre-test configuration.

Results: At two minutes 3 seconds after fire ignition, the motor started to burn violently. The warhead reacted by burning at 16 minutes three seconds into the test. At four minutes 51 seconds after the warhead began burning, the safe and arm device deflagrated mildly. At one minute 13 seconds after the safe and arm device reacted, the booster deflagrated. Figures 11-13 show the pre-test configuration and post-test views of the weapon remains.

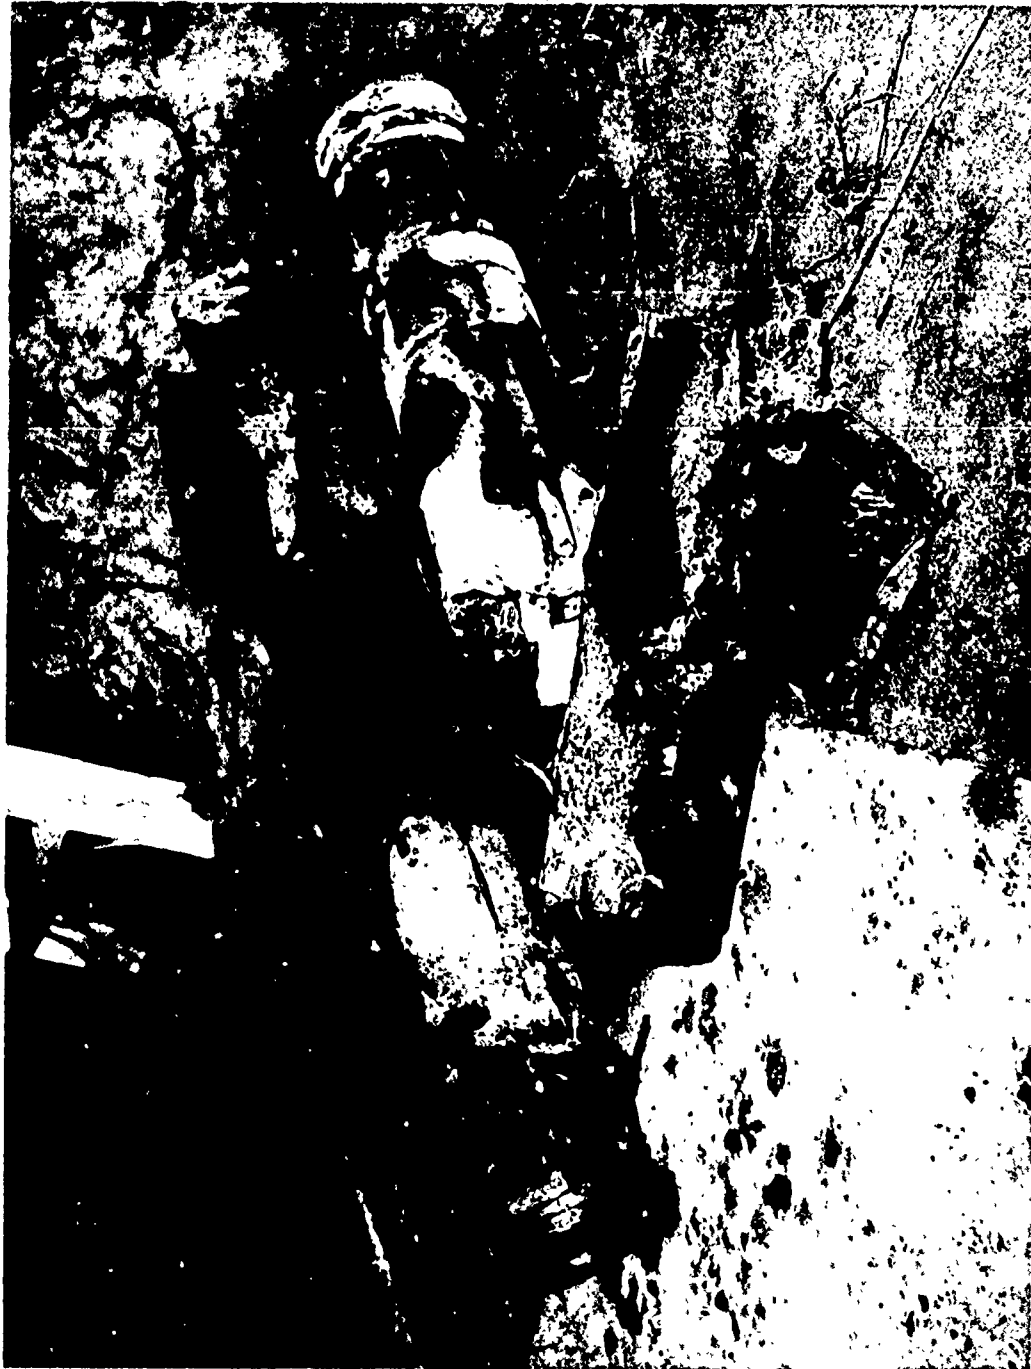
Figure 12

Remains of the SPARROW III AIM-7 Missile after reacting in fast cook-off test. No. GM-5.

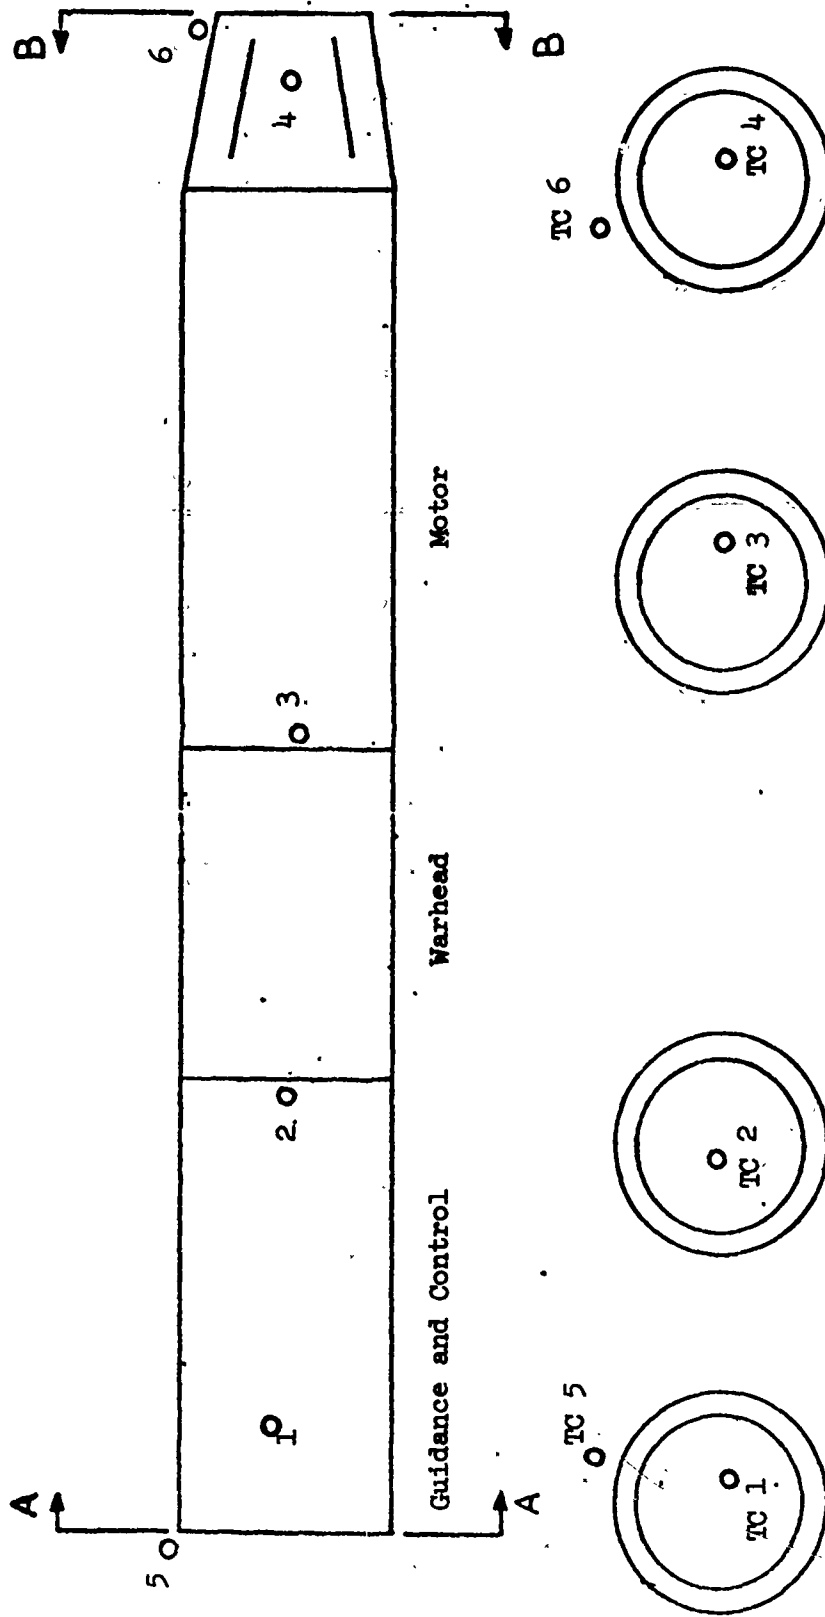
Location of thermocouples in the SPARROW III AIM-7 Missile for fast cook-off test

Thermocouple locations are shown in Figure 14 and the time-temperature data are presented in Figure 15.

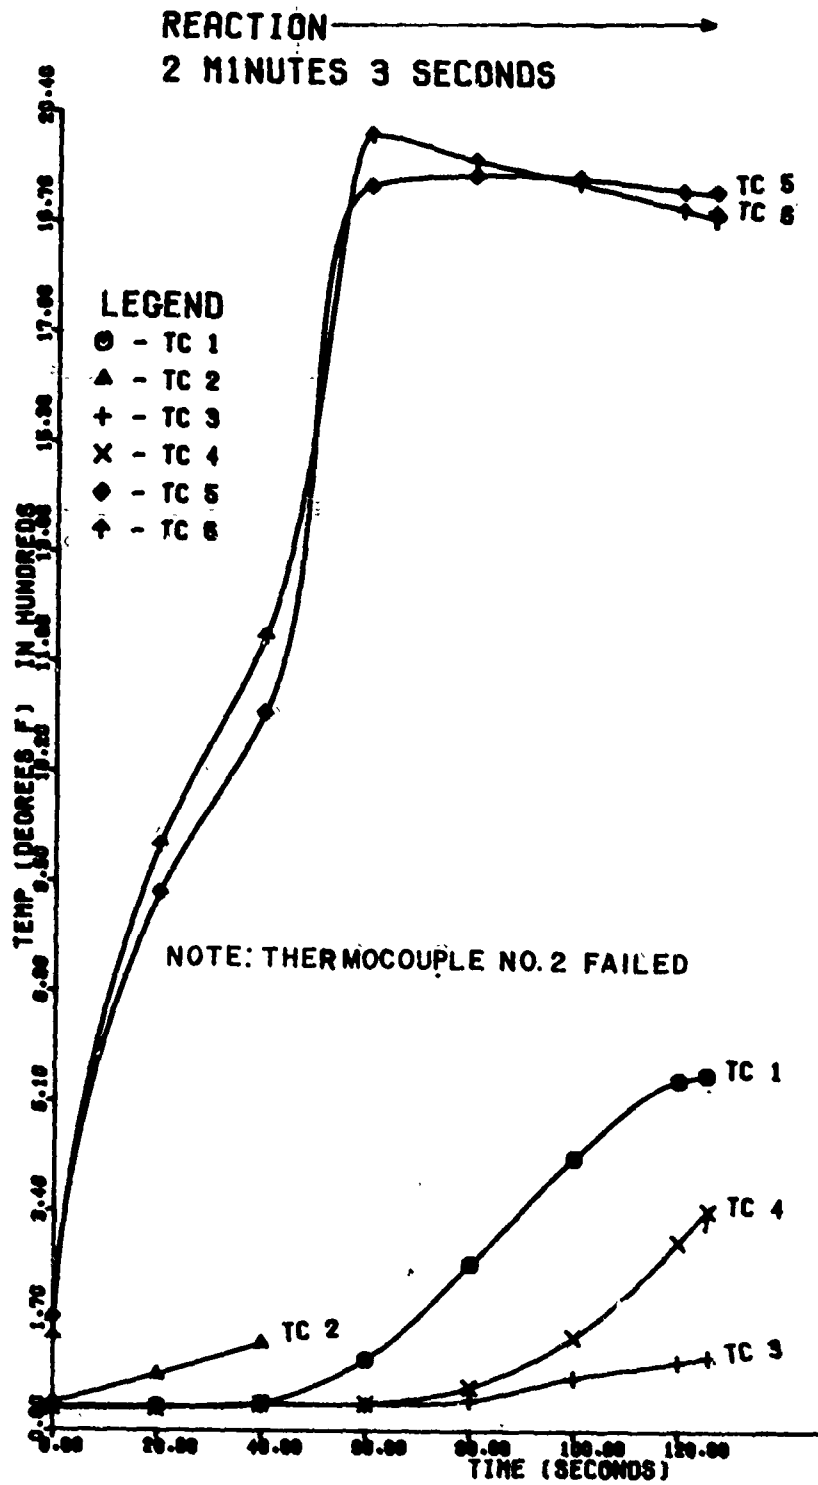
FIGURE 15
TIME-TEMPERATURE DATA FOR FAST COOK-OFF TEST NO. GM-5 OF
THE SPARROW III AIM-7 MISSILE SYSTEM

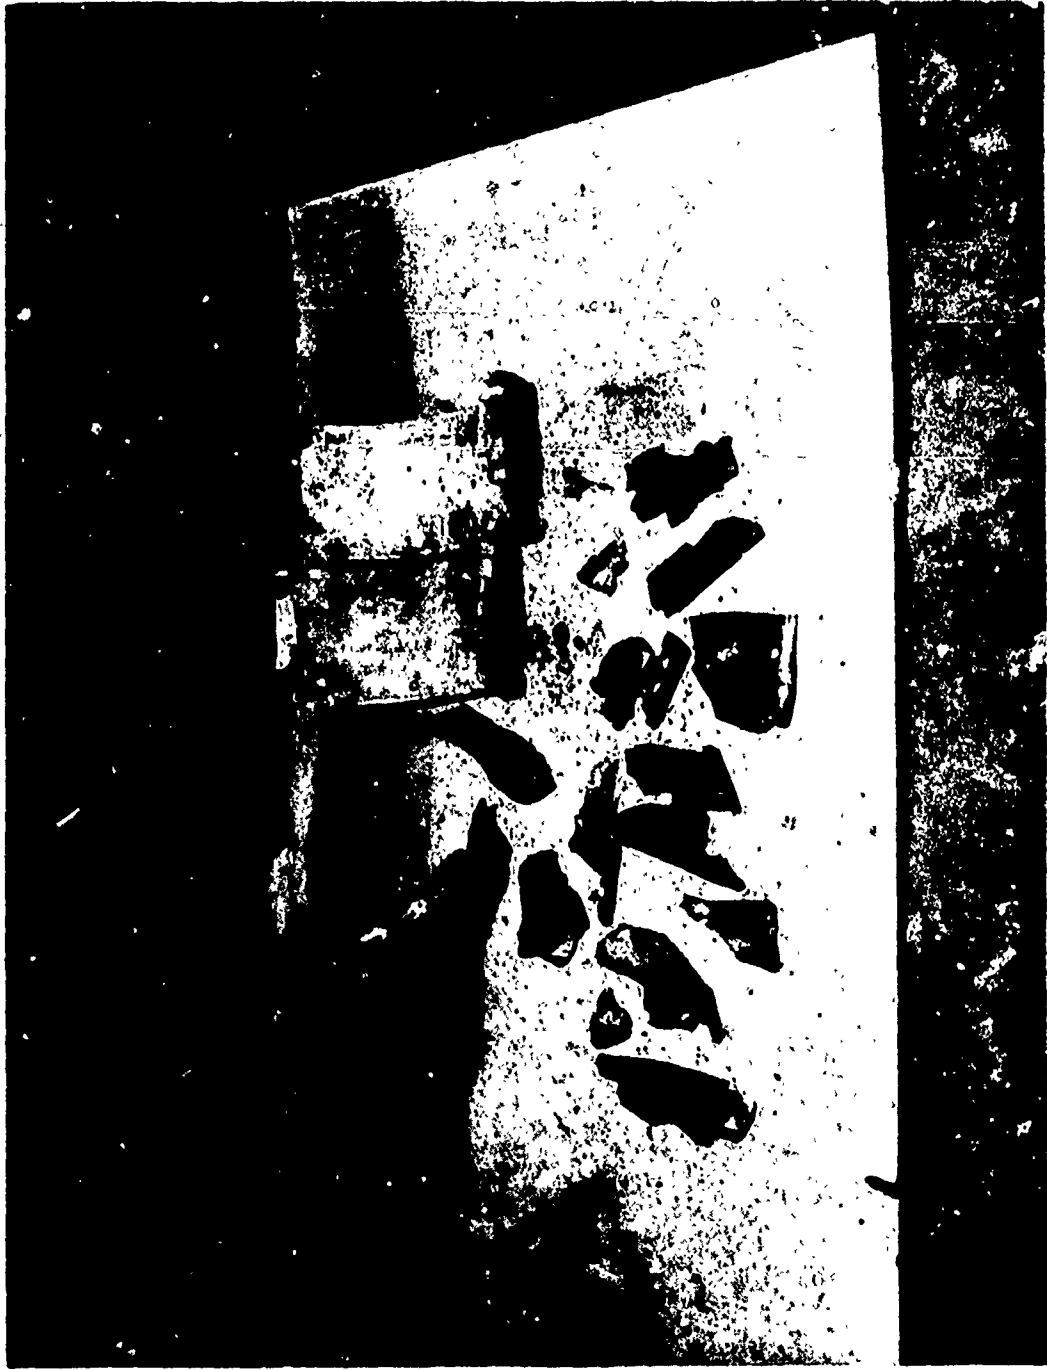
Figure 19

Fragments from SHRIKE AGM-45A Missile warhead and simulated guidance unit after exploding in fast cook-off test No. GM-7.

Results: At one minute 44 seconds after fire ignition,
the rocket motor deflagrated. The warhead
exploded at 13 seconds after the motor reacted,
throwing fragments and burning explosive
about the cage. Figure 17 shows the pre-test
configuration. Figures 18 and 19 show the
motor and warhead remains. Thermocouple
locations are shown in Figure 20 and the time-
temperature data are provided in Figure 21.

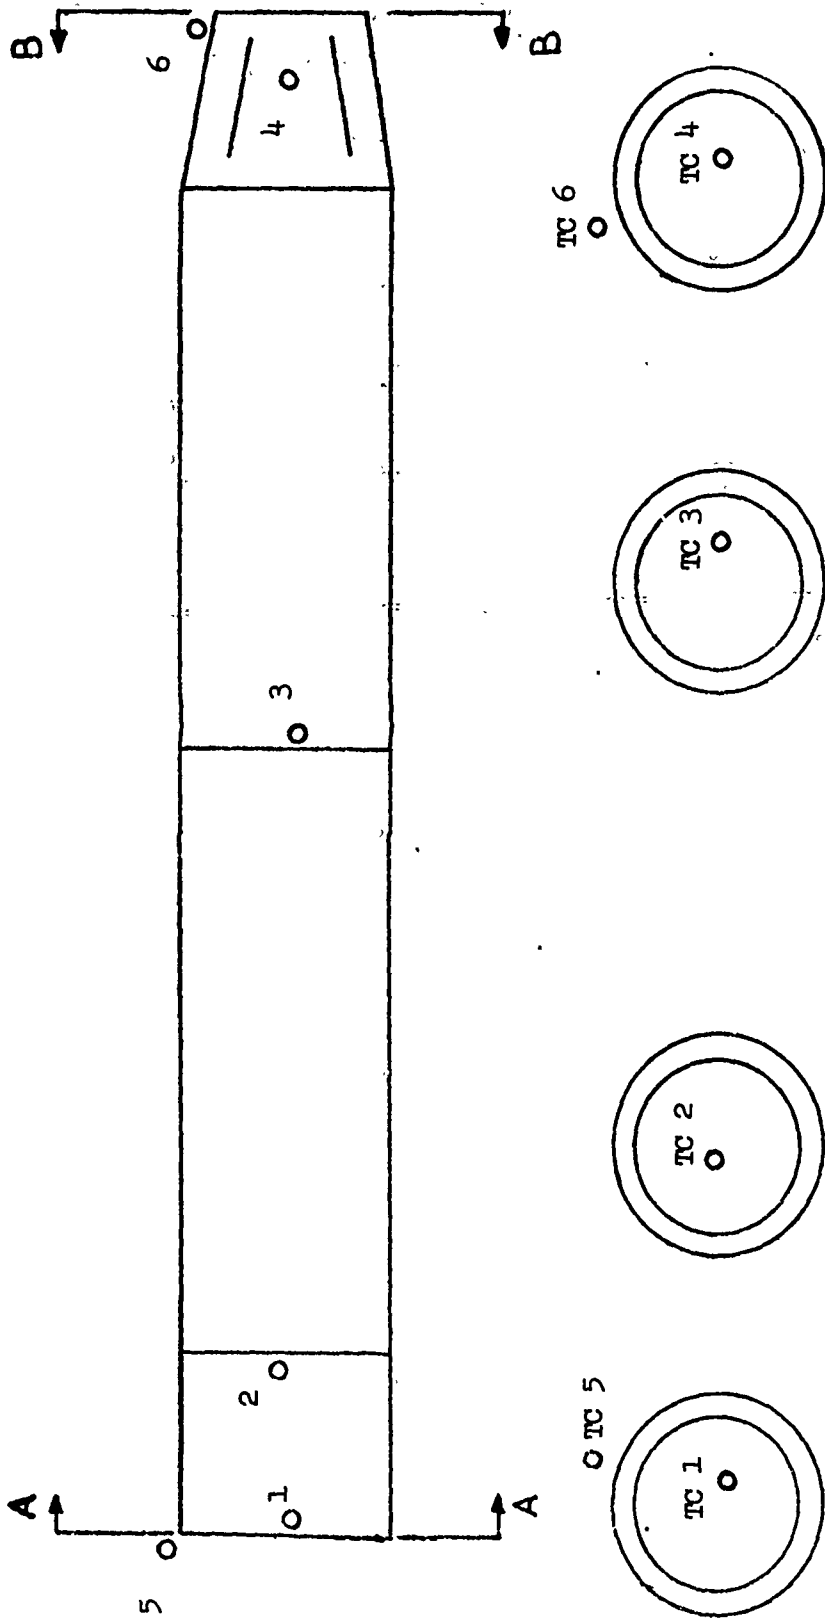
Figure 20

Thermocouple location in the SHRIKE ACM-45A Missile for fast cook-off test. No. GM-7

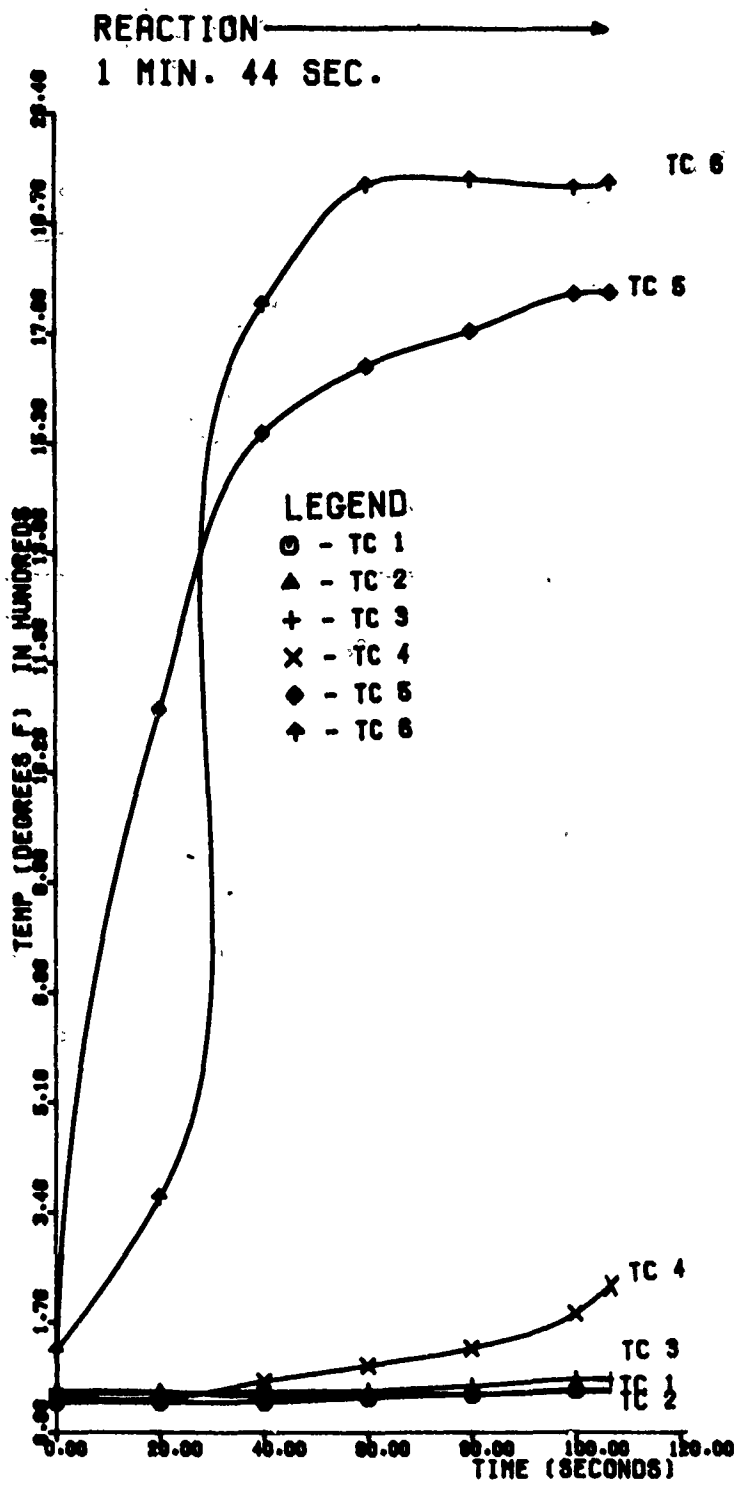
FIGURE 21
 TIME-TEMPERATURE DATA FOR FAST COOK-OFF TEST NO. GM-7 OF
 THE SHRIKE AGM-45A MISSILE SYSTEM

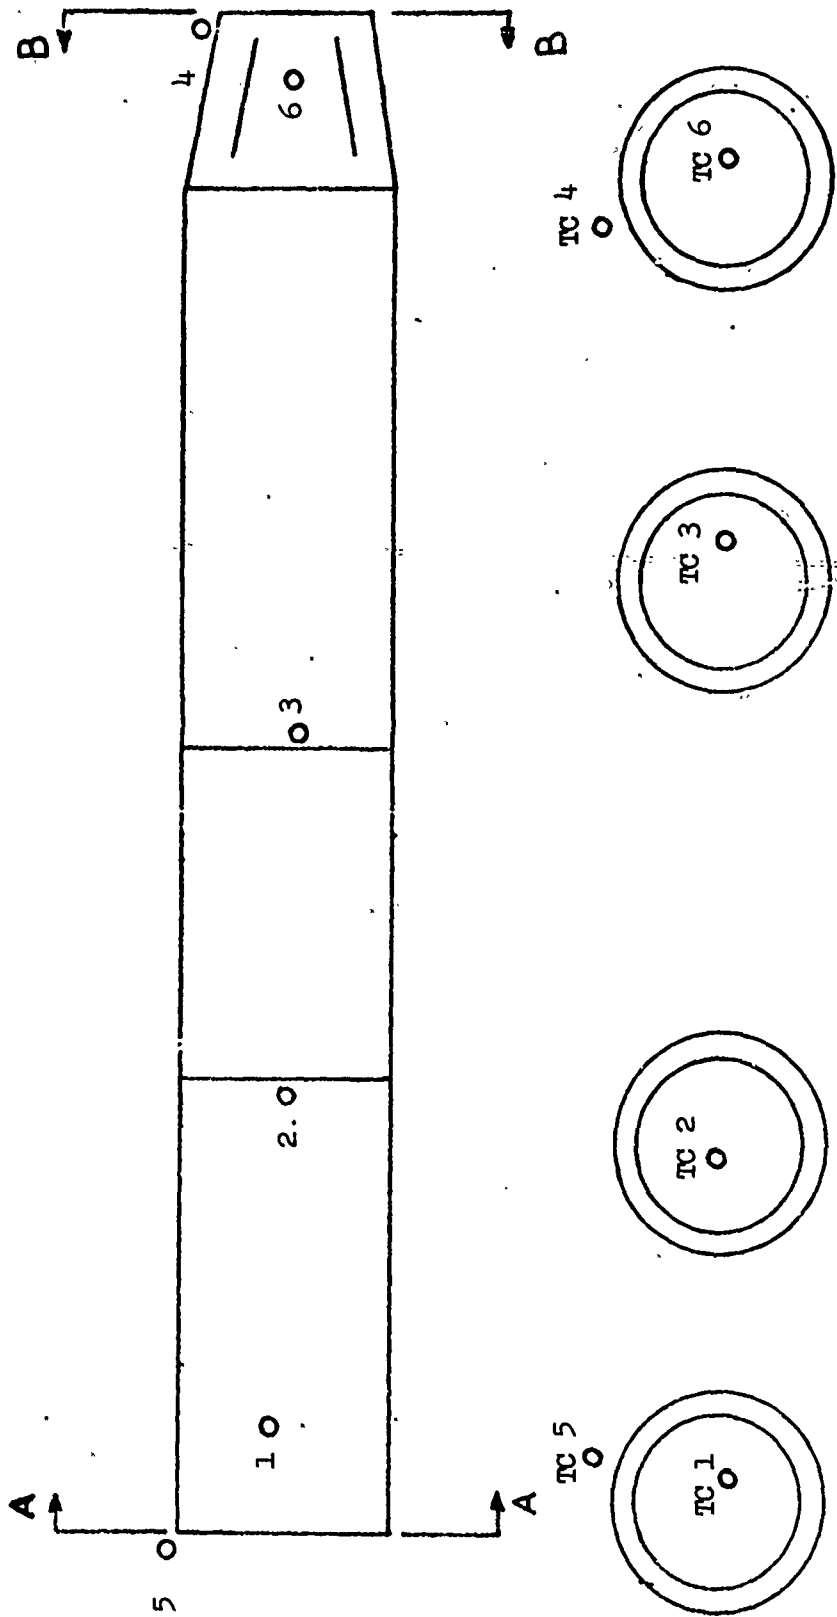
Figure 24

Location of thermocouples in the SHRIKE AGM-45 Missile for fast cook-off test No. GM-8

Results: The warhead exploded at one minute 17 seconds after the fire was started. The motor deflagrated at one minute 29 seconds. Fragments from the warhead were thrown about the test site. Figure 22 shows the warhead fragments that were recovered from the test. The remains from the motor are shown in Figure 23. Thermocouple locations and the time-temperature data are provided in Figures 24 and 25.

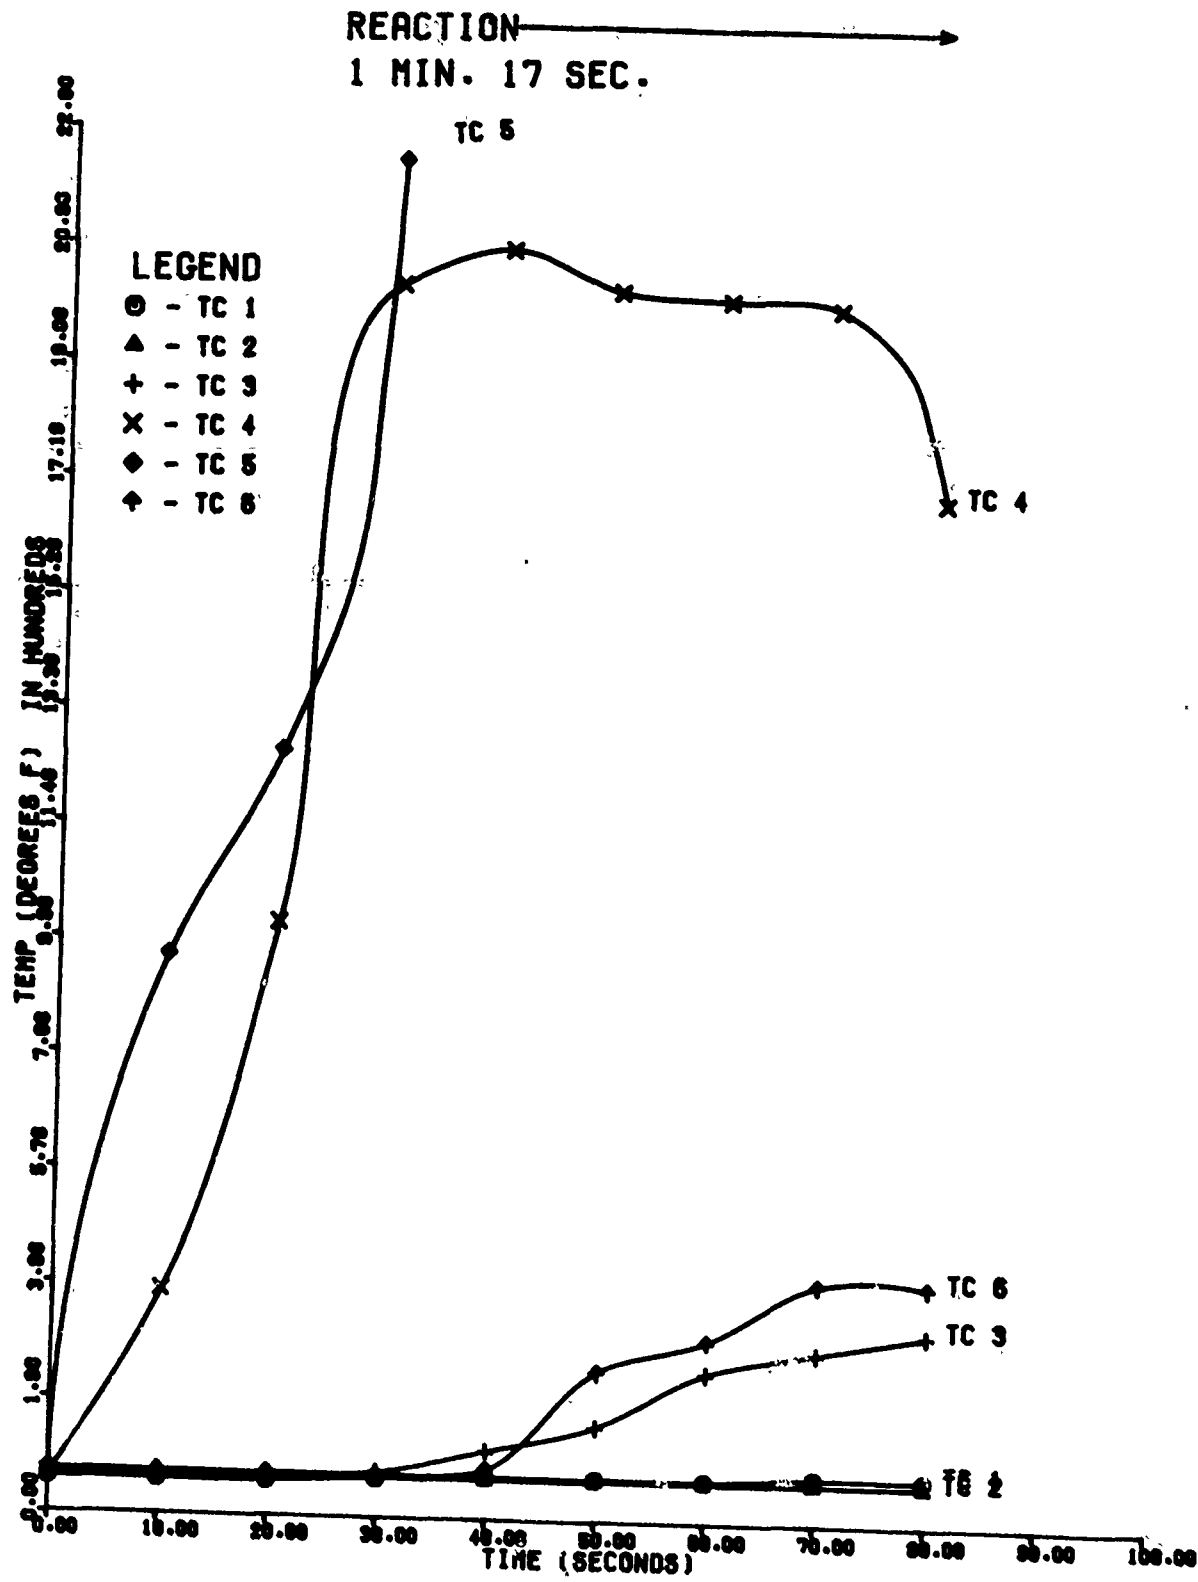
FIGURE 25
TIME-TEMPERATURE DATA FOR FAST COOK-OFF TEST NO. GM-8 OF
THE SHRIKE AGM-45A MISSILE SYSTEM
